## **FACILITIES CONDITION ASSESSMENT**

### **Rivendell Interstate School District**

Rivendell Academy East & West Wings | Samuel Morey Elementary | Westshire Elementary

September 25, 2025

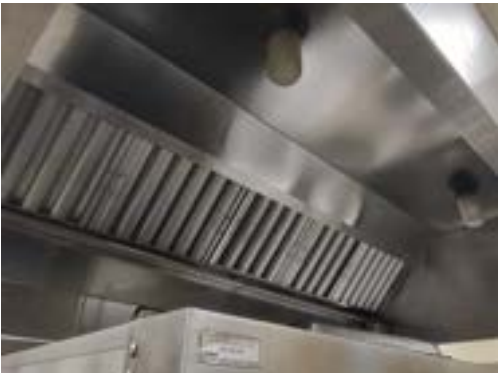
| | | <p>Grill hood to exhaust fan - noise dampening needed. Added burners requested by staff.</p> |

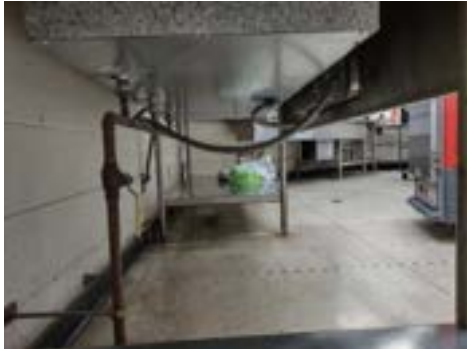
| | | <p>Fill and drains to be upgraded on food service line.</p> |

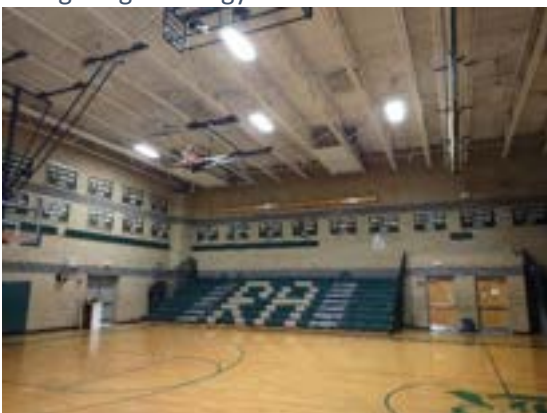
| | | T-8 lighting in the gym. |

T-8s should be replaced with LED.

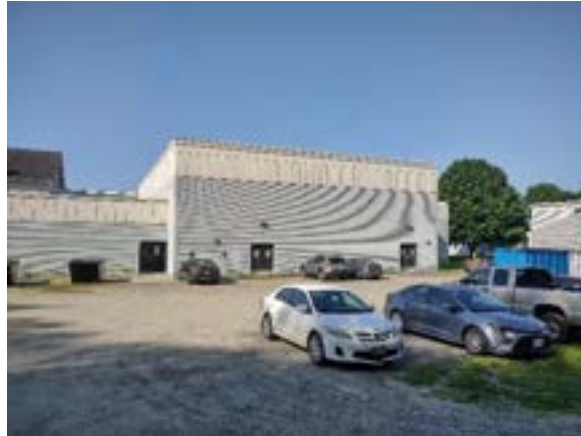
Exterior flood lights limited, showing signs of age.

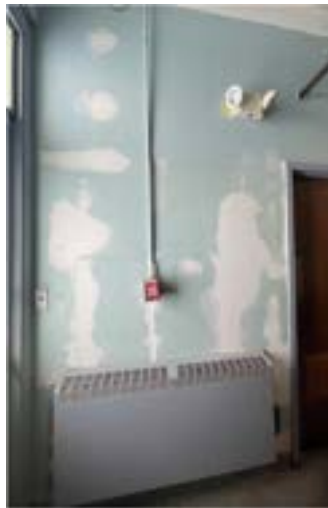
| | | Walls/ Columns | <p>Poor condition. Walls have numerous unfinished patches, wall base missing.<br/>Recommendation – Repair and repaint wall, install wall base.</p> |

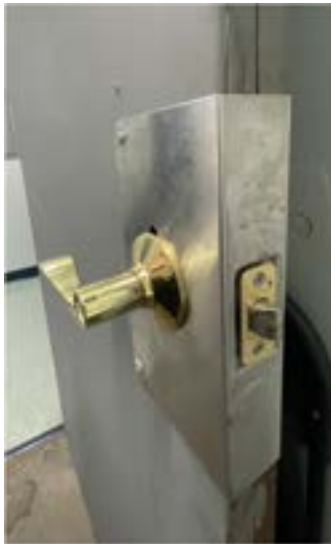
| | | Doors | Poor condition. Metal door has holes, damaged edges.<br>Recommendation – Replace door.<br> |

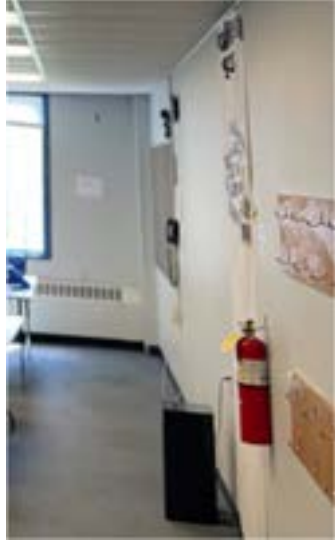
| | | Walls/ Columns | Good condition. Some dings and scrapes on blue wall.<br>Surface mounted fire extinguisher exceeds ADA maximum allowed projection.<br>Recommendation – Touch up damage and repaint blue wall. Place fire extinguisher out of path of travel or mount in semi-recessed cabinet. |

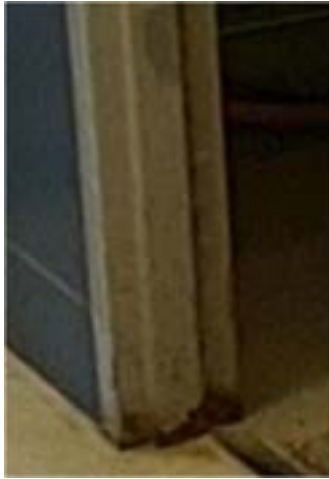
| | | Doors | <p>Fair condition – Interior door. Frame rusted at bottom.</p> <p>Poor condition – Exterior door.<br/>Recommendation – Patch and repaint interior door frame, replace exterior door.</p> |

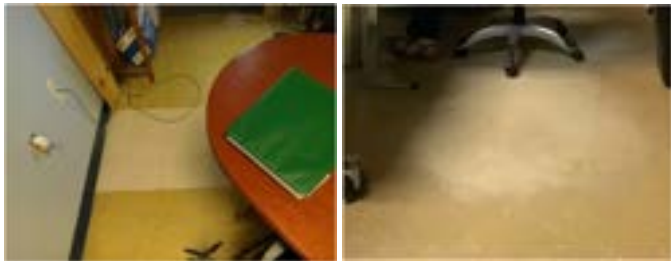
| | | Floor | <p>Fair condition. 2130 has wear pattern at desk. 2132 has mismatched VCT and wear pattern at desk.<br/>Recommendation – Replace worn and mismatched VCT, may require replacement of all VCT in room if product no longer available.</p> |

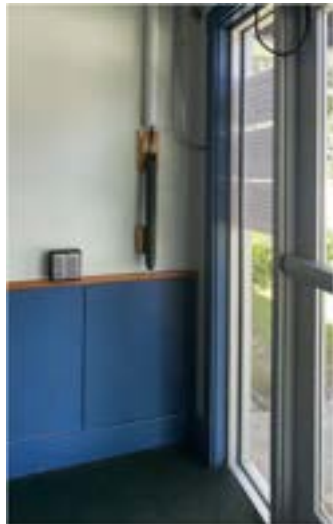
| | | Walls/ Columns | Good condition – Vestibule. Some paint discoloration and chips at “wainscot”, unknown device on south wall.<br><br>Fair condition – Lobby.<br>Recommendation – Repaint discolored areas, properly conceal device on south wall. |

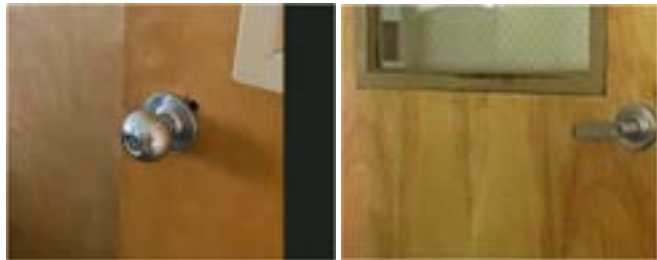
| | | Doors | Fair condition. Office 2148 entry door operating hardware does not conceal holes for previous hardware. Office 2150 entry door lite frame and bottom of door frame have rust.<br>Recommendation – Replace knobs with levers having rosette sized to conceal holes if door is not replaced. Prep and paint rusted elements.<br> |

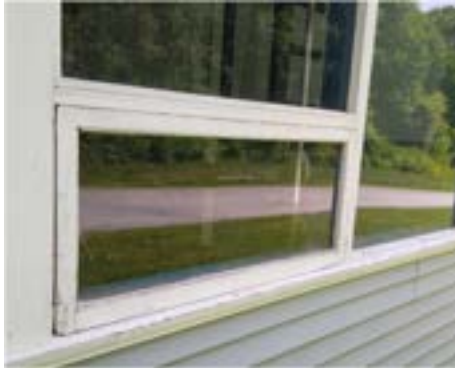
| | Windows | <p>Overall fair condition – South portion. Wood hung windows difficult to open, some screens damaged. Fair condition vinyl, poor condition wood – North portion. Wood windows deteriorated / rotted. Seal is broken on some thermal panes, some screen frames show signs of rust.</p> <p>Recommendation – Replace wood windows, replace thermal panes with broken seals, replace rusty screens.</p> | <br> |

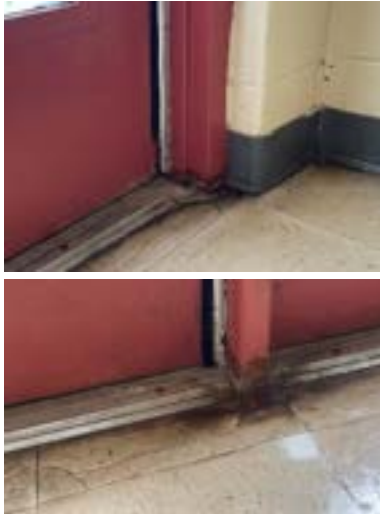
| | | Doors | Poor condition. |

| | | | <p>Recommendation – Replace exterior doors and frames.</p> |

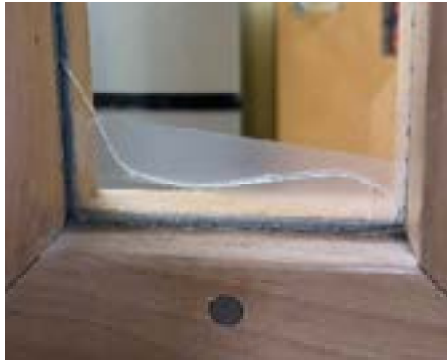
| | | Doors | Good condition. Glass lite cracked inside.<br>Recommendation – Replace door with new glass light. |
| | | | <p>This door was also locked and described as not in use. From the interior side there is no</p> |

| | | | <p>additional door for students to reach the nurses office other than through the adjacent restroom space.</p> <p>Recommendation – Provide access to Nurse 3121 through space other than adjacent restroom.</p> |

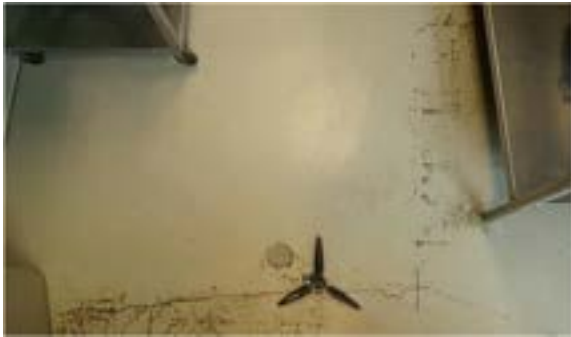
| | | Floor | <p>Poor condition. Paint finish worn away in many locations, cracks in concrete.</p> <p>Recommendation – Repair cracks, install new seamless flooring and integral wall base suitable for kitchen sanitation requirements.</p> |

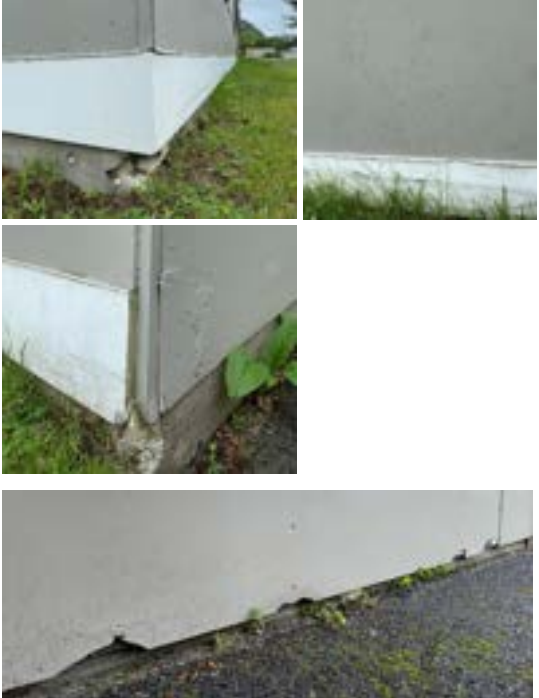
| | | Foundation | <p>Fair condition. Synthetic stucco over insulation board generally in fair condition; corner conditions throughout the building show significant deterioration.</p> <p>Recommendation – Repair corner conditions, patch, repair refinish to match existing.</p> |

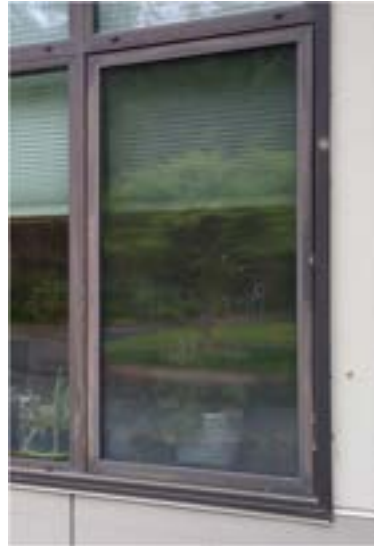
Additional areas of siding damage at windows specifically. Refer to above siding section for recommendations.

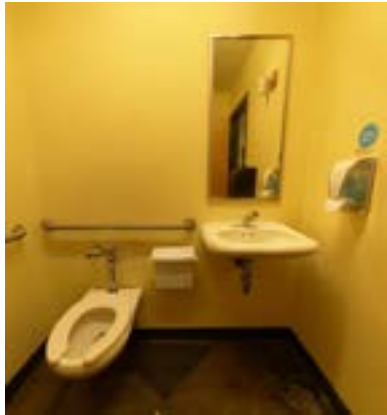
| | | | <p>Paper towel dispenser exceeds 4" protrusion limit.</p> |

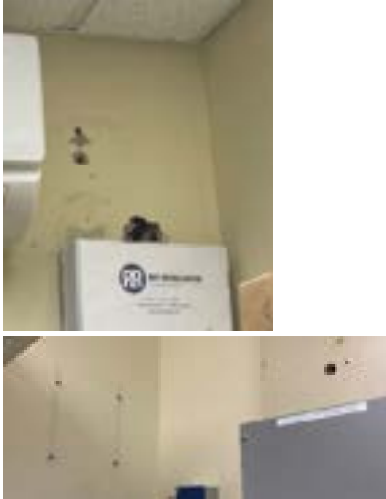
| | | Walls/ Columns | Fair condition some holes.<br><br>Recommendation - Patch holes, repaint wall. |

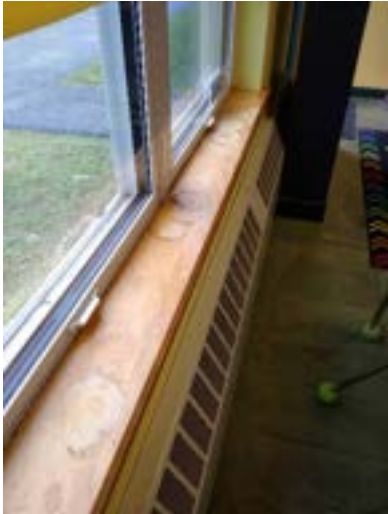
| | | Walls/ Columns | Good condition.<br>Windowsills poor condition.<br>Recommendation – Replace water damaged sills. |

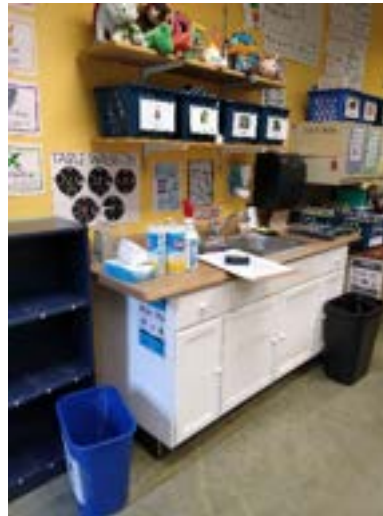
38" sink counter laminate but no clear ADA access below.  
Recommendation – Install ADA access sink cabinet with proper counter height.

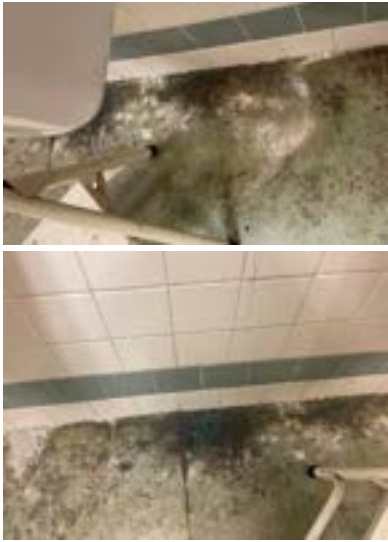
| | | Floor | Poor condition. Damaged floor shows signs of water damage.<br>Recommendation – Replace flooring or provide extensive cleaning / water damage repair to existing flooring. |

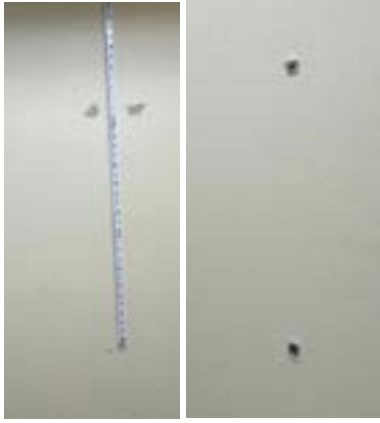
| | | Walls/ Columns | <p>Fair Condition. Holes and damage.</p> <p>Recommendation – Patch and paint.</p> |

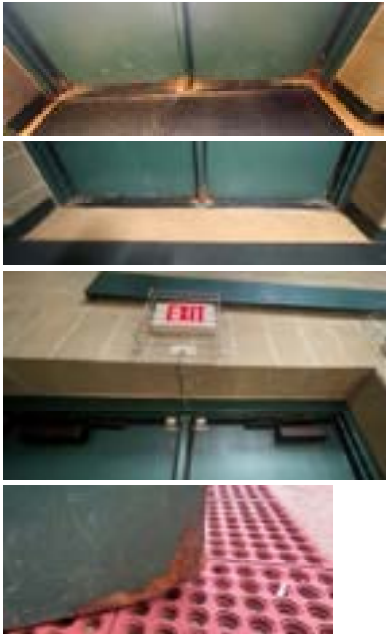
| | | Doors | <p>Poor Condition. Rusted door bottom, missing or broken hardware.</p> <p>Recommendation – Replace doors and all hardware.</p> |

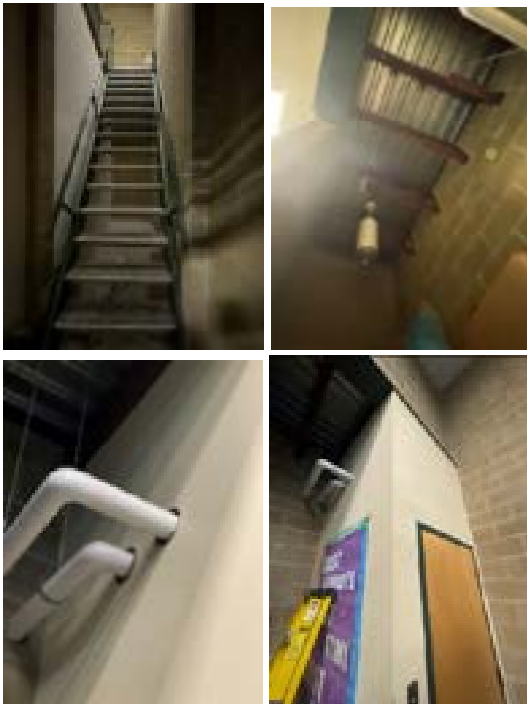
| | | | <p>Stair to mezzanine utility only, non ADA. Shown only for reference.</p> <p>Space is in good condition overall; however, door is rated but only portions of the wall are sealed to meet the required 2-hour rating.</p> |

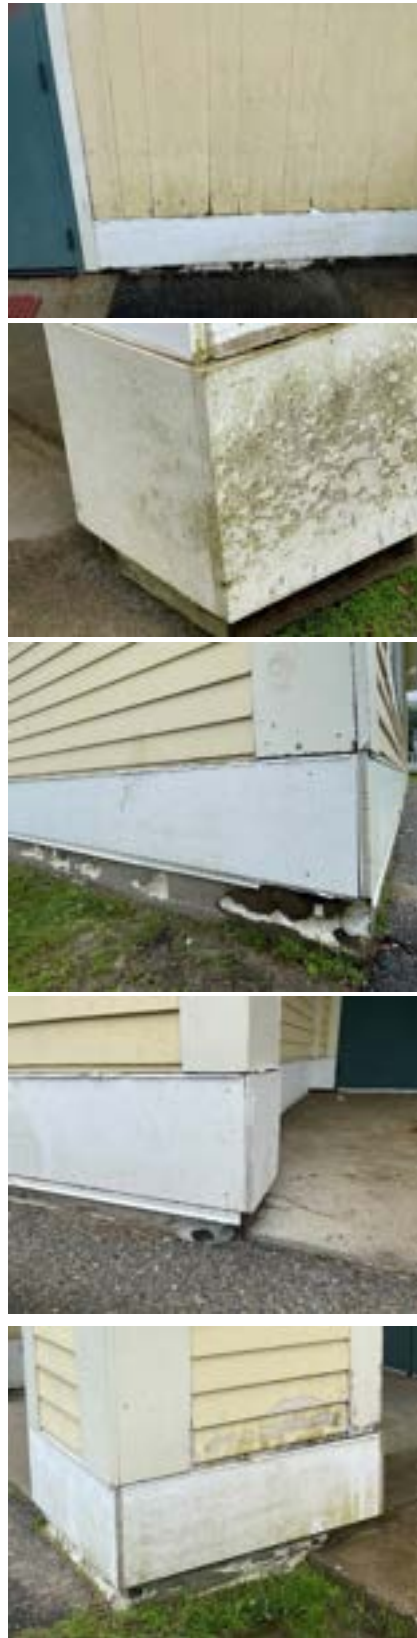
| | Siding / Trim | <p>Poor condition. See below photos for a wide variety of siding issues rendering the need for replacement. Recommendation – Replace siding and all associated trim. Confirm no water damage behind siding.</p> |

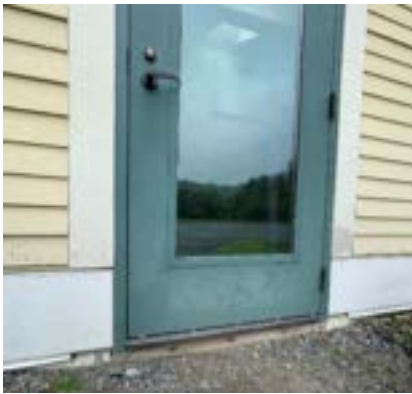
| | | Doors | <p>Poor condition. Damaged base of door and frame, rusted, worn, and faded.</p> <p>Recommendation – Repair doors and replace door / frame where necessary.</p> |
