## **FACILITIES CONDITION ASSESSMENT**

### **Rivendell Interstate School District**

Rivendell Academy East & West Wings | Samuel Morey Elementary | Westshire Elementary

September 25, 2025

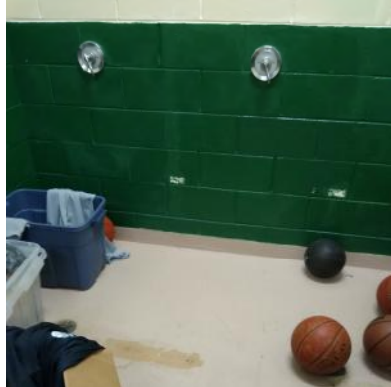
| | | Floor | Poor condition. Epoxy worn in shower areas.<br>Poor condition at the remainder of Locker room floors.<br>Recommendation – replace all locker room tile and remaining flooring.<br> |

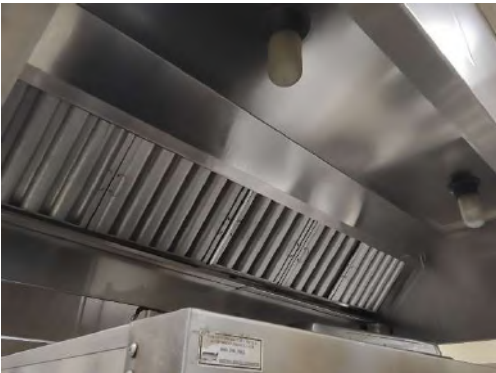
| | | <p>Grill hood to exhaust fan - noise dampening needed. Added burners requested by staff.</p> |

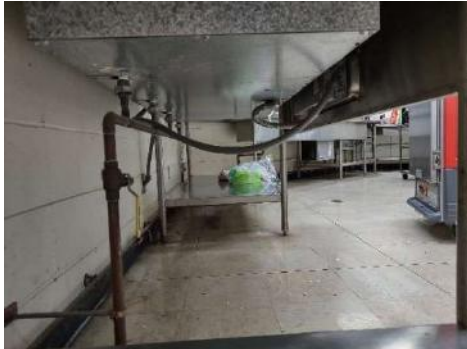
| | | <p>Fill and drains to be upgraded on food service line.</p> |

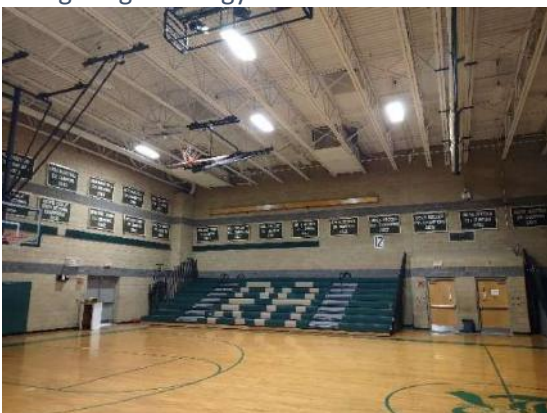
| | | <p>T-8 lighting in the gym.</p> |

T-8s should be replaced with LED.

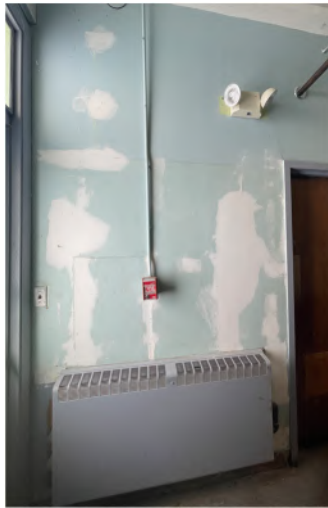
| | | Walls/ Columns | <p>Poor condition. Walls have numerous unfinished patches, wall base missing.<br/>Recommendation – Repair and repaint wall, install wall base.</p> |

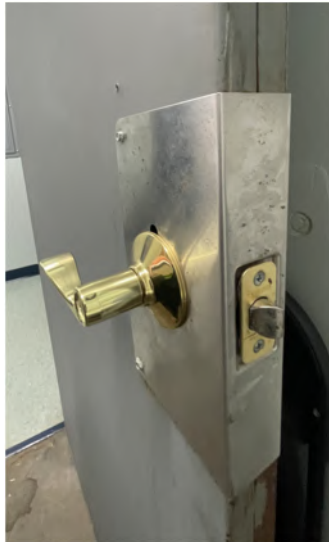
| | | Doors | Poor condition. Metal door has holes, damaged edges.<br>Recommendation – Replace door.<br> |

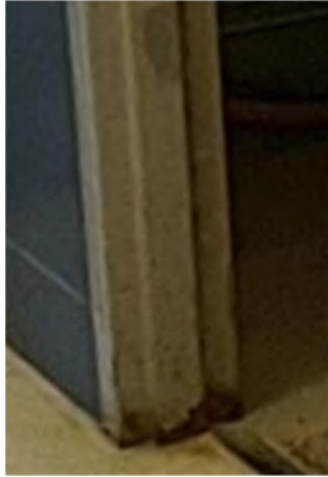
| | | Doors | <p>Fair condition – Interior door. Frame rusted at bottom.</p> <p>Poor condition – Exterior door.<br/>Recommendation – Patch and repaint interior door frame, replace exterior door.</p> |

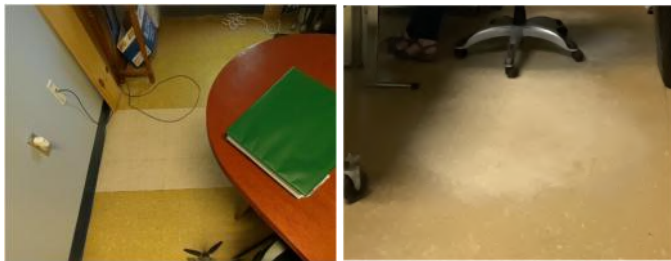
| | | Floor | <p>Fair condition. 2130 has wear pattern at desk. 2132 has mismatched VCT and wear pattern at desk.<br/>Recommendation – Replace worn and mismatched VCT, may require replacement of all VCT in room if product no longer available.</p> |

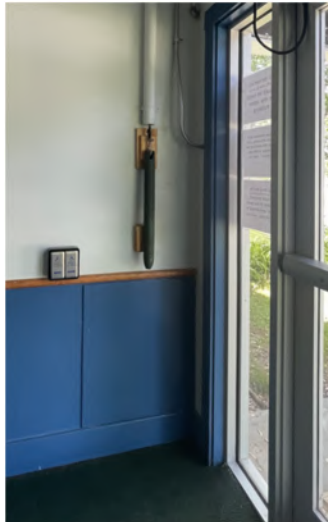
| | | Walls/ Columns | Good condition – Vestibule. Some paint discoloration and chips at “wainscot”, unknown device on south wall.<br><br>Fair condition – Lobby.<br>Recommendation – Repaint discolored areas, properly conceal device on south wall. |

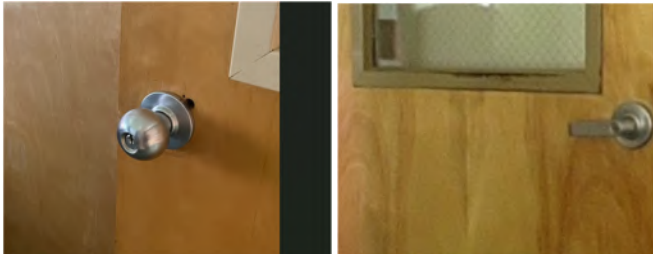
| | | Doors | Fair condition. Office 2148 entry door operating hardware does not conceal holes for previous hardware. Office 2150 entry door lite frame and bottom of door frame have rust.<br>Recommendation – Replace knobs with levers having rosette sized to conceal holes if door is not replaced. Prep and paint rusted elements.<br> |

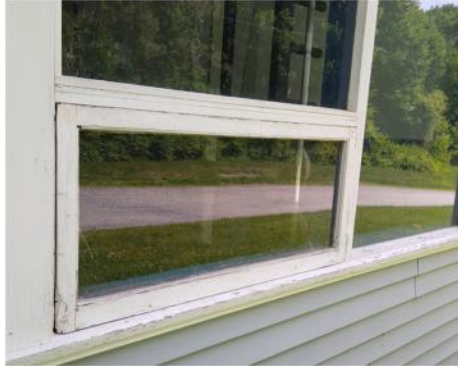
| | Windows | <p>Overall fair condition – South portion. Wood hung windows difficult to open, some screens damaged. Fair condition vinyl, poor condition wood – North portion. Wood windows deteriorated / rotted. Seal is broken on some thermal panes, some screen frames show signs of rust.</p> <p>Recommendation – Replace wood windows, replace thermal panes with broken seals, replace rusty screens.</p> | <br> |

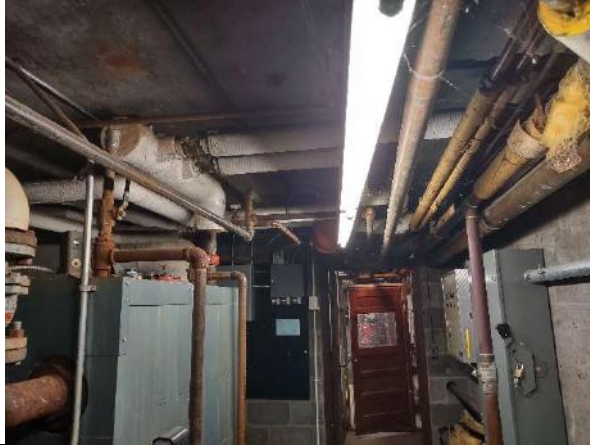
T-8 lighting in the boiler room.

T-8s should be replaced with LED.

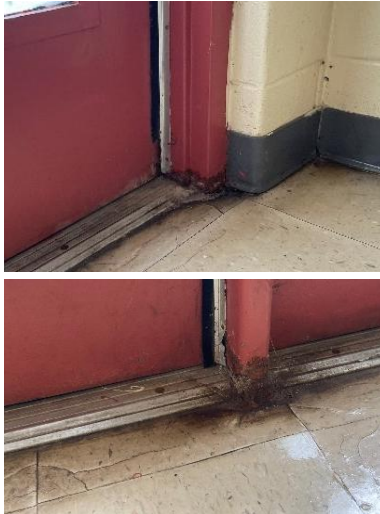
| | | Doors | Poor condition. |

| | | | <p>Recommendation – Replace exterior doors and frames.</p> |

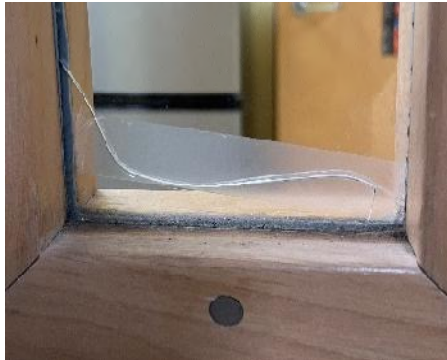
| | | Doors | Good condition. Glass lite cracked inside.<br>Recommendation – Replace door with new glass light. |
| | | | <p>This door was also locked and described as not in use. From the interior side there is no</p> |

| | | | <p>additional door for students to reach the nurses office other than through the adjacent restroom space.</p> <p>Recommendation – Provide access to Nurse 3121 through space other than adjacent restroom.</p> |

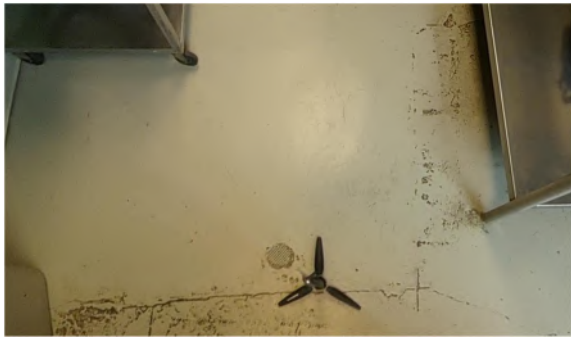
| | | Floor | <p>Poor condition. Paint finish worn away in many locations, cracks in concrete.</p> <p>Recommendation – Repair cracks, install new seamless flooring and integral wall base suitable for kitchen sanitation requirements.</p> |

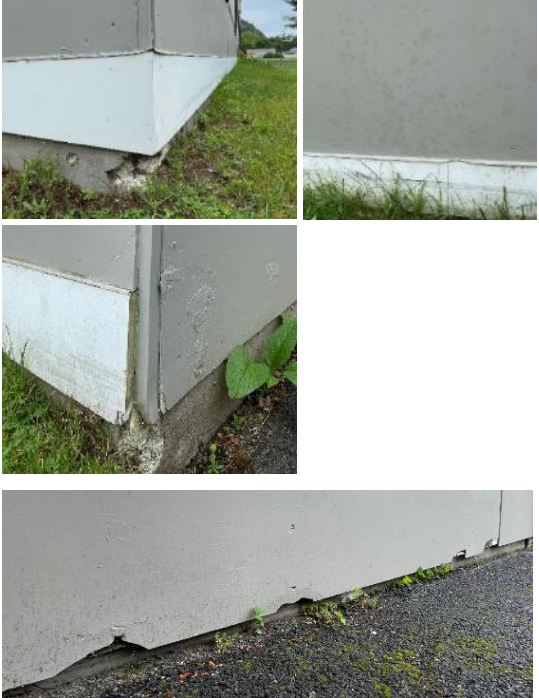
| | | Foundation | <p>Fair condition. Synthetic stucco over insulation board generally in fair condition; corner conditions throughout the building show significant deterioration.</p> <p>Recommendation – Repair corner conditions, patch, repair refinish to match existing.</p> |

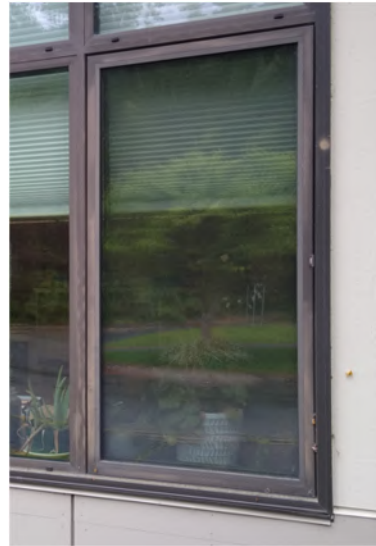
Additional areas of siding damage at windows specifically. Refer to above siding section for recommendations.

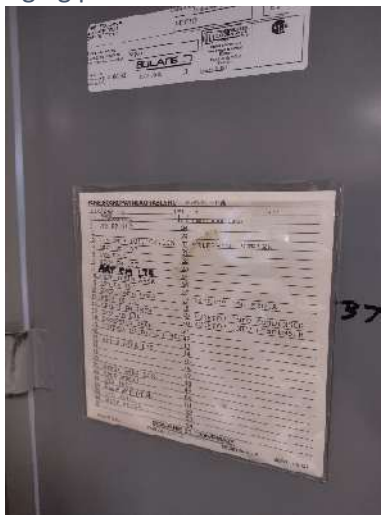
Aging panelboard.

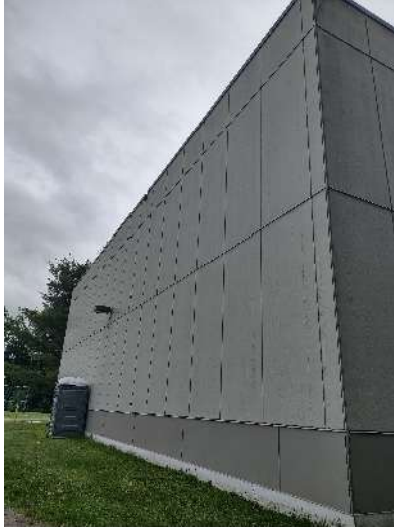
Exterior flood lights to be upgraded.

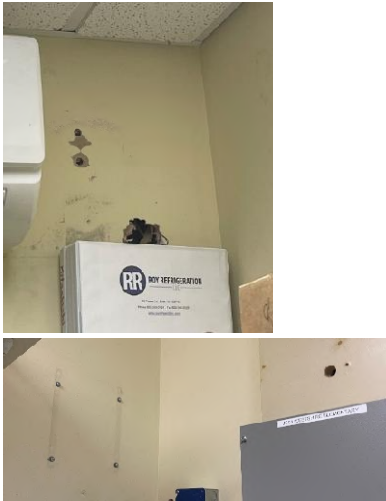
| | | Walls/ Columns | Fair condition some holes.<br><br>Recommendation - Patch holes, repaint wall. |

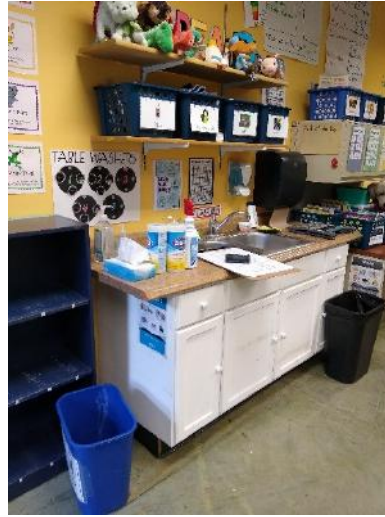
38" sink counter laminate but no clear ADA access below.  
Recommendation – Install ADA access sink cabinet with proper counter height.

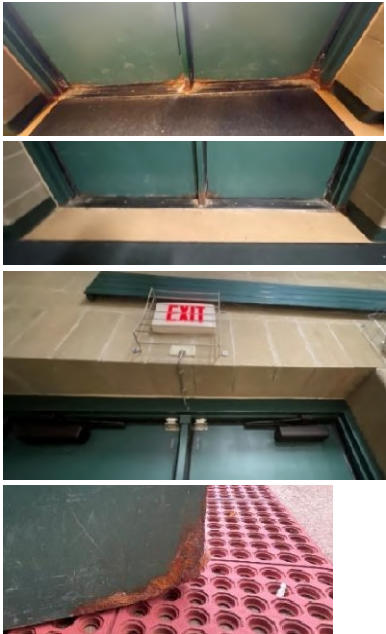
| | | Doors | <p>Poor Condition. Rusted door bottom, missing or broken hardware.</p> <p>Recommendation – Replace doors and all hardware.</p> |

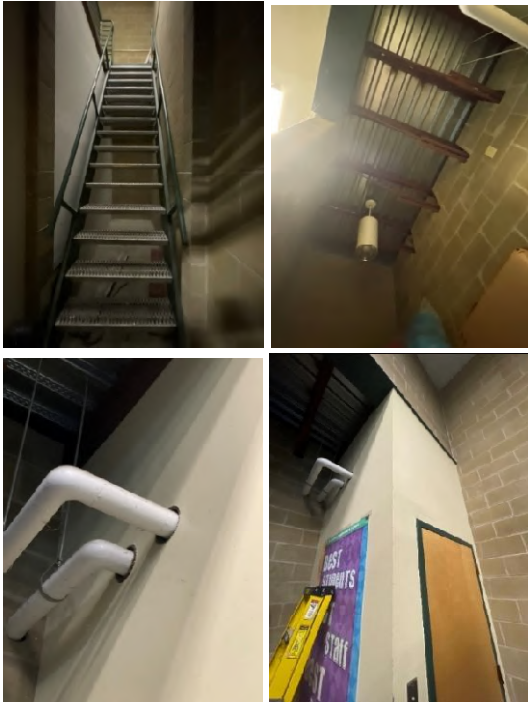
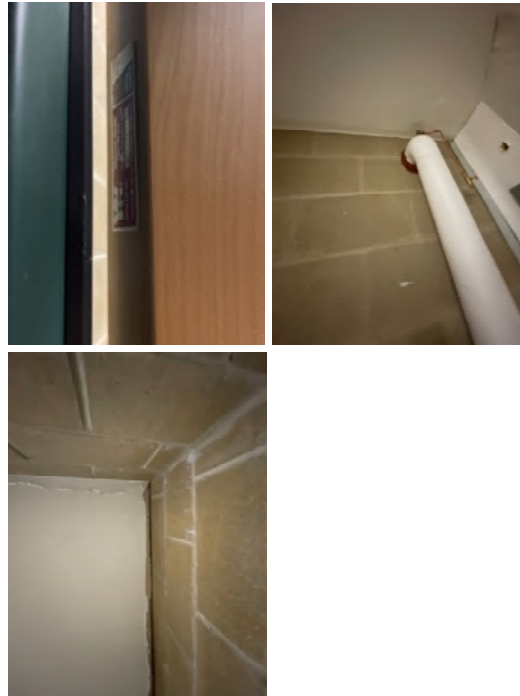
| | | | <p>Stair to mezzanine utility only, non ADA. Shown only for reference.</p> <p>Space is in good condition overall; however, door is rated but only portions of the wall are sealed to meet the required 2-hour rating.</p> |

Recommendation – Verify the seal is complete around the perimeter of the mezzanine mechanical space. If not complete, then apply proper seal.

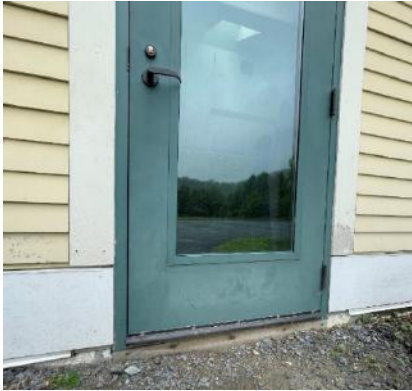
| | | Doors | <p>Poor condition. Damaged base of door and frame, rusted, worn, and faded.</p> <p>Recommendation – Repair doors and replace door / frame where necessary.</p> |

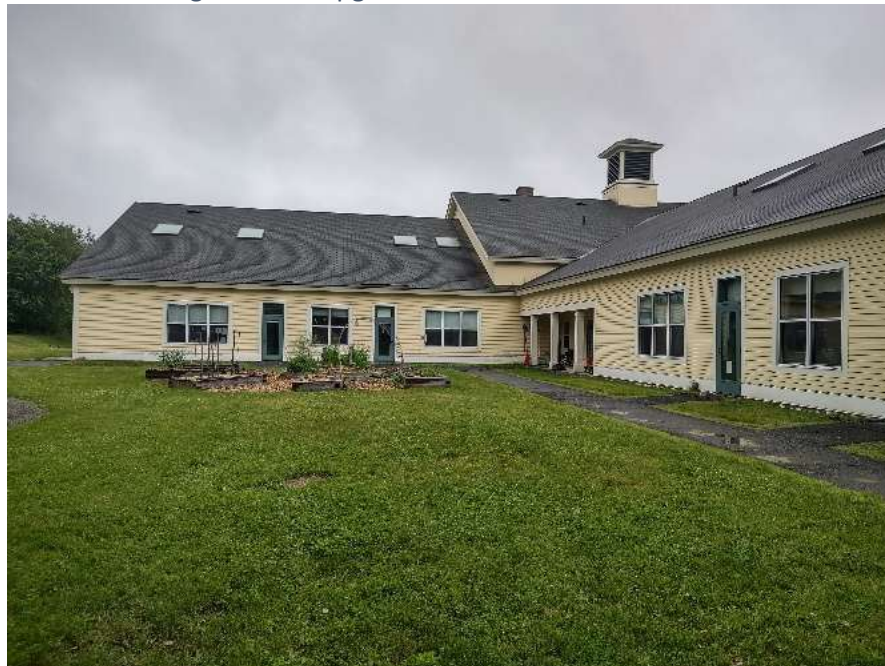
Exterior flood lights to be upgraded.
