### PUBLIC HEARING INFORMATION

## BANK BUILDING – 154 MAIN STREET

**Town of Belmont**  
Existing Police Facility and Main Street Bank/Post Office  
Building  
**Existing Conditions Assessment**  
November 5, 2018

EXISTING CONDITIONS - EXECUTIVE SUMMARY

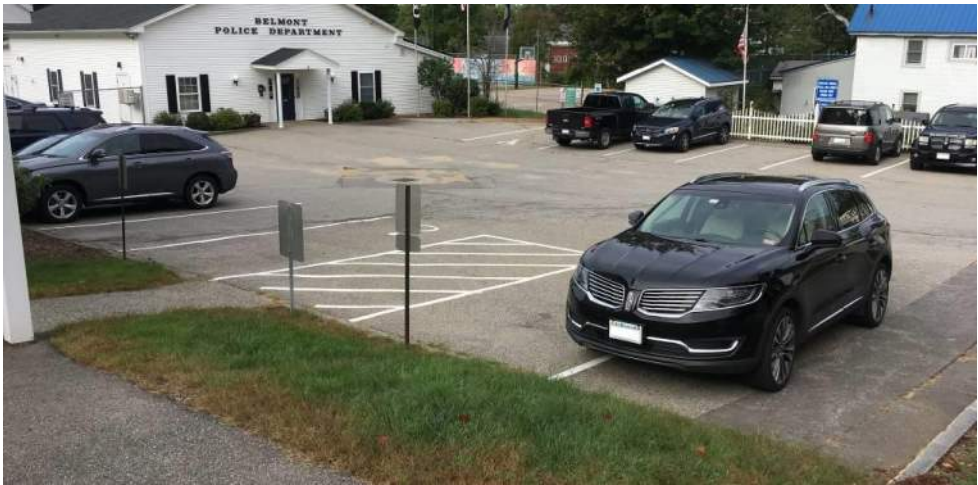
Visitor parking, including ADA spaces are located along the northeast portion of the subject site within the right-of-way easement and is shared with the Belmont Corner Meeting House. The parking area is in fair condition with a single catch basin providing for surface drainage.

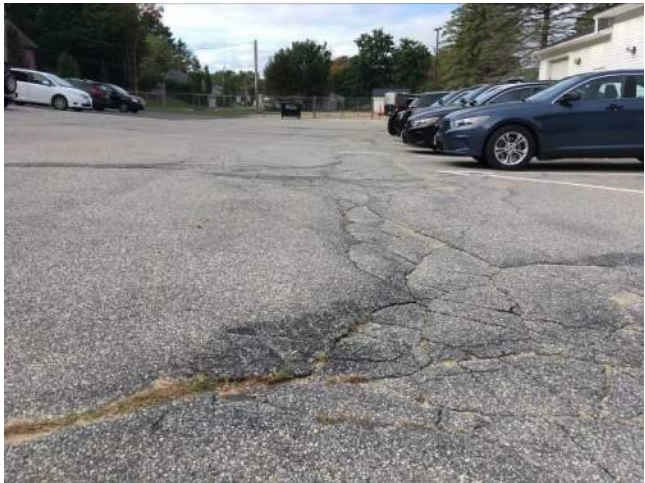
Parking for municipal police vehicles and staff is provided along the south side of the building and is encircled by a chainlink fence. The pavement is in fair condition with a single catch basin providing for surface drainage. The pavement slopes moderately toward the building. This area would be potential impacted by any proposed building additions being contemplated.

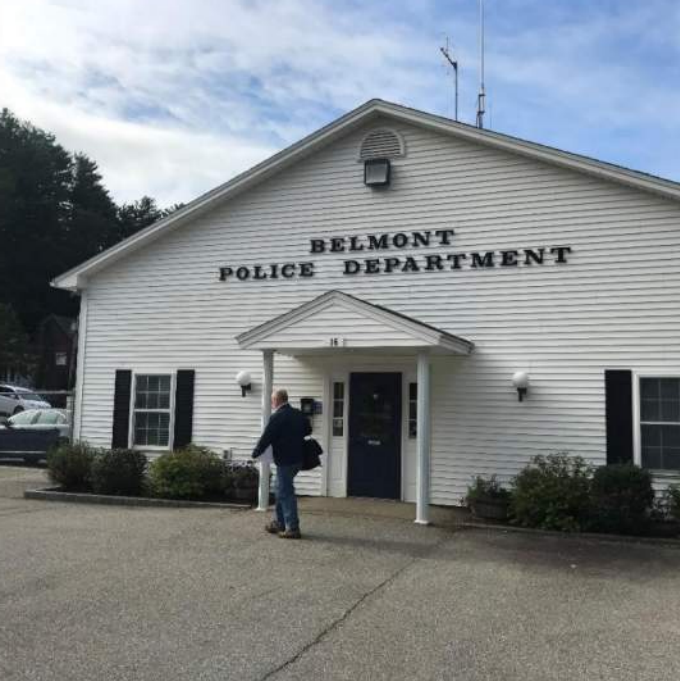
*North Facade*

The clapboard siding and trim appear to be in good condition and well maintained with only minor imperfections typical from normal use seen. There were no noticeably deficiencies, bowing, leaning or the like noted. Additionally, there were no signs of water infiltration directly related to the wall assembly itself. As noted previously during its retrofit the exterior perimeter wall was furred out with 2x4 non-bearing wood stud framing including 3 ½” of batt insulation. Based upon similar projects and materials used likely achieving an R13 energy rating. It is unknown if a warm side vapor barrier was installed during these renovations. Typically recommended for such assembly, if one was not installed, further investigation would be needed to rule out moisture damage (rot, mold, etc..) that could have or are occurring. Specific concern would be within the shower/locker areas where moisture and humidity would be at greater levels. Current applicable building energy code requires similar wall assemblies to achieve a R19.6 or greater. The current wall assembly would not meet such code standards nor performance comfort expected in contemporary structures. The proximity of siding to the finish grade elevation is below industry standards. While moisture may not directly affect the vinyl siding / masonry products there may be concern along the west wing addition believed to be

stick framed wood framing. Code requires a minimum offset from grade of 8” clear for wood members with exception for preserved wood materials and other protection methods. The clearance along the west side varies from near 0” to 4” +/- . In addition to proximity of grade the roof edge on this façade drips directly onto the landscape adjacent. There is a likelihood of deterioration of existing framing at the wall baseplate along this wall line. At a minimum we would recommend consideration to install a gutter system along the west wall as well as to replace a portion of landscape with a stone drip edge or other medium to promote drainage as well as to protect the existing siding from landscaping procedures.

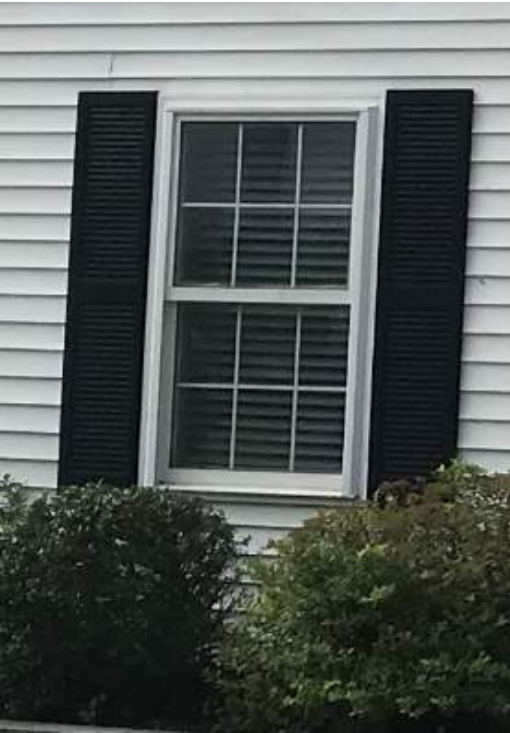
Typical Window

Exterior windows on the east and north walls of the police department are residential grade insulated clad windows. Windows look to be in good condition with no visible signs of failure. The thermal insulating nature generally should perform well when maintained. In general windows should be cleaned and weather stripping should be inspected and replaced if necessary. Good practice as part of the interior renovation would be to remove and install new perimeter sealant at all openings. Where reachable the project should consider the use of a low expanding foam insulation product for better sealing and insulation properties. Average life expectancy of such windows is generally 10-15 years.

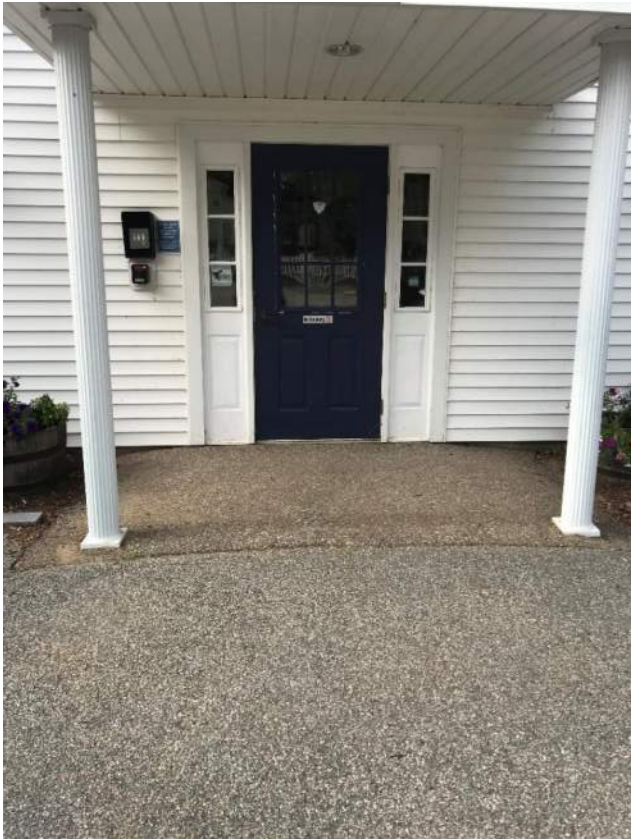
Main Entry – Exterior

The existing garage bay door is in fair condition with no noted concerns or issues. Perimeter man doors are in various conditions with unprotected hollow metal doors showing indication of deterioration from weather exposure. The main entry door protected by the existing overhang is in fair condition however indication of moisture penetration can be seen along the base of the door and adjacent side lites. Approach of door from the exterior does not meet ADA requirements for flatness and will require regrading to address. East side egress door weatherstripping and threshold in need of replacement due to weather exposure. It would be recommended that overhang protection be considered for additional protection of door and egress path.

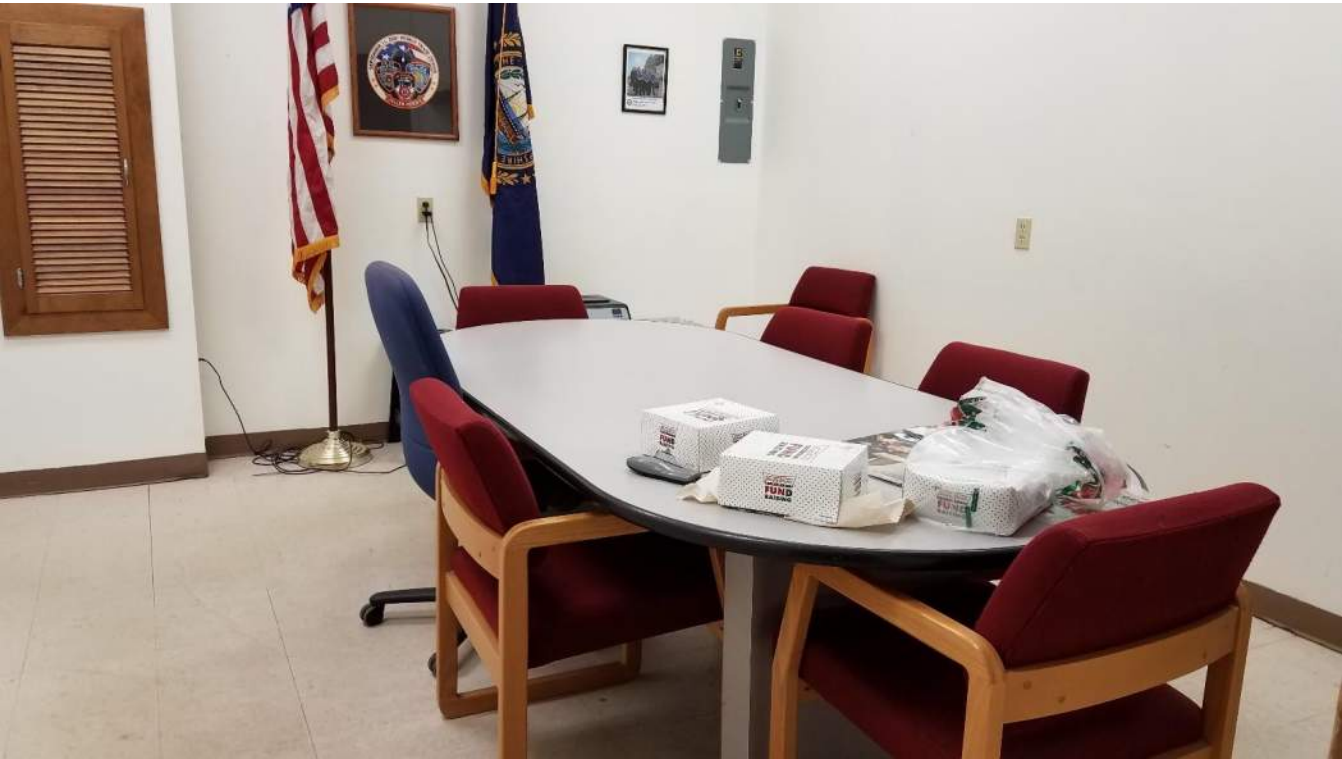
Typical Office/Conference Area

Walls and floors appear to be well maintained for the age of the facility. Most of the general office and common areas are in good condition where painting will be determined by aesthetic desire as much as by need. The south sallyport bay and abutting egress corridor is in poor condition as would be expected within a working garage bay. Some minor patching and painting would be prudent regardless aesthetic in these areas.

Flooring consists of VCT tile and looks to be in fair condition with little to no lifting. Some joint separation can be seen however does not look to be nor had heard of any ongoing issues. As it is highly unlikely that a vapor barrier was installed below the former fire station slab on grade potentially there may be moisture transmitting from the slab below causing these issues. It’s important to note that today’s adhesives may be more susceptible to these issues showing greater compromises. Any scope of work looking to replace flooring should consider manufacturer adhesives and flooring capable of addressing such concerns or include a remediation program for such.

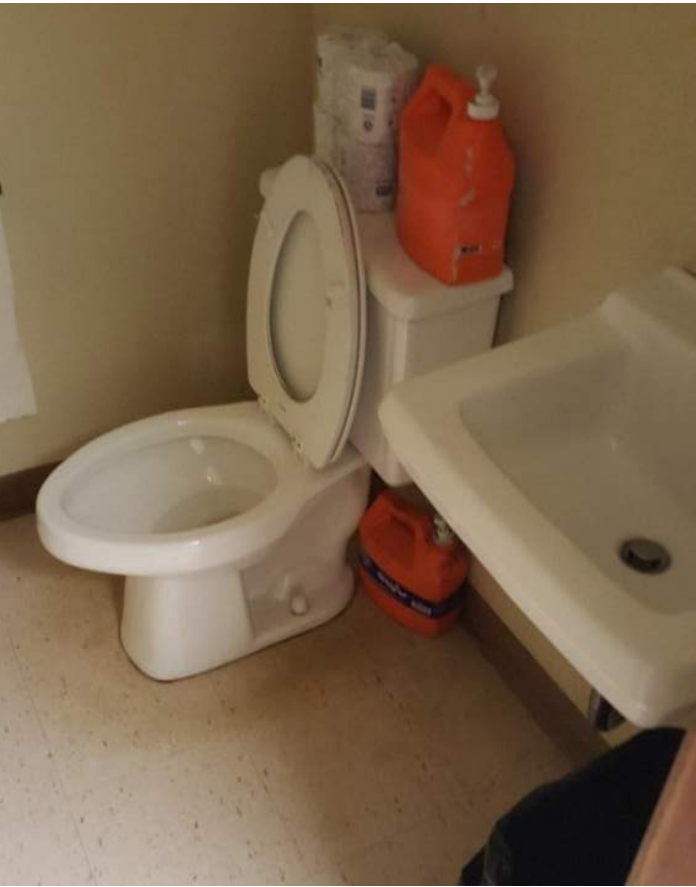
Police Department

The existing toilet and locker room facilities for are not compliant to applicable code and ADA requirements for clearances, fixtures and accessories and should incorporate new accessible toilet and shower areas meeting the calculated occupant load. The existing toilet room is in fair condition and may be salvaged as a non-accessible single user bathroom in addition to new compliant accessible locations.

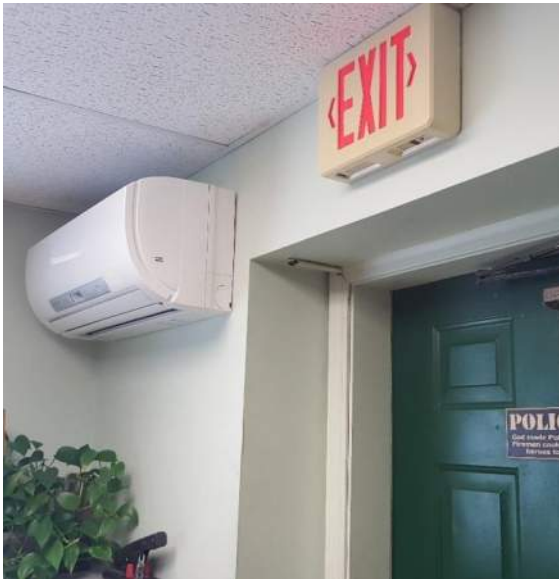
There is supplementary cooling provided by a Mitsubishi Model MUZ-FE09NA Split System in the Dispatch Room. The indoor unit is a wall-mounted type and the exterior condensing unit is hung on the wall directly exterior to the room. This unit is intended to handle the additional internal loads existing in the Dispatch Office including multiple monitors, radio equipment and computers. The unit appears to be in good condition and another 15 years of useful life is expected.

Dispatch Room Indoor Evaporator

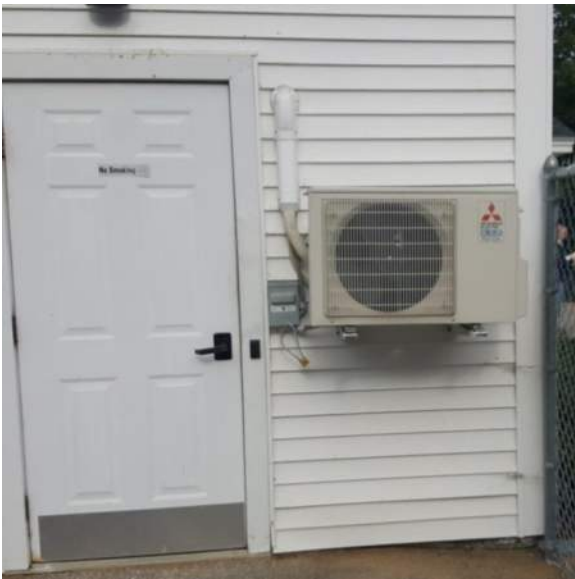
Dispatch Room Outdoor Heat Pump

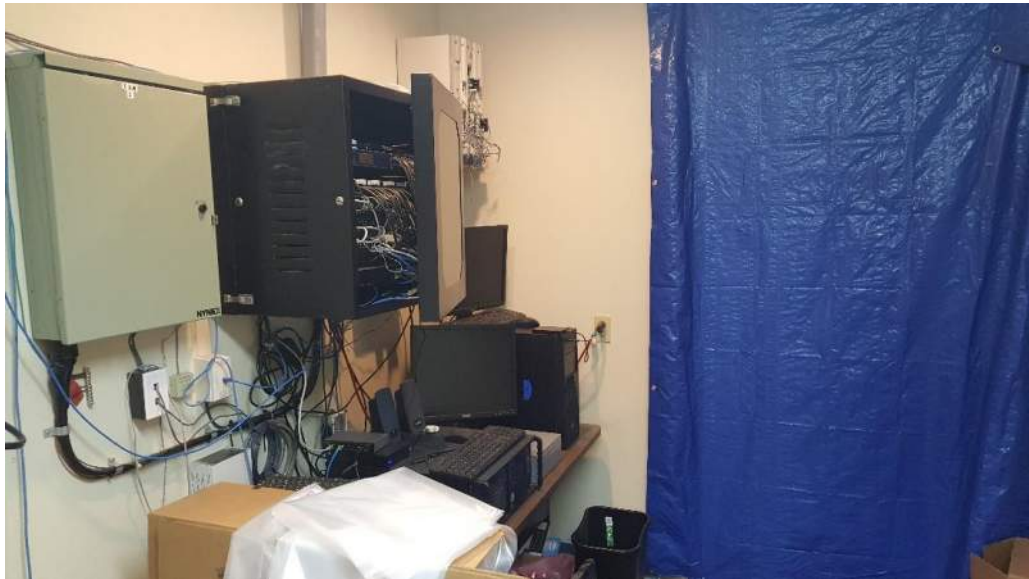
The server room is at the rear of the building and is only separated from the adjacent locker room thru the use of a tarp. This allows heat and humidity from the locker room to infiltrate the server room. As the server room does not have additional cooling, the infiltrations of heat and humidity could potentially cause damage to the server systems located in the room due to higher temperatures and humidity.

Server and Data Room

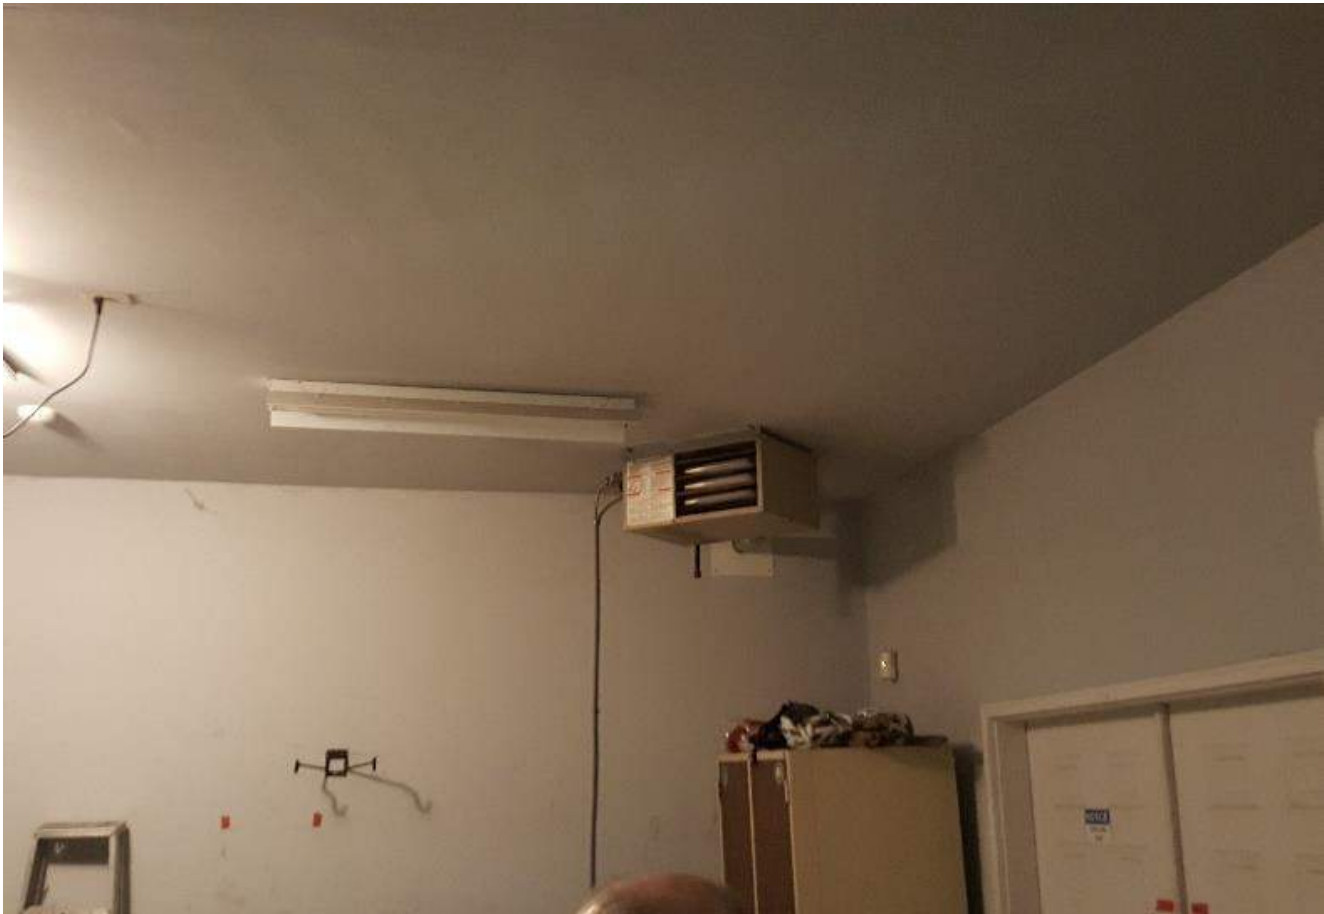
The sally port does not have any ventilation or sensors to monitor for CO/NO<sub>x</sub> in the space. It is heated via an electric unit heater located at the ceiling.

Sally Port Unit Heater

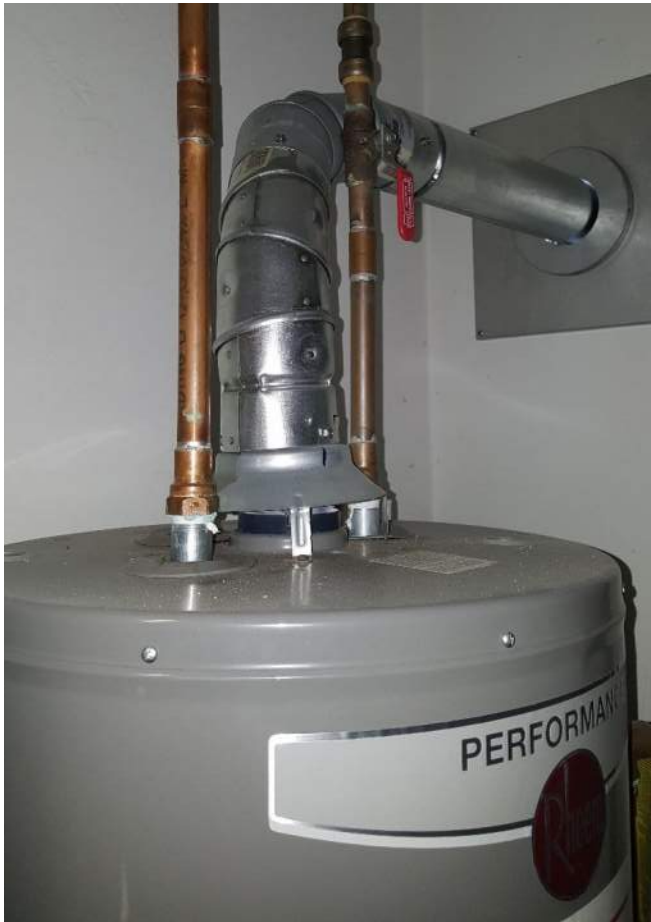
The building’s domestic hot water is a RHEEM Model XP40T06EC32U1 LP gas fired domestic hot water tank type heater located in the closet of the locker room. It is an atmospheric type and is not provided with combustion air, nor is the wall penetration around the flue vent properly sealed. Day light is visible. It was manufactured in 2016 and is in good condition. There is no ASSE 1017/1070 rated thermostatic mixing valve installed which is required by code if the discharge temperature is above 120°F for protection against scalding. The piping is not insulated as required by IECC 2009 and the system is not provided with a hot water recirculation system to maintain water temperatures.

Domestic Hot Water Heater Flue Vent

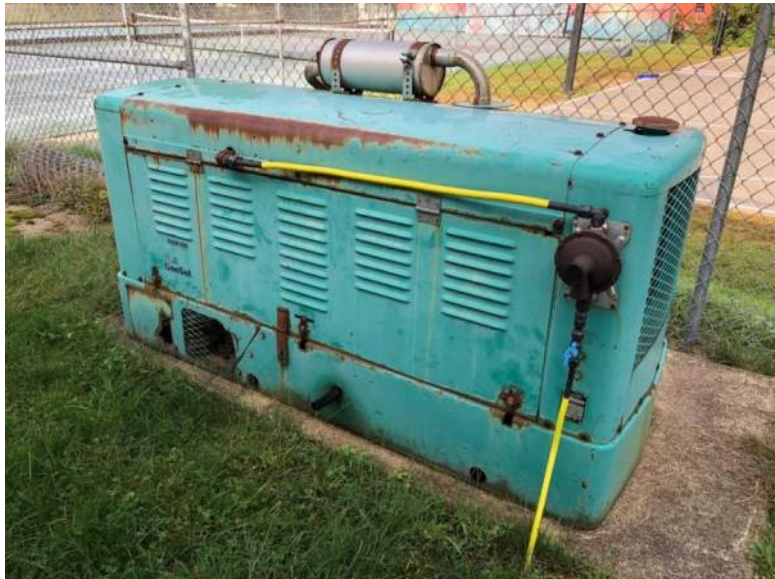
The building is served by an older generator that is in a deteriorating condition. From discussions on site, the generator is fully operational with no known issues. The rating of the generator is unclear.

Generator

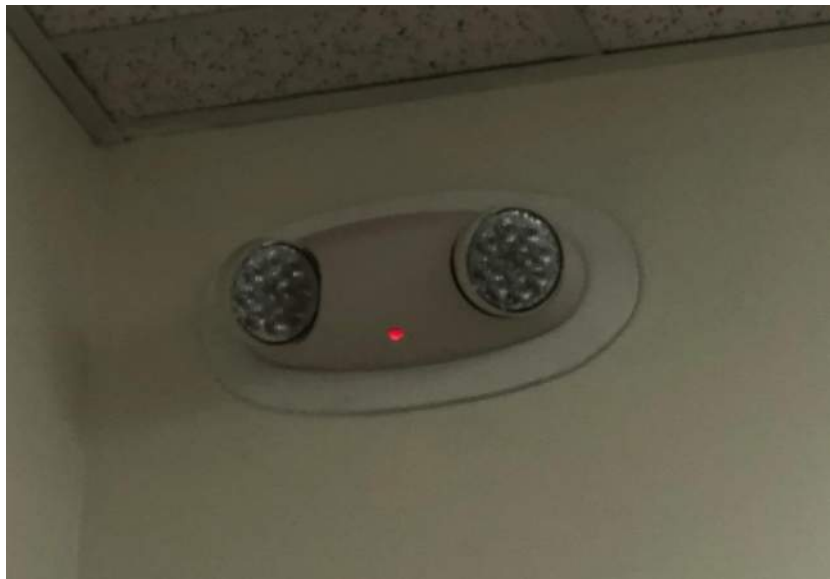
The interior lighting is all fluorescent of various types. The emergency lighting is a mix of newer and older fixtures. Several units were tested and were not operational.

Newer Emergency Fixture

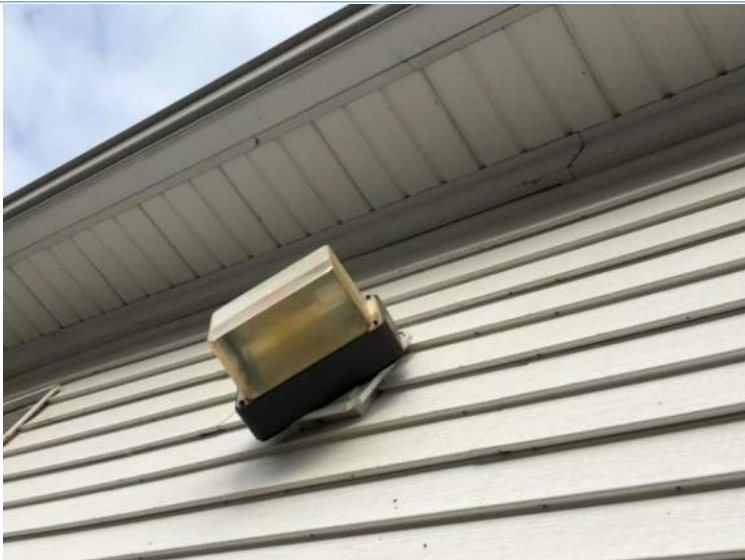
The exterior lighting is generally metal halide with the exception of one fixture observed to have been replaced with LED. There is no code required emergency lighting at any of the building exits. Besides some exterior building mounted fixtures, the front parking area is provided with a single building mounted light fixture.

Exterior Metal Halide Fixture

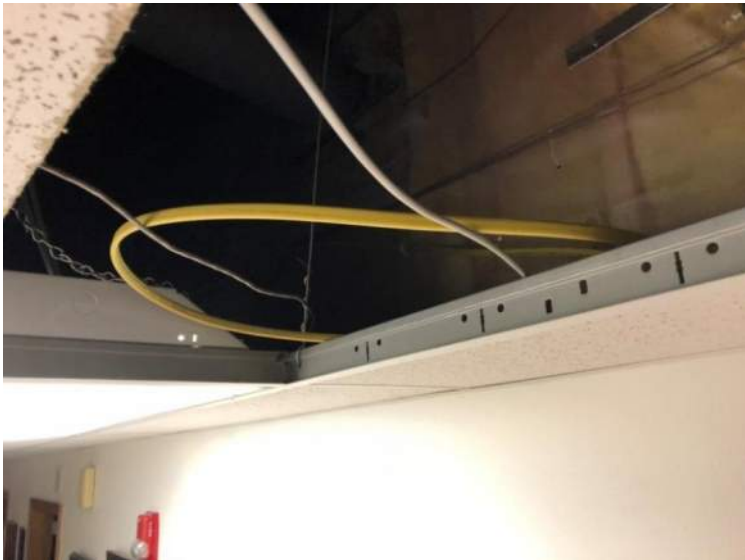
The building wiring system includes some type NMx (ROMEX) which is installed in a manner that does not meet current code requirements.

Non-Compliant Wiring

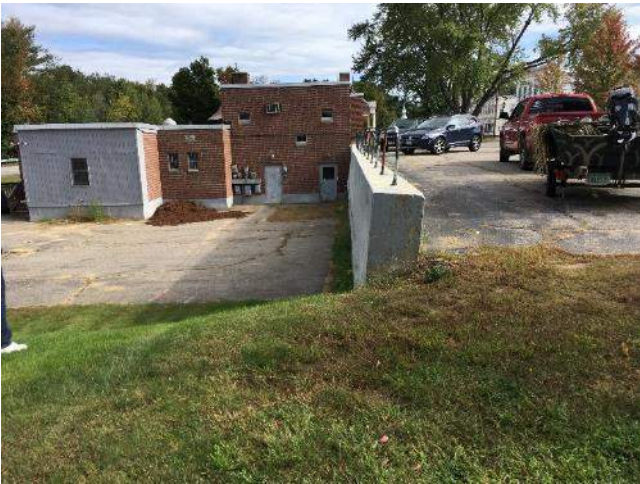
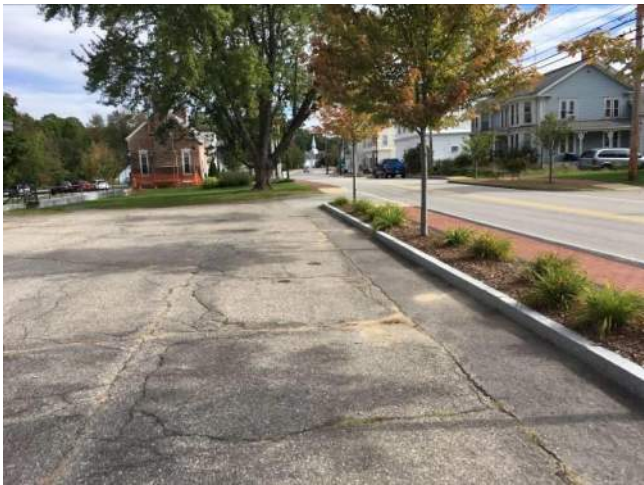
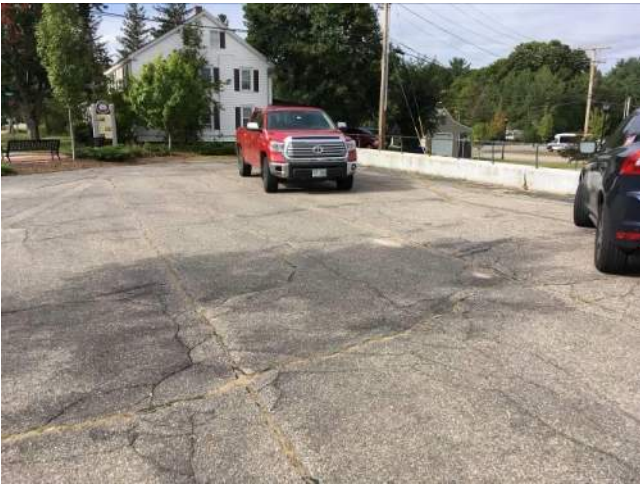
The lower portion parking area is in fair condition with a single catch basin providing for surface drainage. The catch basin appears to be clogged either within the structure or the outlet pipe. Vegetation was observed to be growing from within the structure.

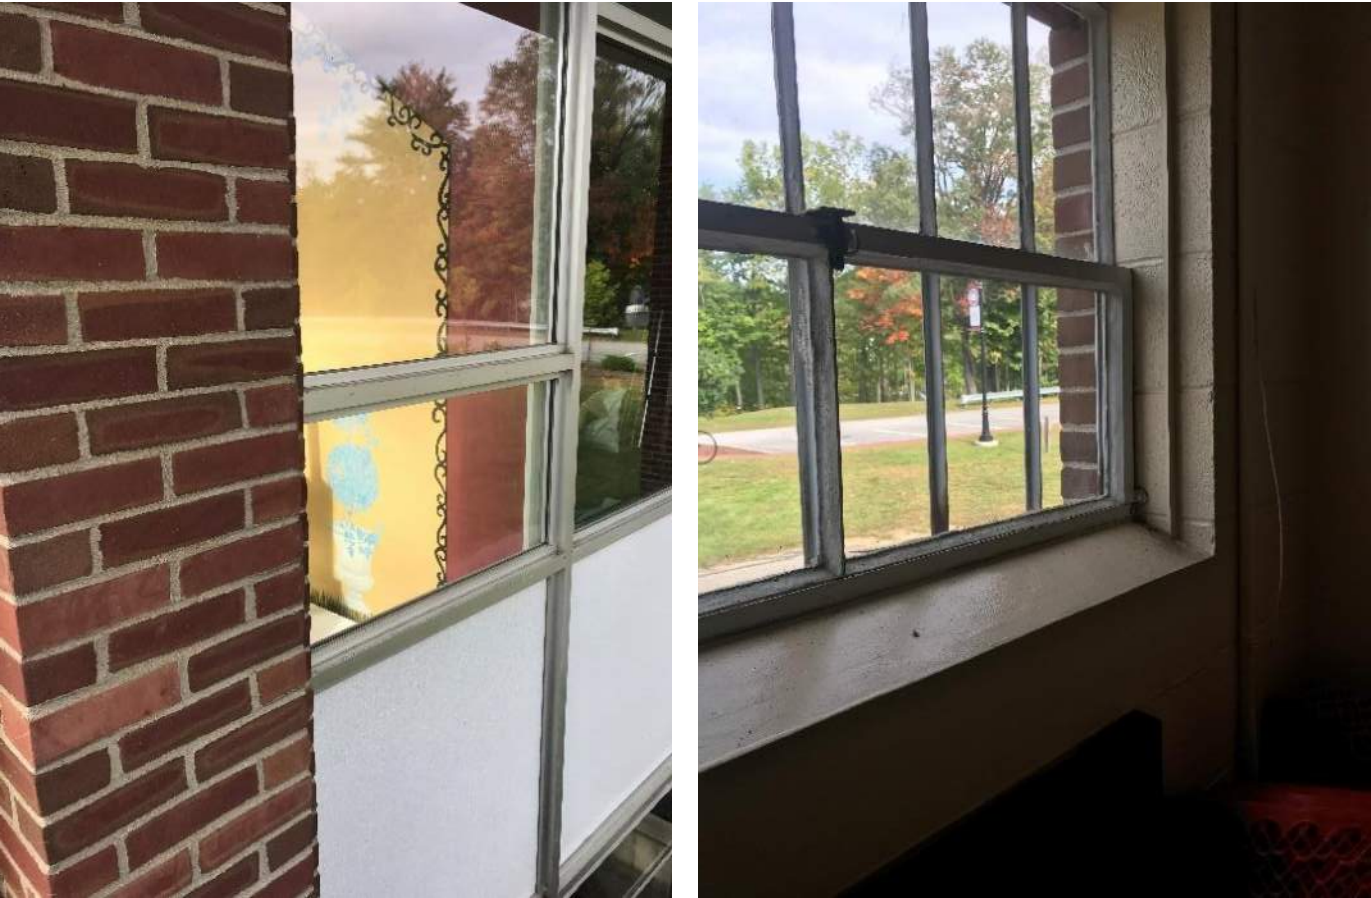
As noted previously a mix of windows was observed at the existing facility with some original windows having been replaced with residential grade thermally insulated clad units. Most window units remain are composed of original single pane metal framed units. Such units are no longer energy code compliant nor would meet the expected performance expectation of a contemporary structure. Such issues as condensation sweating, heat gain, heat loss, air infiltration would be common expectations with such units. Perimeter and pane sealants and glazing have exceeded life expectancy adding to the recommendation of replacement. Some glazed units were noted (north east façade) as damaged or missing.

Typical Window (Exterior & Interior)

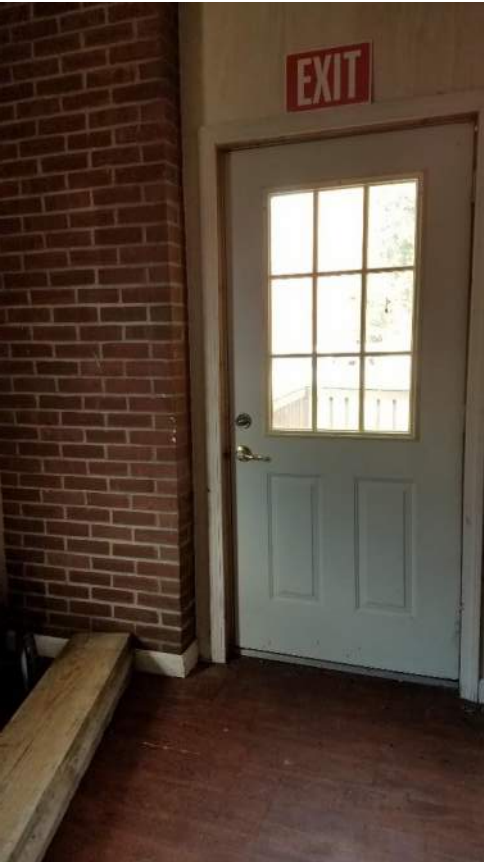
Existing exterior doors are composed of a mix of single pane un-insulated aluminum doors and residential grade hollow metal doors with glazing. Aluminum doors are non-compliant with current energy and accessibility codes and need replacement. The west side egress door is in fair condition. Door hardware must be replaced with proper egress type hardware (remove deadbolt) and replacement of the existing threshold to meet ADA requirements will be required. Depending upon calculated occupant load swing direction and the requirements for panic/push type devices may be required. The South façade egress door shows signs of deterioration and should be replaced. Vision panel placement is not compliant. Approach push and pull as well as platform at exterior must be reviewed and accommodated.

West Side Egress

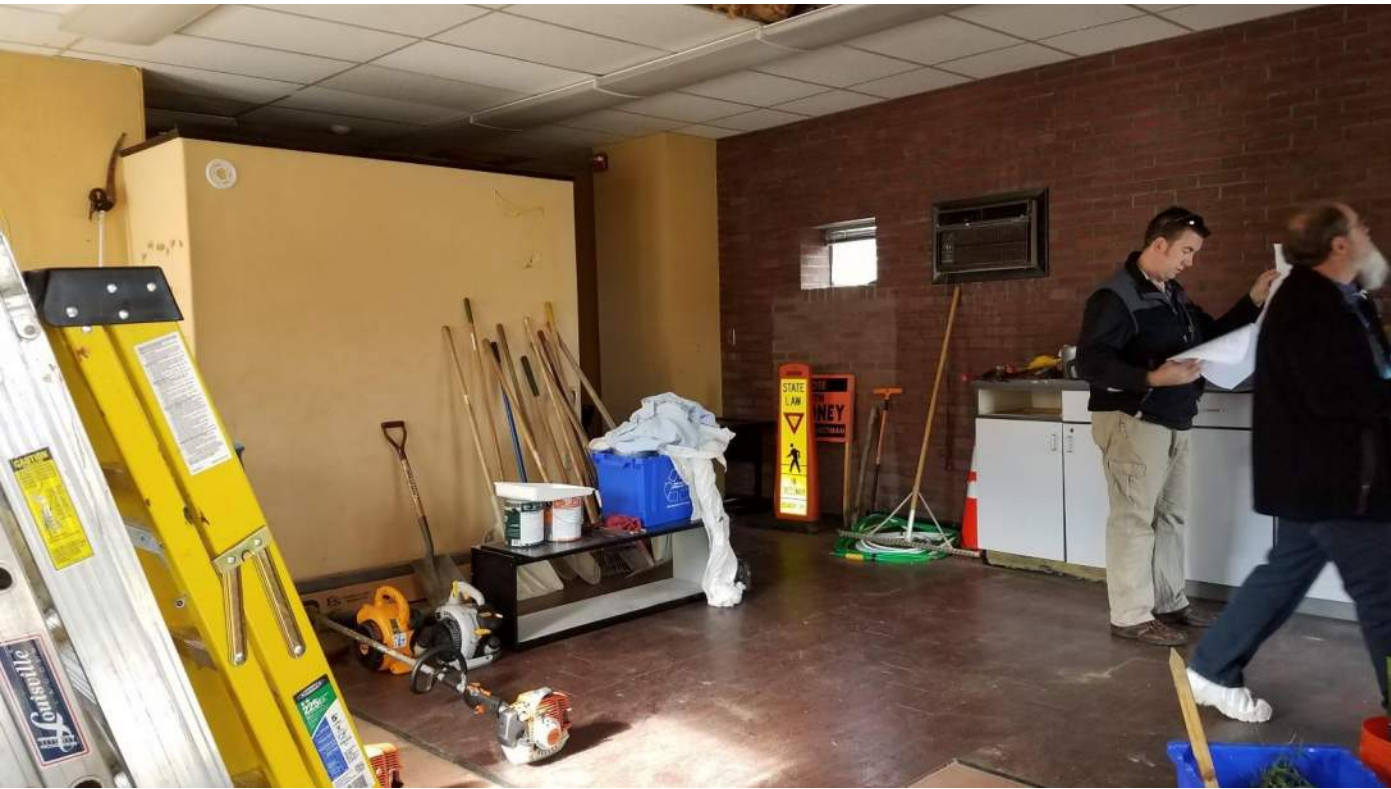
Walls and floors are in poor condition in need of replacement. Portions of the exterior wall assembly incorporate an interior masonry veneer that is in good condition and may be cleaned and left exposed as an aesthetic if desired. However, one should consider options in addressing energy code compliance and if such will require the furring out and concealment of such walls as one option. Secondary options would be to address insulation at the exterior face. Concealment of such walls however should include a technical study of the masonry to ensure alteration of the walls natural ability to breath can be tolerated.

Upper Level Interior

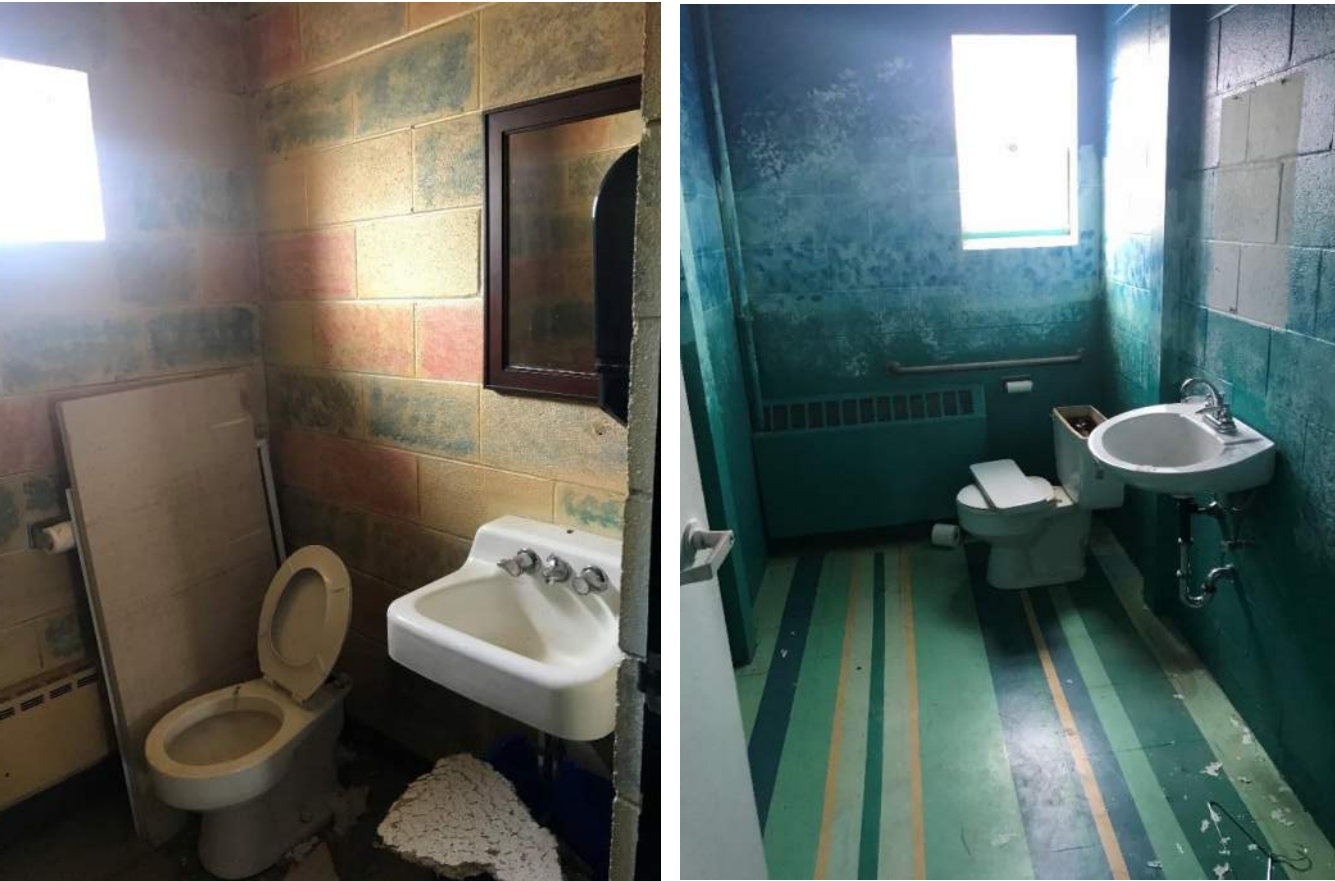
Bank/Post Office

The existing toilet facilities are not compliant to applicable code and ADA requirements for clearances, fixtures and accessories and should incorporate new accessible toilet areas meeting the calculated occupant load. Fixtures are in poor to non-working condition and should be replaced in full.

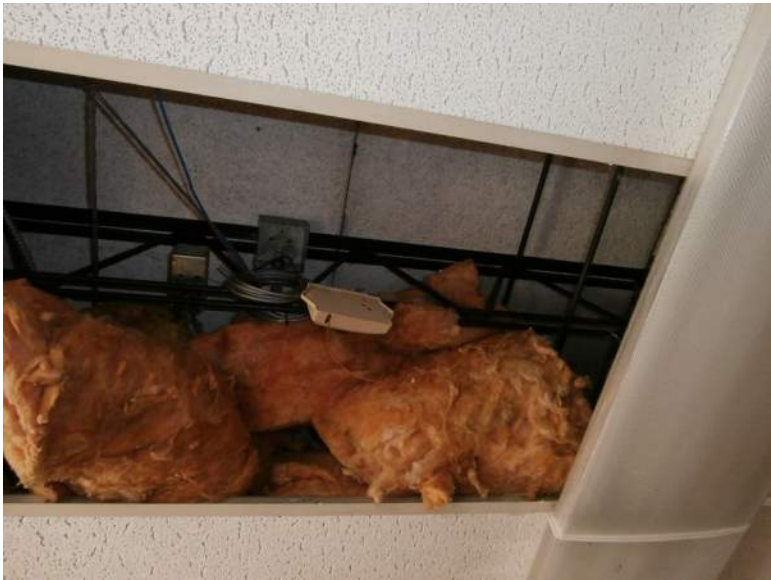
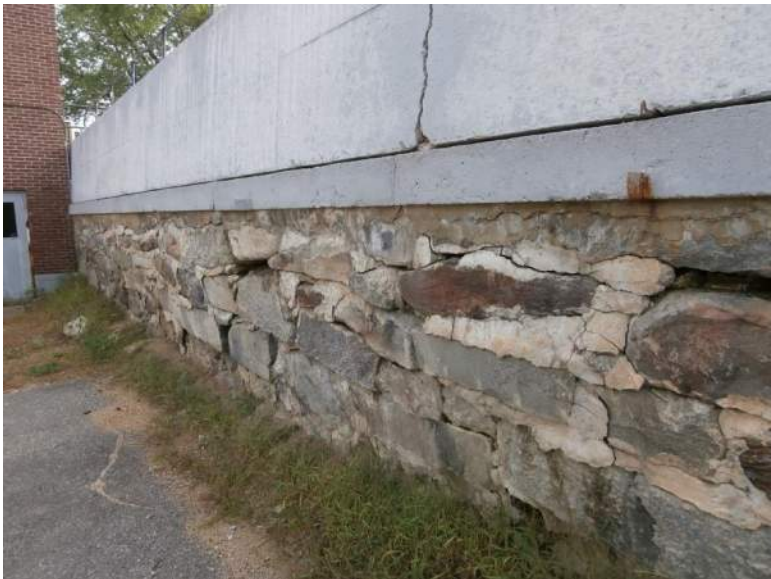
The retaining wall sections north and south of the building footprint are in poor condition. The lower stone masonry sections of the wall exhibit large cracks indicative of movement and rotation under horizontal earth pressures. The concrete cap is poorly integrated with the stone section, and similarly the upper concrete parapet is poorly

Integrated with the cap. There is evidence of relative movements and “hinging” action at the construction joints above and below the concrete cap.

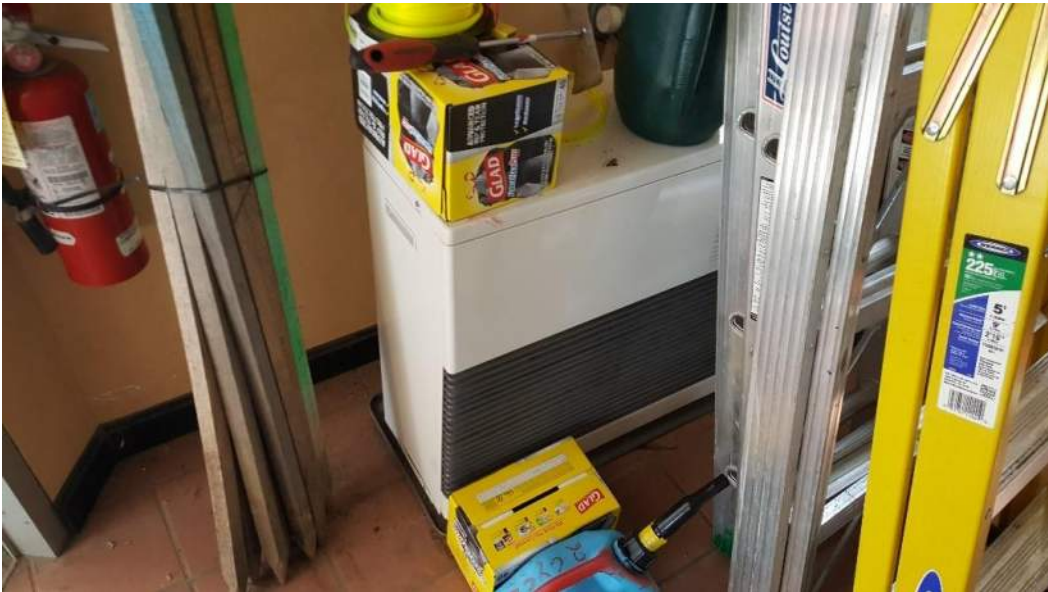
Abandoned Point of Use Fuel Oil Heater

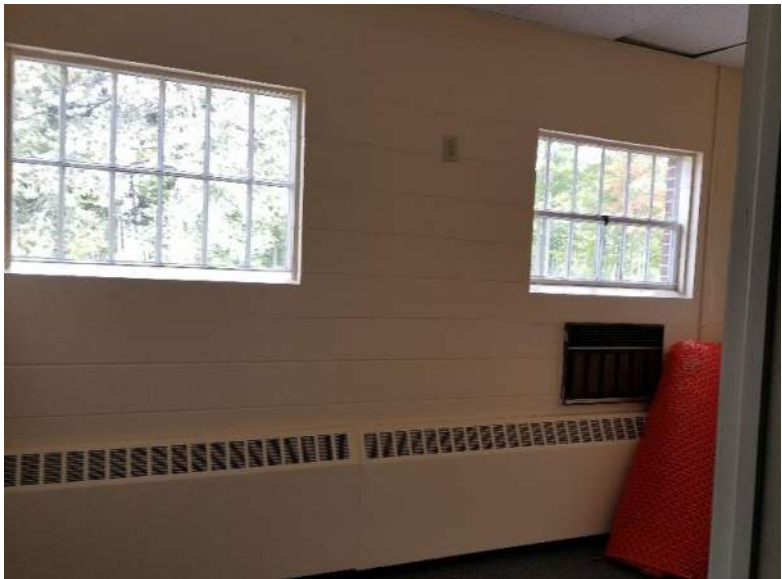
Abandoned Fin Tube Radiation and Thru-Wall Air Conditioner on Lower Floor

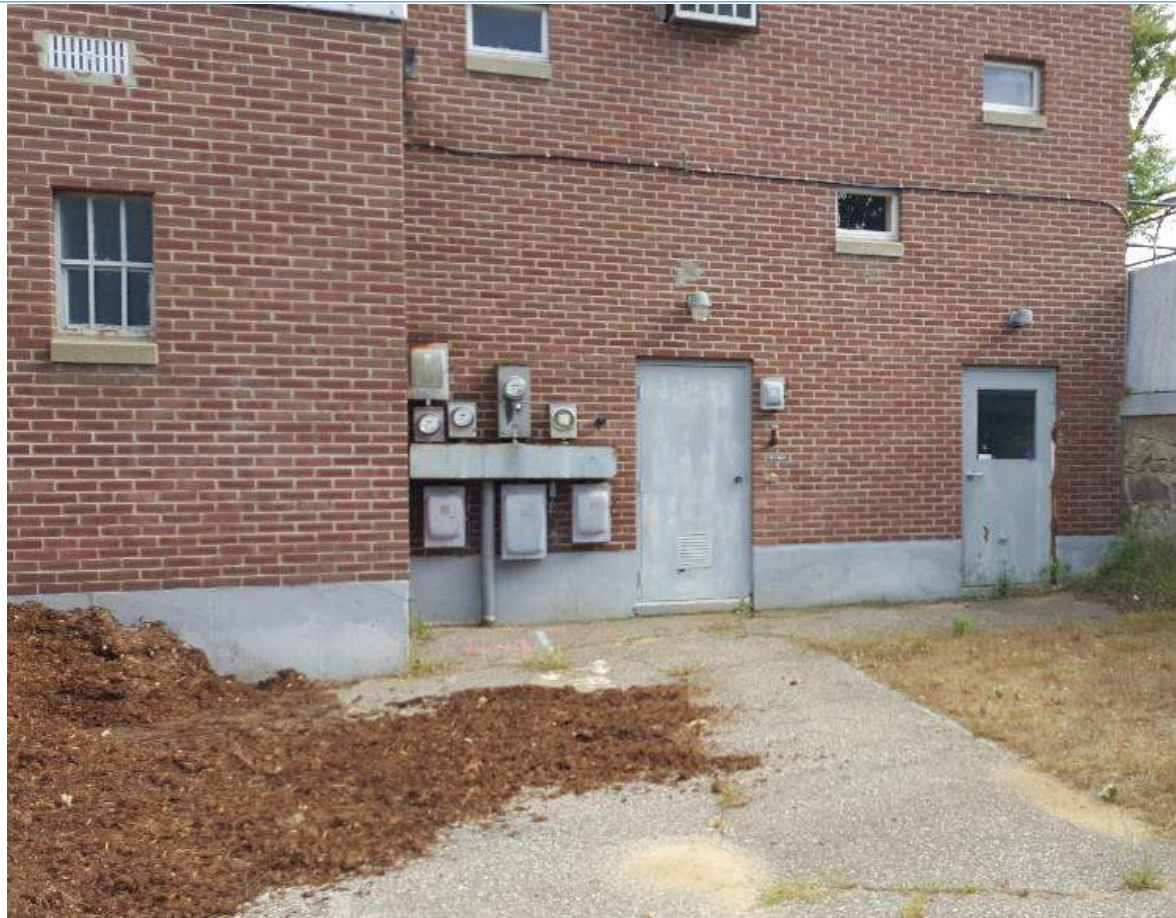
Abandoned Boiler Room and Location of Removed Oil Tank

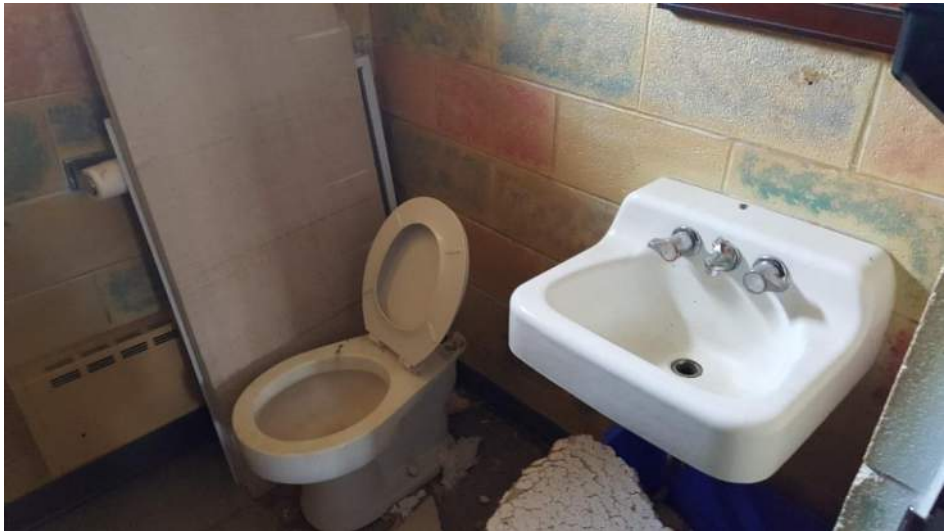
The building’s domestic water system is not functional and all current plumbing fixtures are in poor condition. Piping, where visible, is un-insulated copper. The domestic water service is located in the abandoned boiler room and is turned off. It is assumed that the building sanitary and storm leave the building through the boiler room. As the boiler room was not accessible during our visit, sanitary and storm exits are not verified, nor is the size of the domestic water, storm or sanitary systems. It is recommended that all plumbing equipment, fixtures, piping, and valves be removed and replaced with new if the building is to be reutilized. The existing under slab sanitary piping should be tested before being reused to ensure there are no clogs or breaks in the line. This is critically important as the piping has sat unused, in an unconditioned setting for quite some time. Furthermore, proper removal of existing water/weatherproofing of pipes does not appear to have been undertaken based on the observation of water still in water closets. This indicates possible damage to the piping from numerous freeze thaw cycles that the building has undergone since it was last utilized.

Upper Level Bathroom

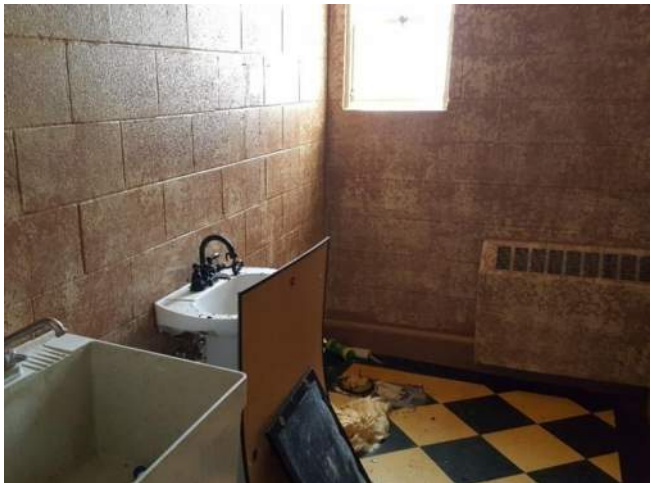
Lower Level Bathroom Missing Toilet and with Laundry Sink

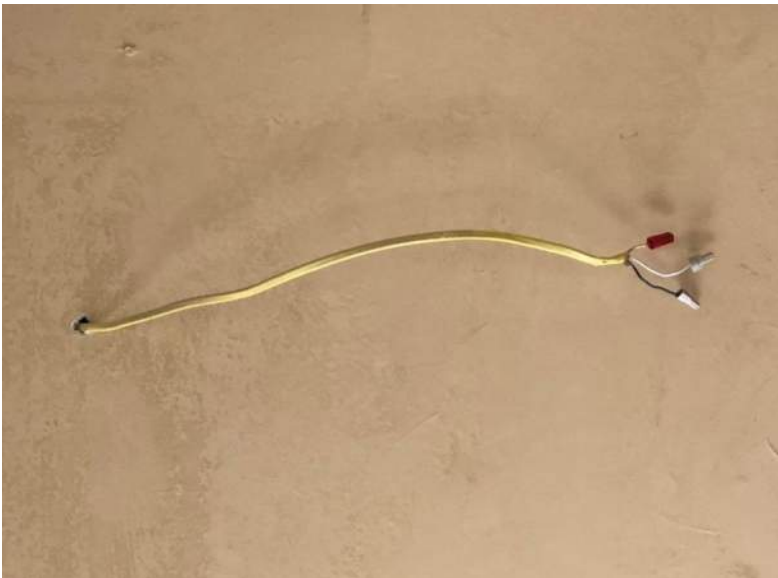
The building wiring system included type NMx (ROMEX) in a manner that does not satisfy current codes.

Romex Wiring

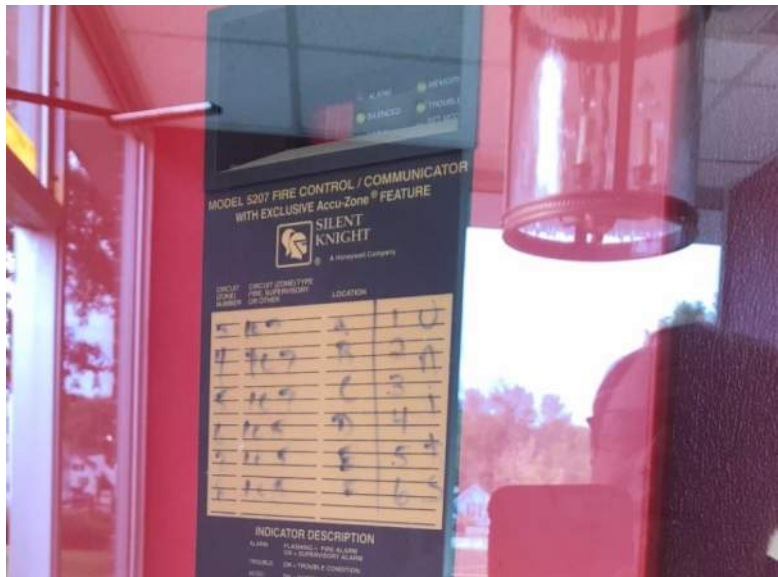
The building is protected with an older Silent Knight zoned fire alarm system. The notification device coverage is inadequate.

Fire Alarm Panel
