### PUBLIC HEARING INFORMATION

## BANK BUILDING – 154 MAIN STREET

**Town of Belmont**  
Existing Police Facility and Main Street Bank/Post Office  
Building  
**Existing Conditions Assessment**  
November 5, 2018

EXISTING CONDITIONS - EXECUTIVE SUMMARY

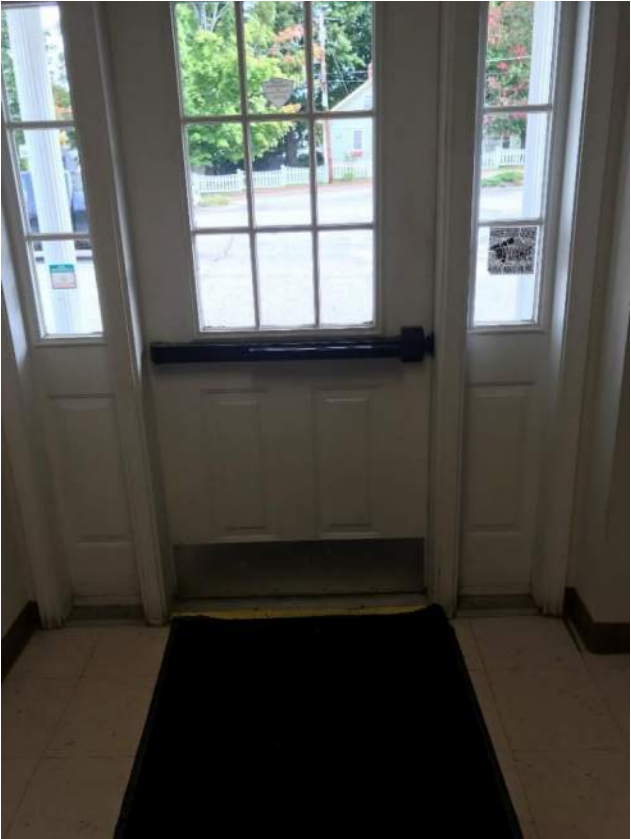
Main Entry – Interior

The existing garage bay door is in fair condition with no noted concerns or issues. Perimeter man doors are in various conditions with unprotected hollow metal doors showing indication of deterioration from weather exposure. The main entry door protected by the existing overhang is in fair condition however indication of moisture penetration can be seen along the base of the door and adjacent side lites. Approach of door from the exterior does not meet ADA requirements for flatness and will require regrading to address. East side egress door weatherstripping and threshold in need of replacement due to weather exposure. It would be recommended that overhang protection be considered for additional protection of door and egress path.

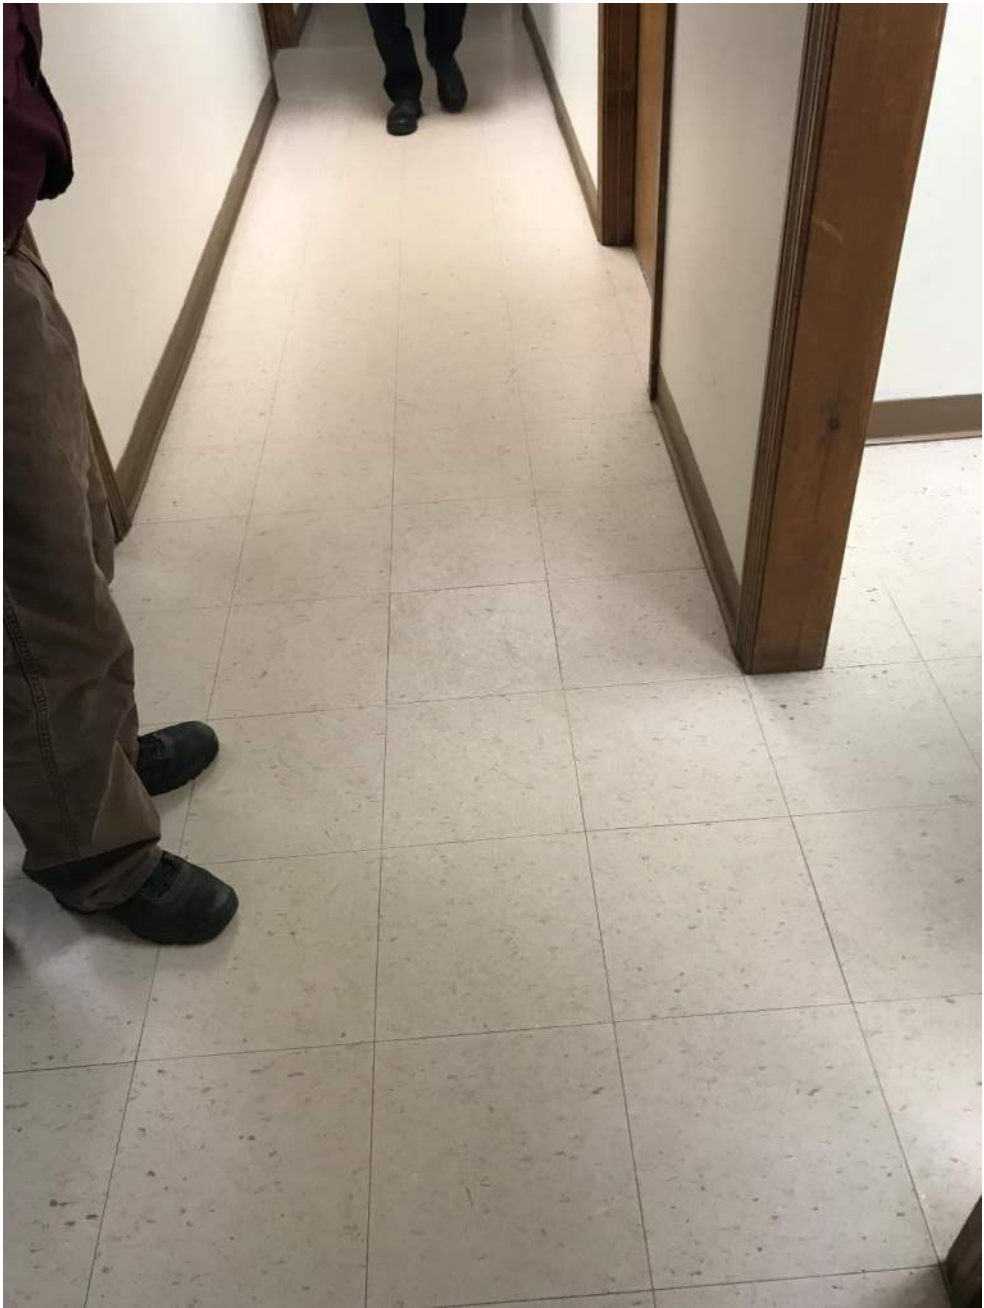
Typical Flooring System

Flooring consists of VCT tile and looks to be in fair condition with little to no lifting. Some joint separation can be seen however does not look to be nor had heard of any ongoing issues. As it is highly unlikely that a vapor barrier was installed below the former fire station slab on grade potentially there may be moisture transmitting from the slab below causing these issues. It’s important to note that today’s adhesives may be more susceptible to these issues showing greater compromises. Any scope of work looking to replace flooring should consider manufacturer adhesives and flooring capable of addressing such concerns or include a remediation program for such.

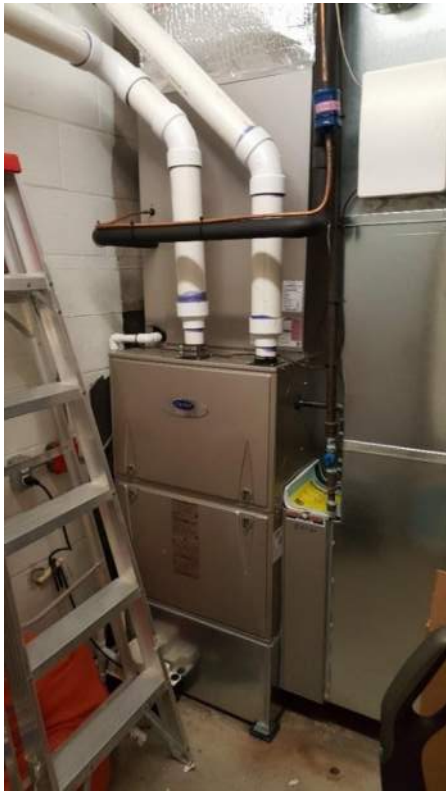
The building utilizes a Carrier Model: 59TN6A120V241122 LP Gas fired furnace with a split DX cooling coil. The condensing unit is located on the roof of the building. The unit is a direct vent type with both intake and flue gases ducted to a termination on the exterior of the building. The furnace and its associated DX system are recent replacements with a manufactured date of 2016. The system only conditions the first-floor level with the second story area abandoned and unheated. It is estimated that this system has 15 years of useful life left in its existing installation. There is a 6-inch diameter outdoor air intake routed from the roof down to the return air duct feeding the furnace. This ductwork is not insulated which could potentially cause issues with condensation during low outdoor temperatures based on the un-tempered nature of the outdoor air. The intake is controlled via a manual volume damper. It is unlikely that the 6-inch duct provides sufficient ventilation air to meet IMC 2009 or ASHRAE 62.1 ventilation standards for the spaces it is serving.

Existing Gas Fired Furnace with DX cooling

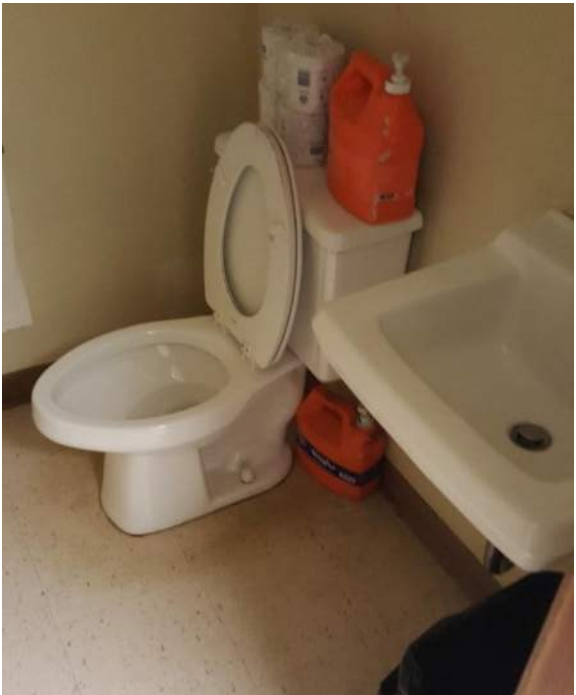
The building is provided with tank type water closets, flush valve urinals and wall hung lavatories. The lavatories are not provided with ASSE 1070 tempering valves to prevent scalding. The locker facilities are not provided with ADA compliant fixtures including trap and piping guards. The public bathroom is not provided with trap and piping guards on the lavatories.

Public Bathroom Facilities

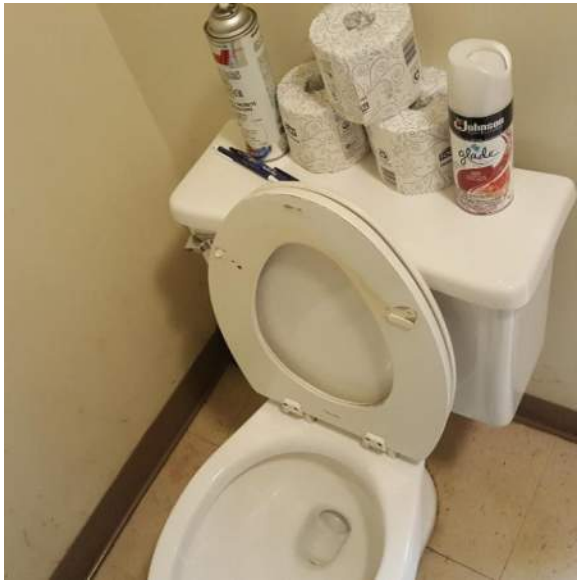
Locker Room Water Closet

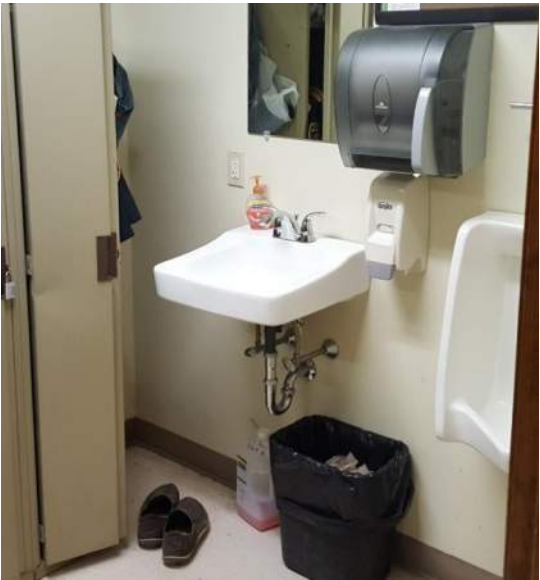
Locker Room Urinal and Lavatory

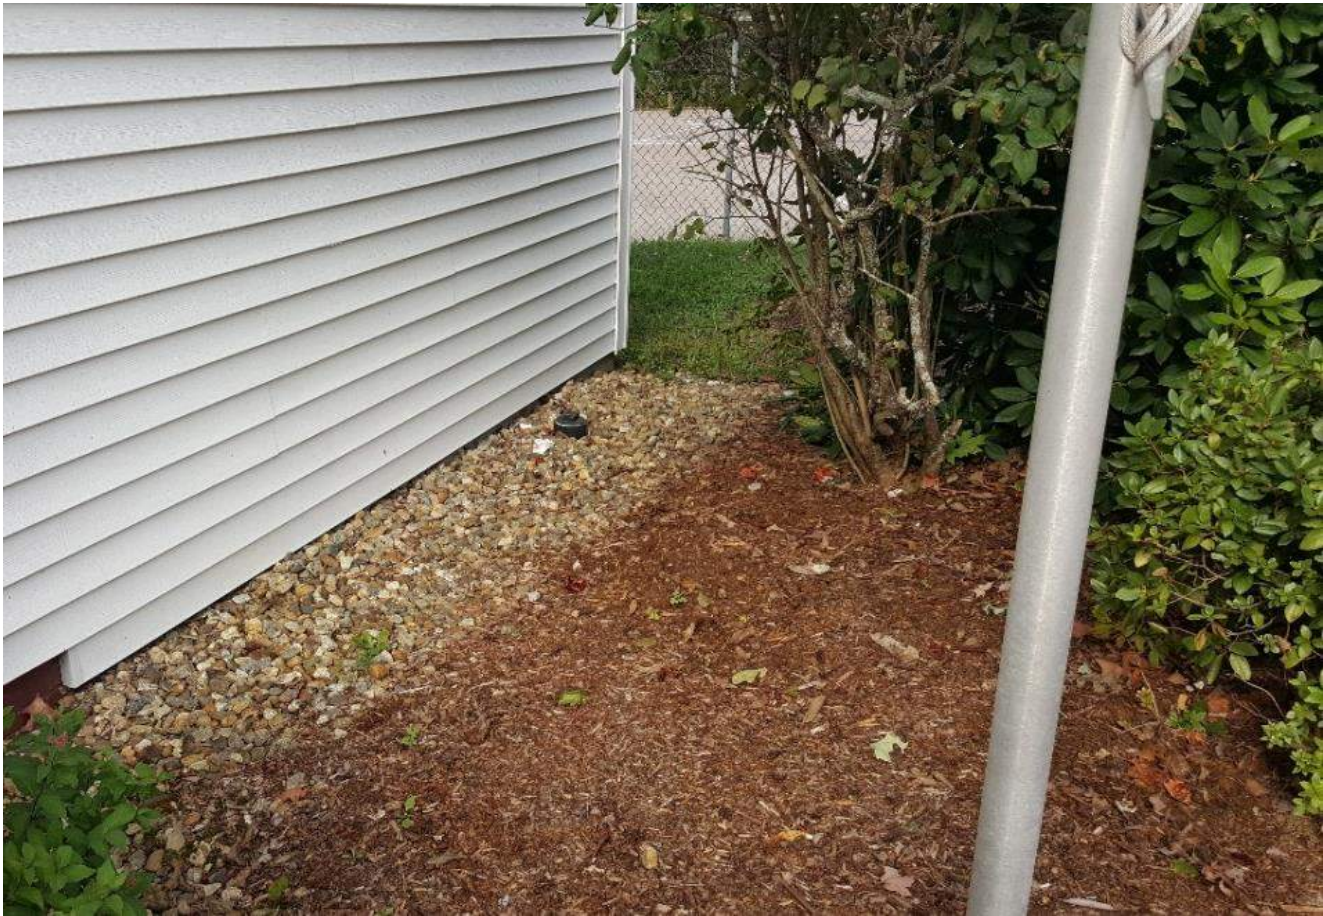
Facility sewer runs under the building headed northeast with an exterior clean out located adjacent to the building. The size is unknown but assumed to be 4” diameter minimum and appears to run to Fuller Street. There are no occupant complaints on the operation of the sanitary system. It is observed that the sanitary appears to have been installed when the addition was placed on the rear of the building based on the point of exit.

Exterior Cleanout for Sanitary

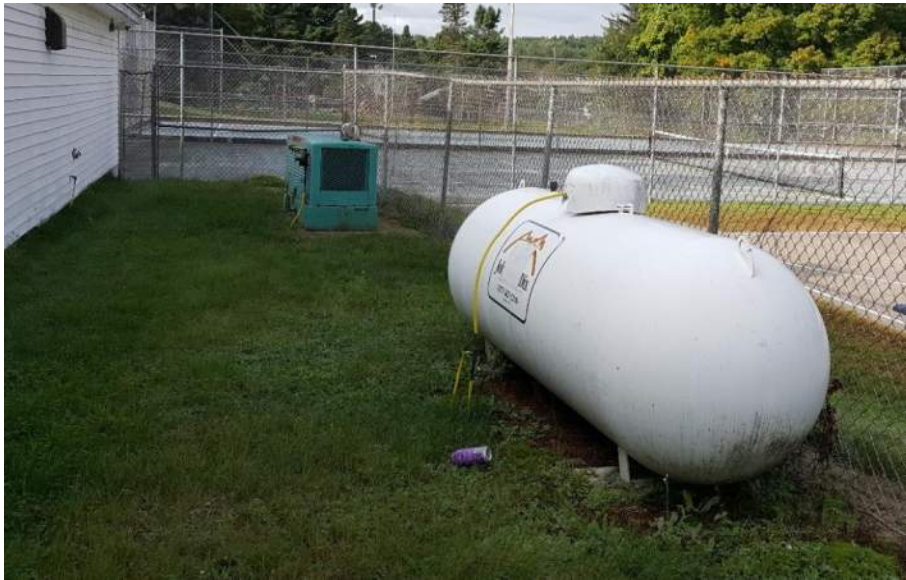
The building is served by an above ground 1,500-gallon LP tank which is piped below grade to the building and the existing generator. There does not appear to be any below slab piping within the building. The second stage regulator is located on the exterior wall adjacent to the closet containing the domestic hot water heater.

LP Gas Tank and Generator

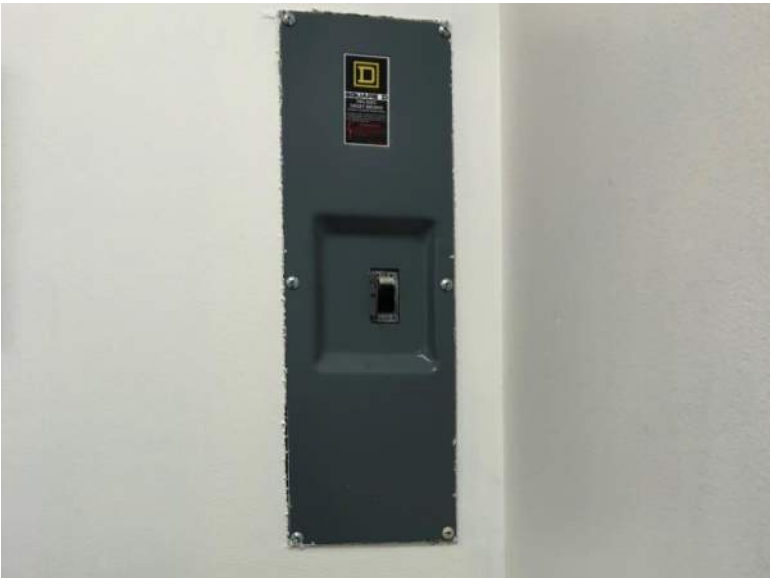
The building is served underground from the utility at 120/240V, 200A. The main service disconnect (recessed 200A/2P enclosed circuit breaker) is located in the breakroom on the exterior wall opposite the exterior wall mounted utility meter.

Main Service Disconnect

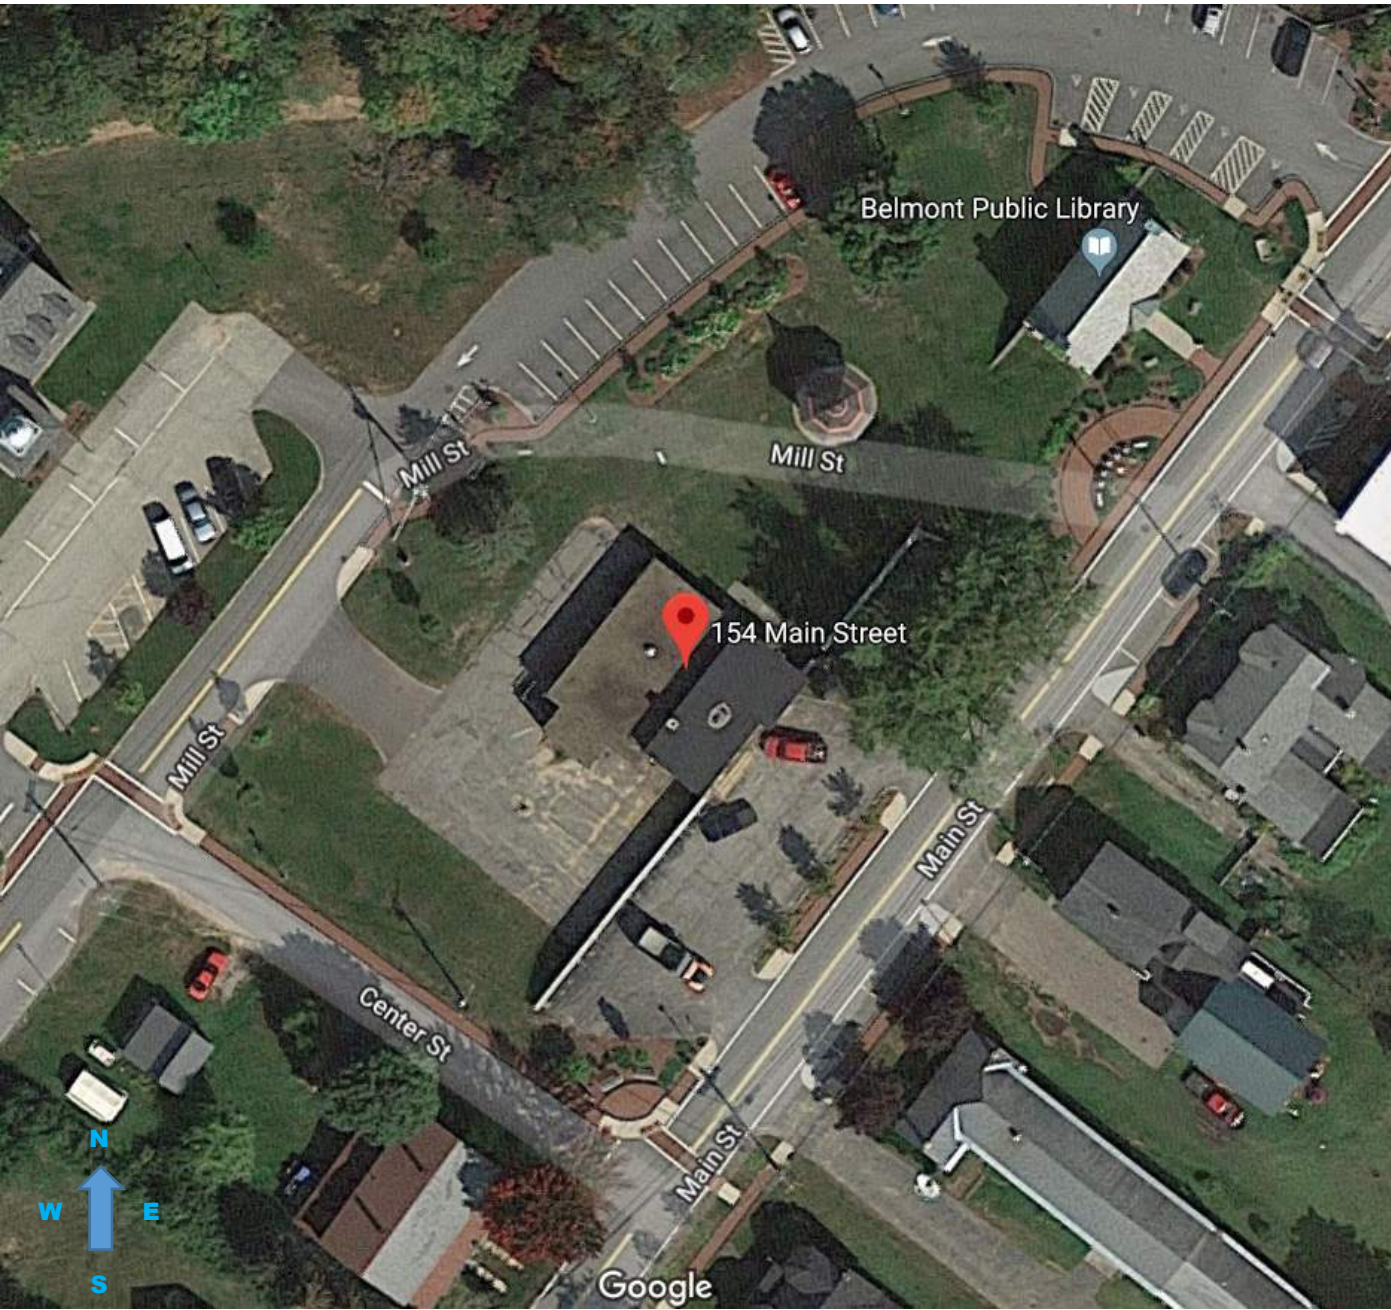
The lower portion parking area is in fair condition with a single catch basin providing for surface drainage. The catch basin appears to be clogged either within the structure or the outlet pipe. Vegetation was observed to be growing from within the structure.

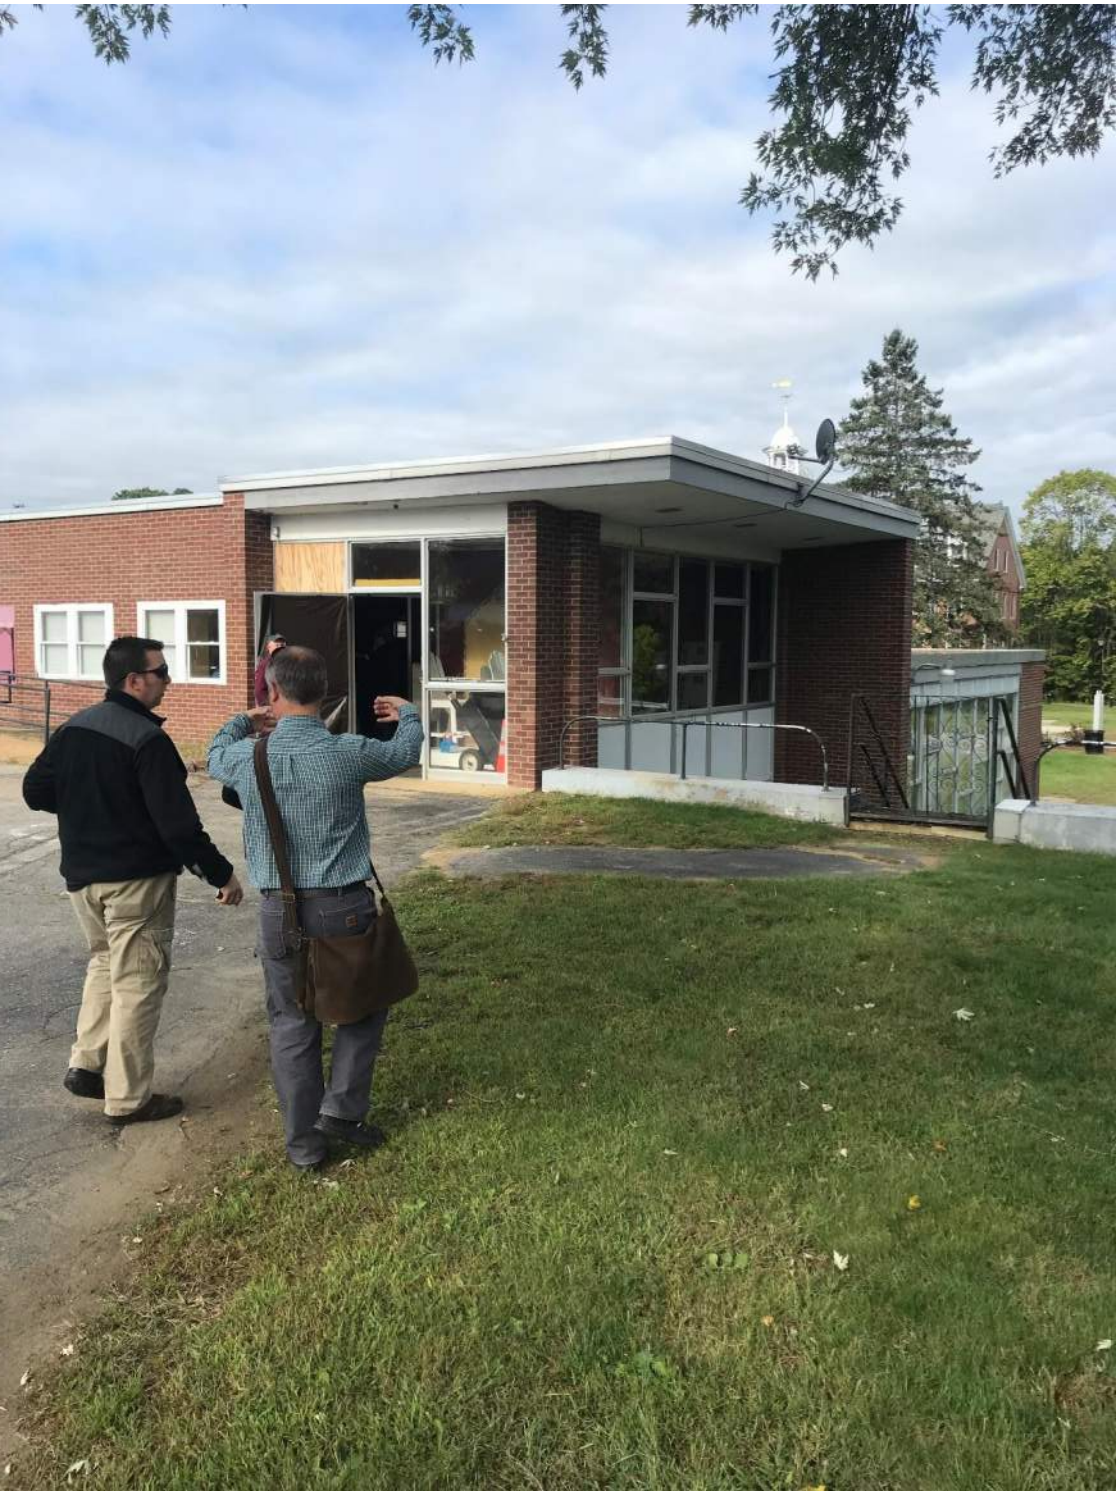
North East Facade

Though no significant issues were seen at this time it is highly recommended, at a minimum, that the scope of work consider a complete sealant replacement program to limit the penetration of moisture into the wall assembly. Other recommendations may include a general cleaning of the façade particularly at the west façade adjacent grade. Some minor repointing and masonry repair should be anticipated for good maintenance and aesthetic reasons.

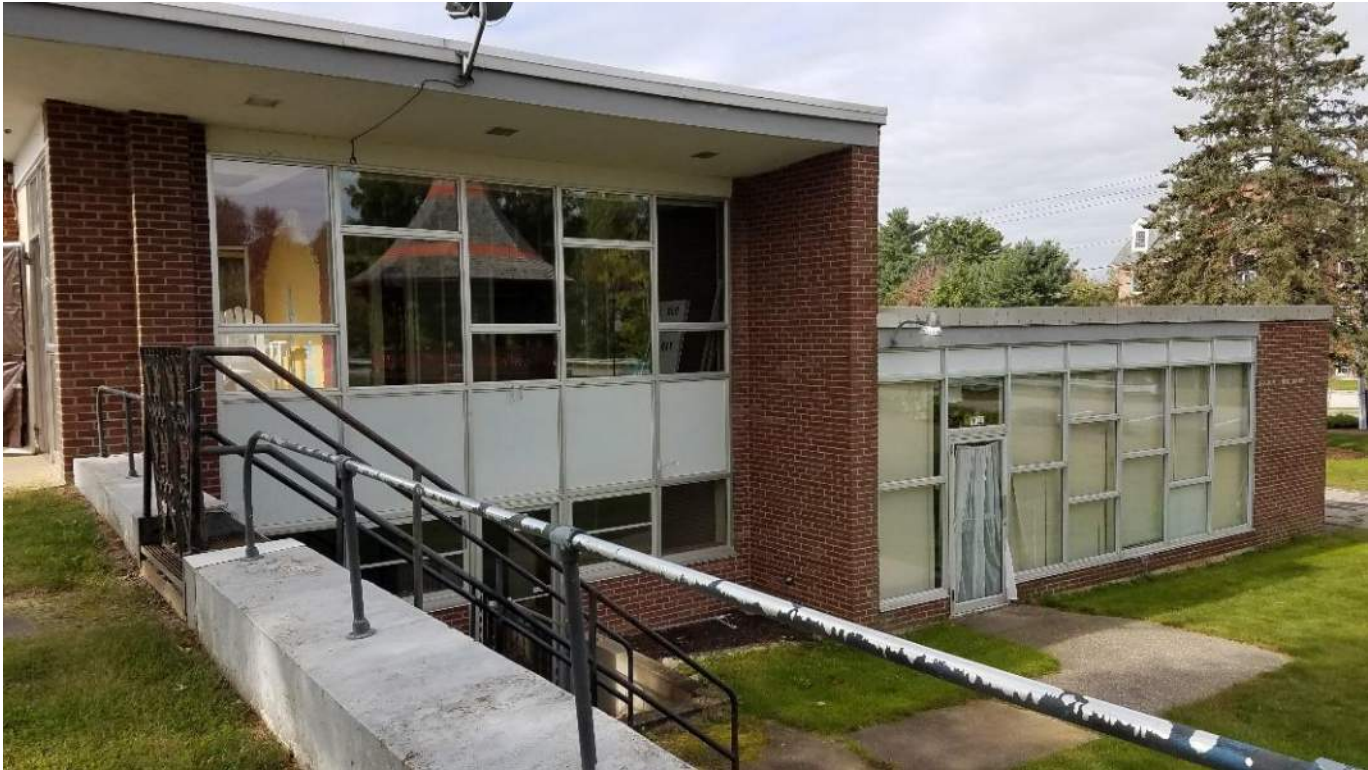
Glazed Wall

As noted previously a mix of windows was observed at the existing facility with some original windows having been replaced with residential grade thermally insulated clad units. Most window units remain are composed of original single pane metal framed units. Such units are no longer energy code compliant nor would meet the expected performance expectation of a contemporary structure. Such issues as condensation sweating, heat gain, heat loss, air infiltration would be common expectations with such units. Perimeter and pane sealants and glazing have exceeded life expectancy adding to the recommendation of replacement. Some glazed units were noted (north east façade) as damaged or missing.

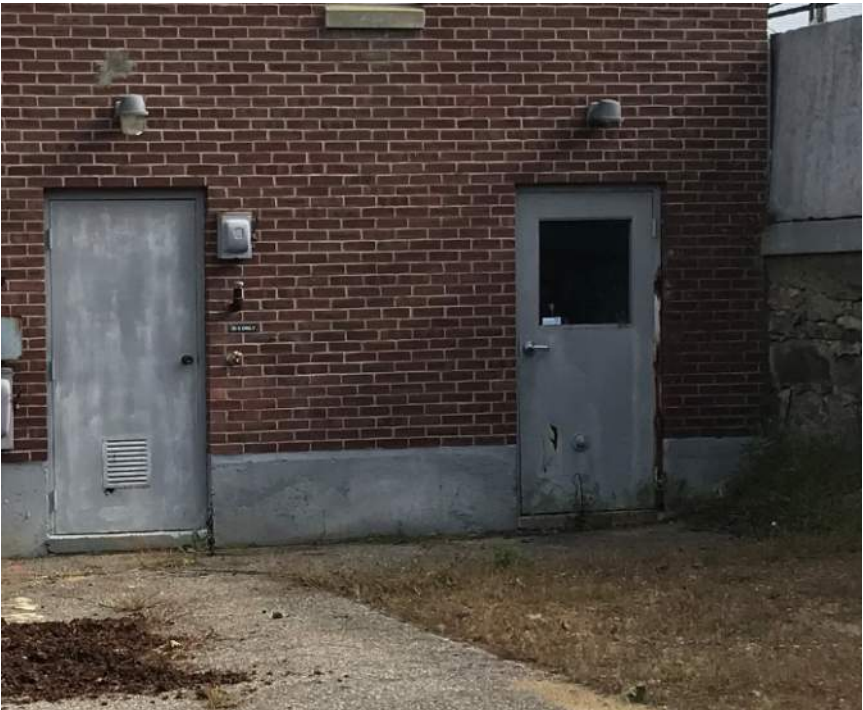
South Side Egress and Mech Room Entry

Existing exterior doors are composed of a mix of single pane un-insulated aluminum doors and residential grade hollow metal doors with glazing. Aluminum doors are non-compliant with current energy and accessibility codes and need replacement. The west side egress door is in fair condition. Door hardware must be replaced with proper egress type hardware (remove deadbolt) and replacement of the existing threshold to meet ADA requirements will be required. Depending upon calculated occupant load swing direction and the requirements for panic/push type devices may be required. The South façade egress door shows signs of deterioration and should be replaced. Vision panel placement is not compliant. Approach push and pull as well as platform at exterior must be reviewed and accommodated.

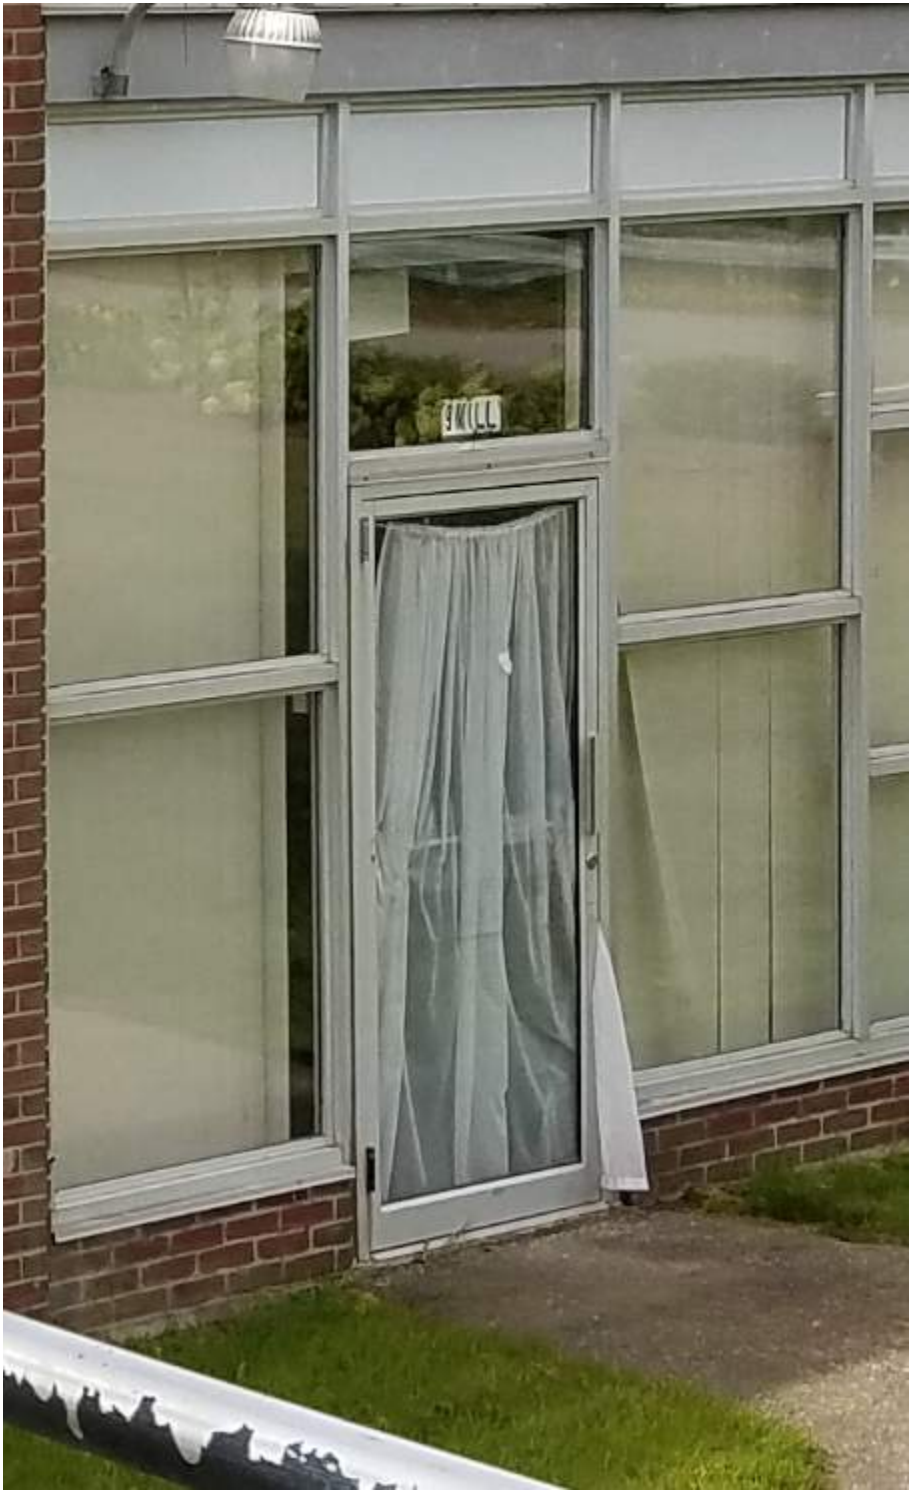
Typical Aluminum Door System

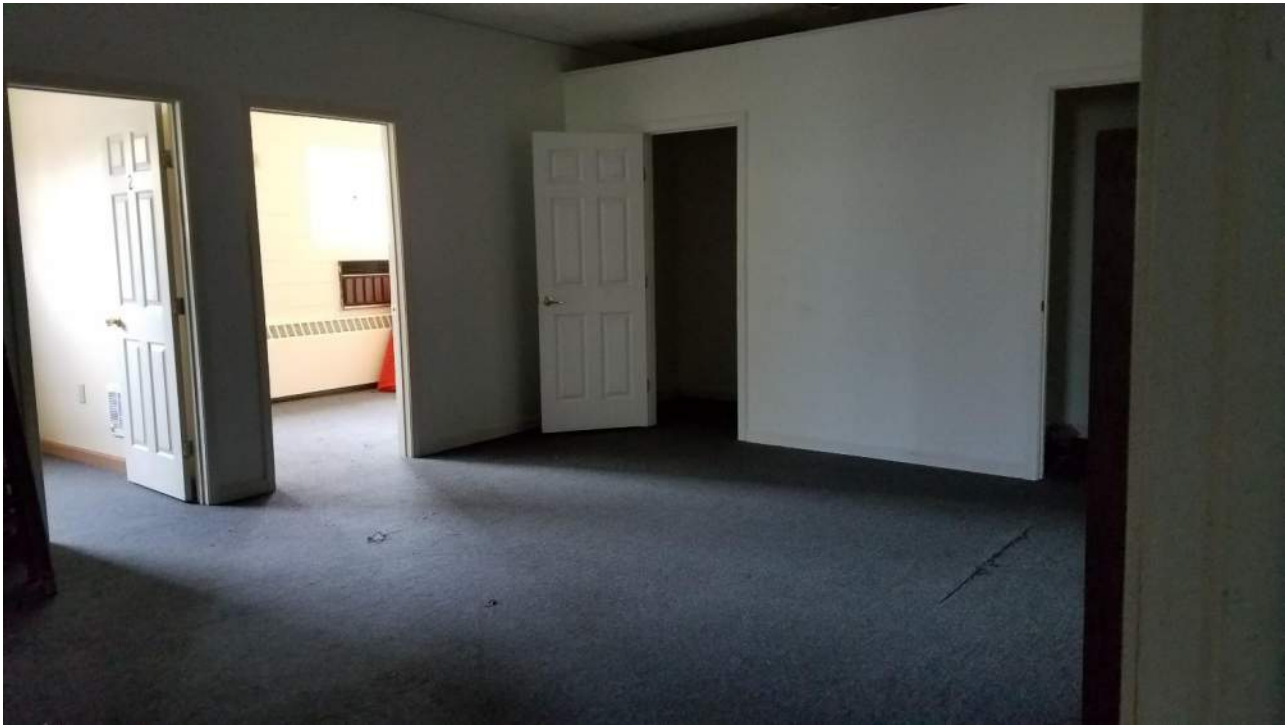
Lower Level Interior

Walls and floors are in poor condition in need of replacement. Portions of the exterior wall assembly incorporate an interior masonry veneer that is in good condition and may be cleaned and left exposed as an aesthetic if desired. However, one should consider options in addressing energy code compliance and if such will require the furring out and concealment of such walls as one option. Secondary options would be to address insulation at the exterior face. Concealment of such walls however should include a technical study of the masonry to ensure alteration of the walls natural ability to breath can be tolerated.

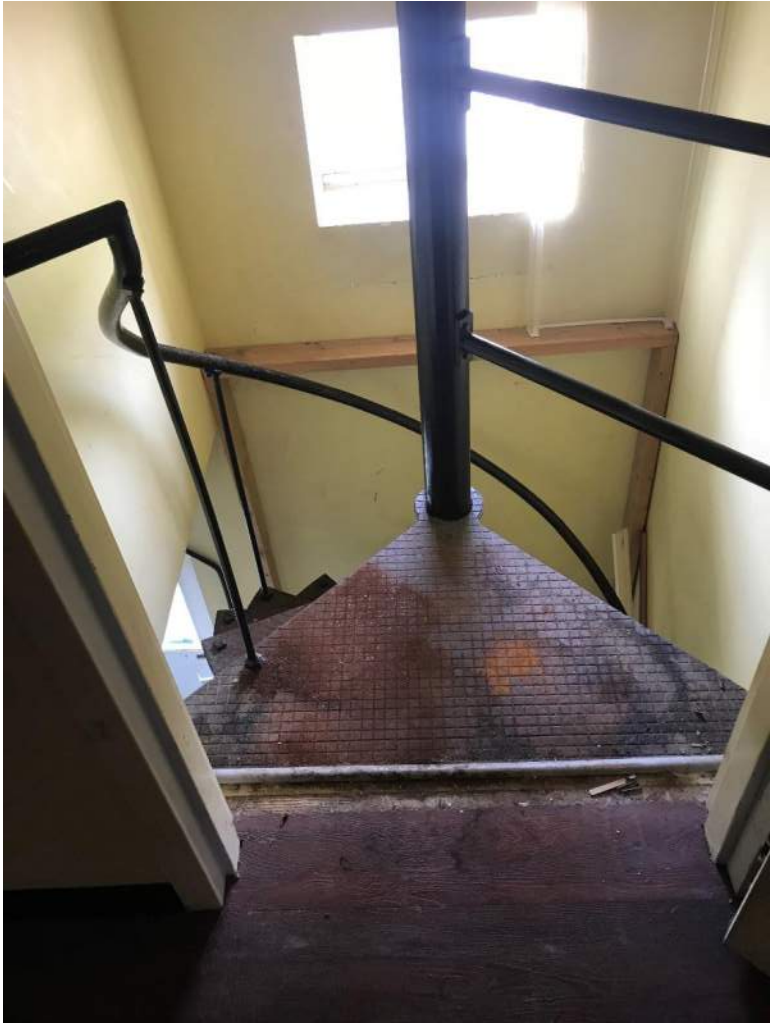
Current two-story configuration incorporates a single non-compliant metal spiral stair opening connecting the upper and lower levels. It is conceivable that the lower level meets egress compliance with the three existing at grade egress points. The upper level however is served by a single at grade egress along main street and would rely on a stair for its required second means of egress. In whatever configuration the program considers for use of this upper level a new compliant egress stair tower should be incorporated within such program.

Bank/Post Office Spiral Stair

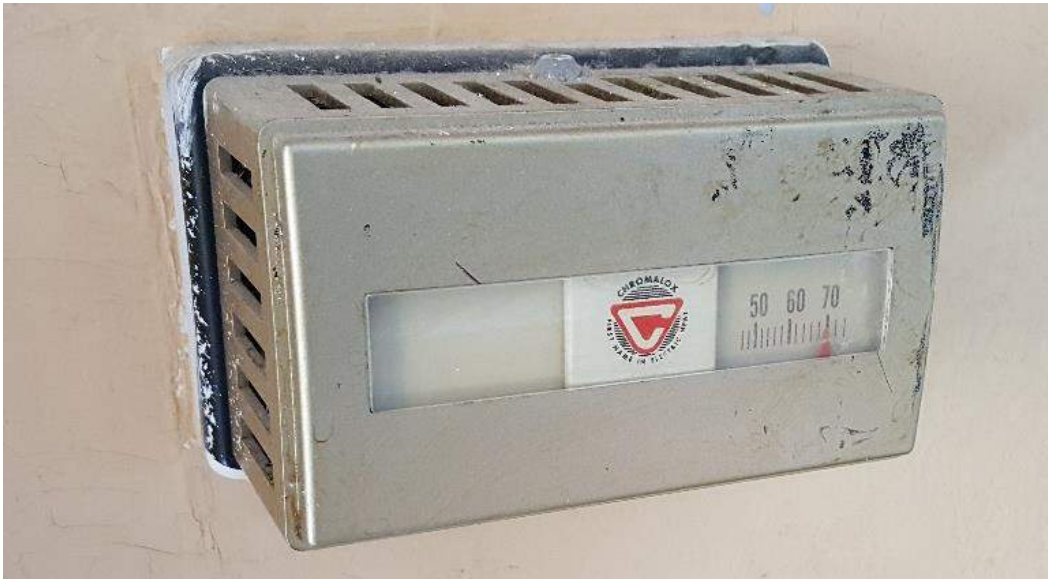
The building currently does not have a functional HVAC system. There are both abandoned hydronic systems and abandoned point of use fuel oil heaters located through-out the building. There are currently no functional heating, cooling or ventilation systems. None of the existing equipment is recommended for reuse. The existing fuel oil tank was removed. The building currently is unconditioned.

Abandoned Thermostats

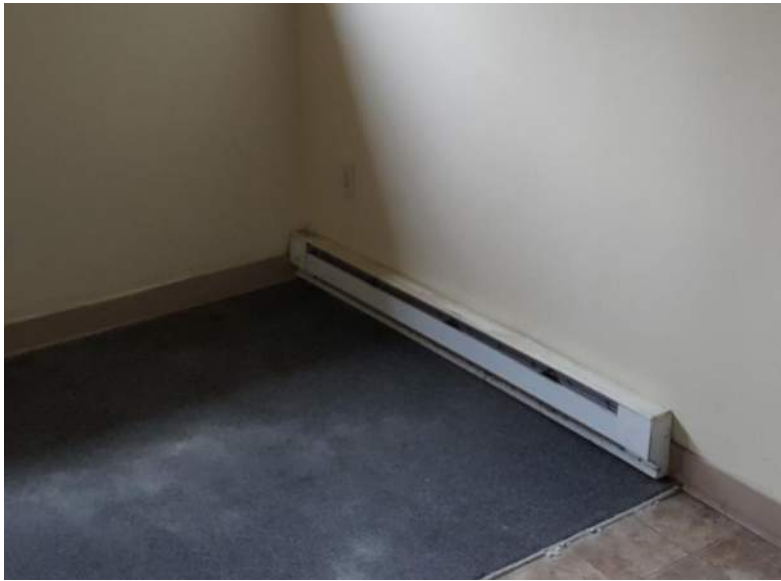
Abandoned Baseboard Radiation in Space

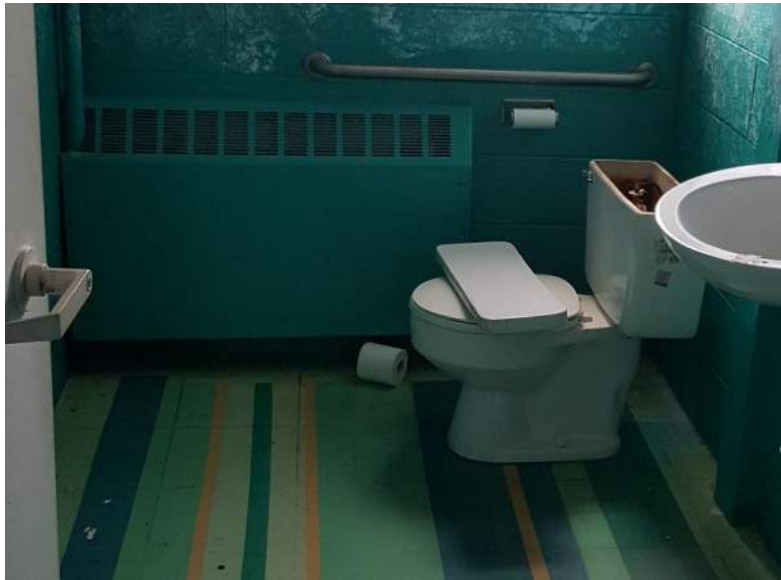
Abandoned Convectors in Bathrooms

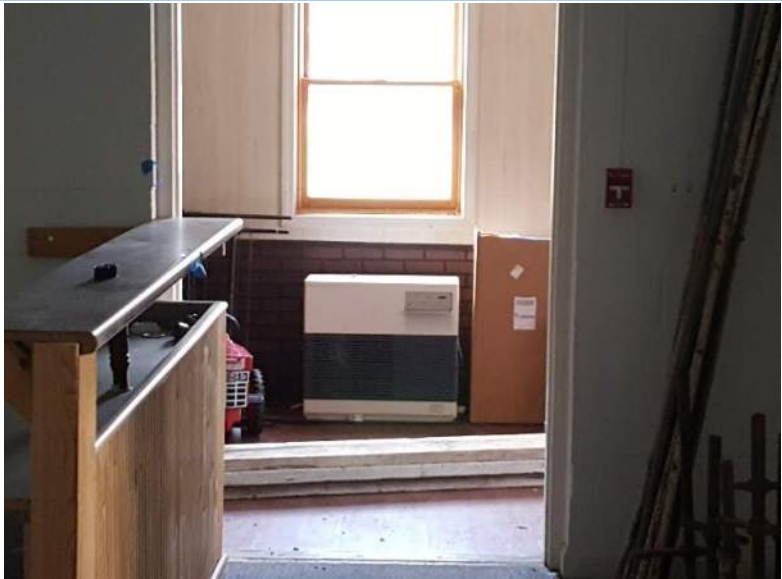
Abandoned Point of Use Fuel Oil Heater at Lower Level Entry

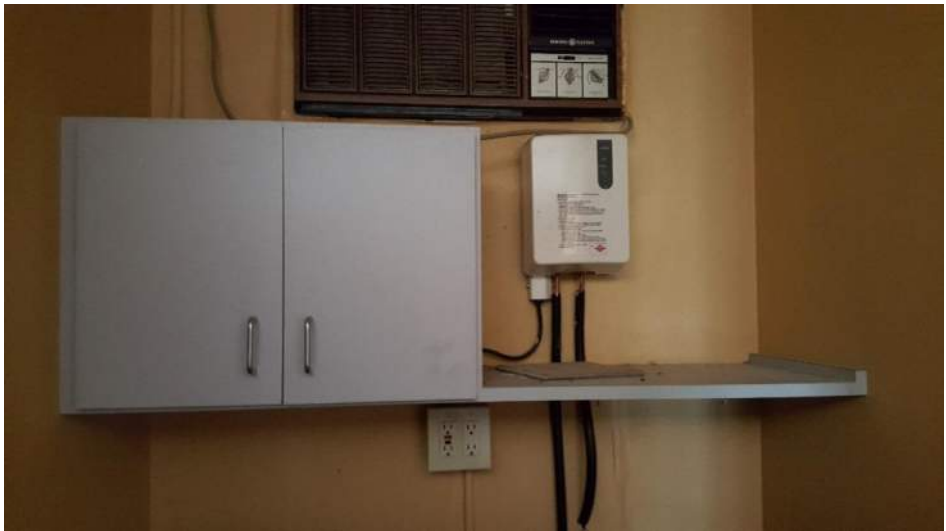
Existing Upstairs Point of Use Water Heater

The buildings plumbing systems as they currently exist are likely to be inadequate for reuse based on the poor conditions exhibited in the observable fixtures and systems. It is possible that the sanitary is reusable but must be checked to confirm there are no blockages or breaks in the lines based upon the lack of heating recently and the building experiencing a number of freeze thaw cycles without proper winterization as based on the finding of water in the water closets rather than propylene glycol. This would indicate there is water in the sanitary pipes at minimum which during freezing could have caused damage to the traps, pipes and fittings. The existing domestic water system is likely not functional or repairable as exhibited by a number of abandoned point-of-use water heaters in the space.

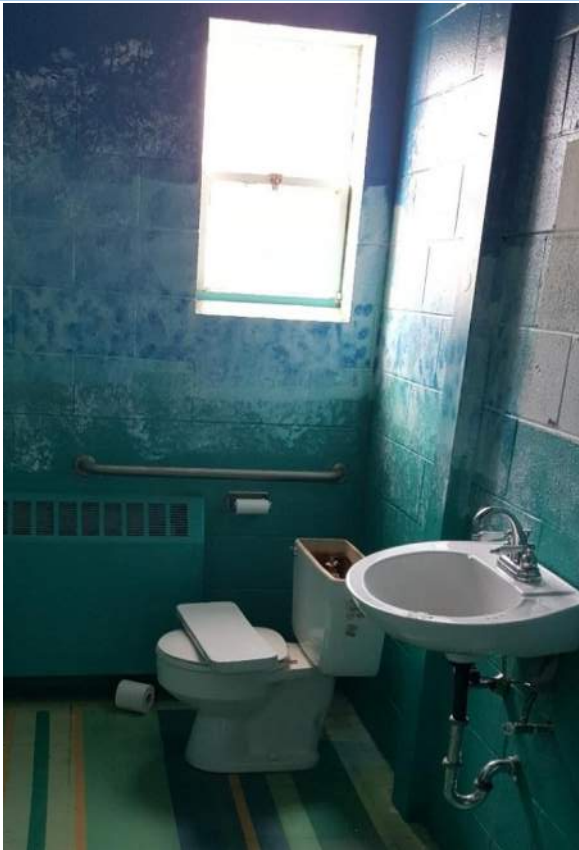
The building’s domestic water system is not functional and all current plumbing fixtures are in poor condition. Piping, where visible, is un-insulated copper. The domestic water service is located in the abandoned boiler room and is turned off. It is assumed that the building sanitary and storm leave the building through the boiler room. As the boiler room was not accessible during our visit, sanitary and storm exits are not verified, nor is the size of the domestic water, storm or sanitary systems. It is recommended that all plumbing equipment, fixtures, piping, and valves be removed and replaced with new if the building is to be reutilized. The existing under slab sanitary piping should be tested before being reused to ensure there are no clogs or breaks in the line. This is critically important as the piping has sat unused, in an unconditioned setting for quite some time. Furthermore, proper removal of existing water/weatherproofing of pipes does not appear to have been undertaken based on the observation of water still in water closets. This indicates possible damage to the piping from numerous freeze thaw cycles that the building has undergone since it was last utilized.

Lower Level Bathroom with Water in Toilet

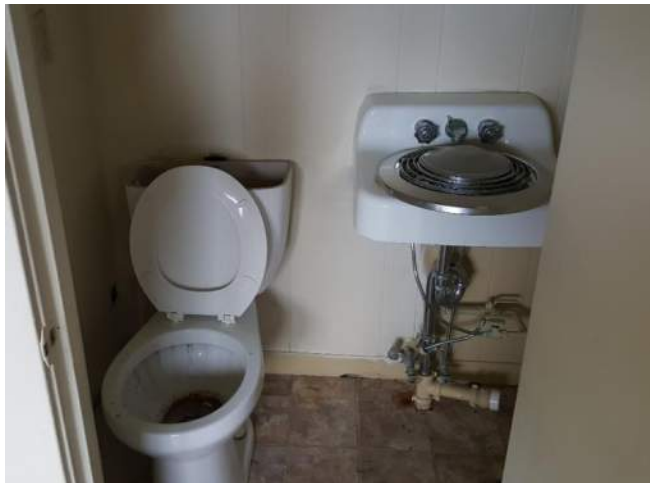
Lower Level Bathroom with Water in Toilet

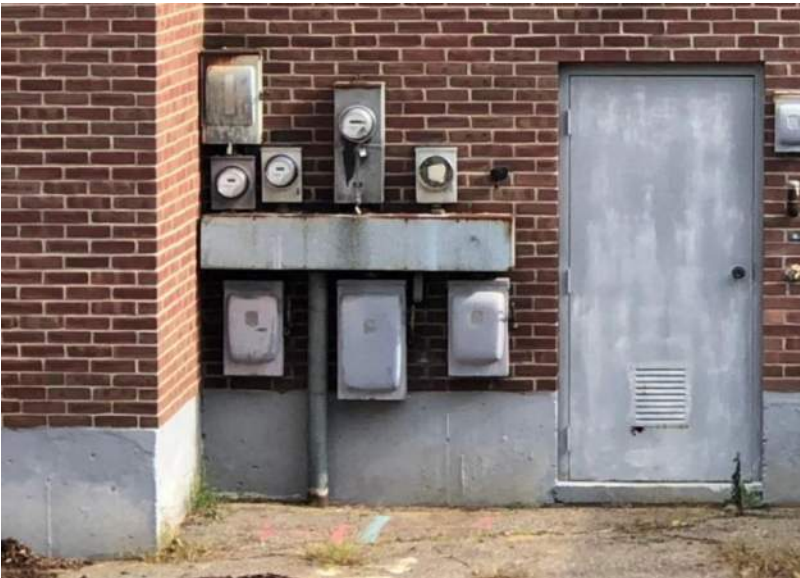
The building electrical service entrance is currently configured for multiple tenants with multiple utility meters and service panels.

Building Electrical Service/Meters

Rehabilitation of this building would require substantial electrical work since the building is currently configured for multiple tenants. The current, obvious code deficiencies would be required to be corrected. All emergency lighting would need to be replaced. The existing fire alarm system will require significant work or replacement. Existing lighting is likely nonfunctional and would need to be replaced as well.

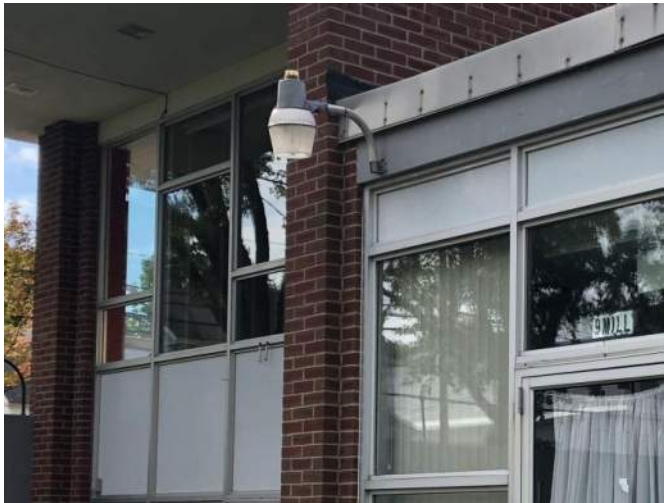
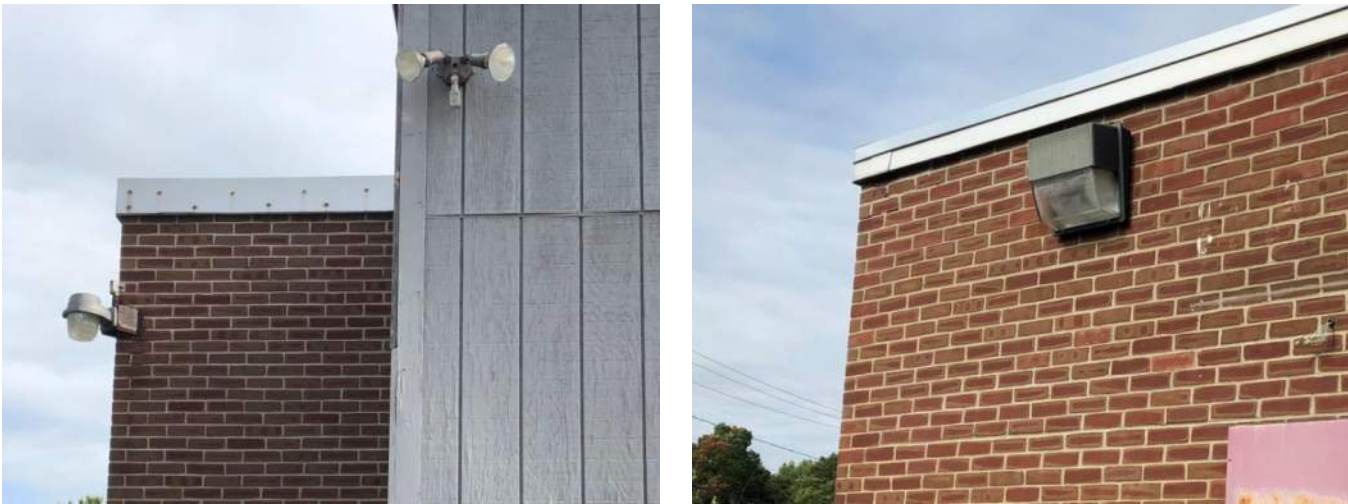
Exterior Lighting

Exterior lighting consists of both HID type as well as incandescent. There is no emergency lighting at any exit doors.
