## **FACILITIES CONDITION ASSESSMENT**

### **Rivendell Interstate School District**

Rivendell Academy East & West Wings | Samuel Morey Elementary | Westshire Elementary

September 25, 2025

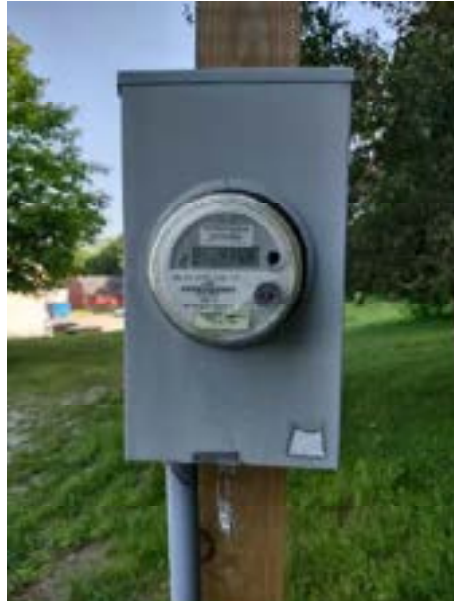
Meter for electrical service.

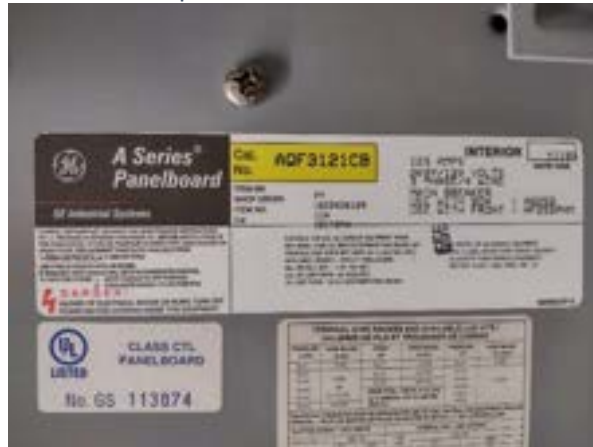
Generator subpanel.

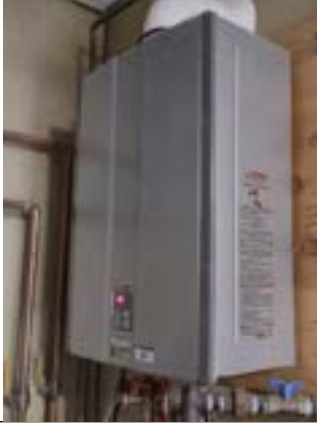
Room 133 boiler #2 Room - Newer hot water heater.

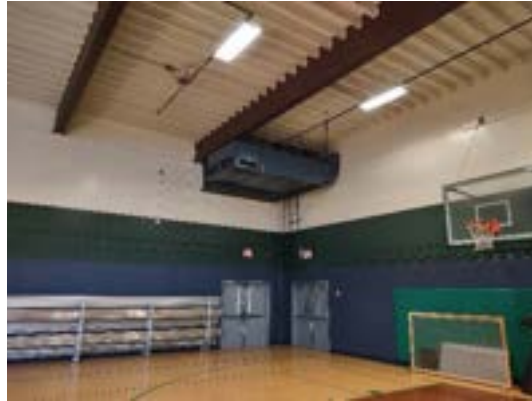
AHU in gym – older unit at the end of its service life.

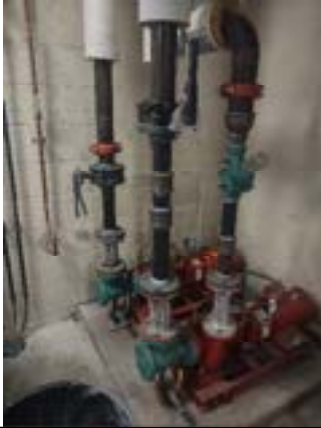
New auto control valves – Very good condition

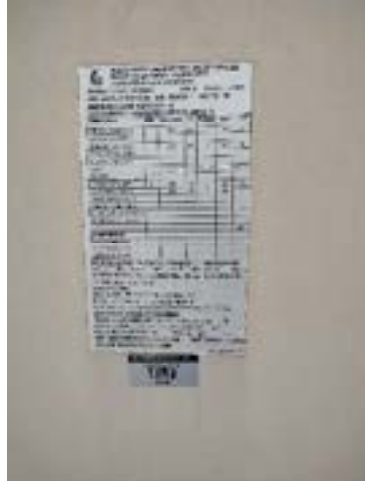
RTU on roof

Paint mechanical rooms and repair all through wall penetrations.  
Replace RTUs and split duct cooling systems.

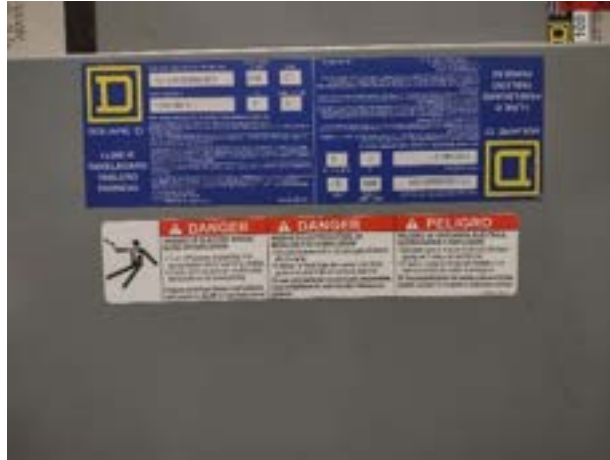
Older panelboard with fire emergency circuit.

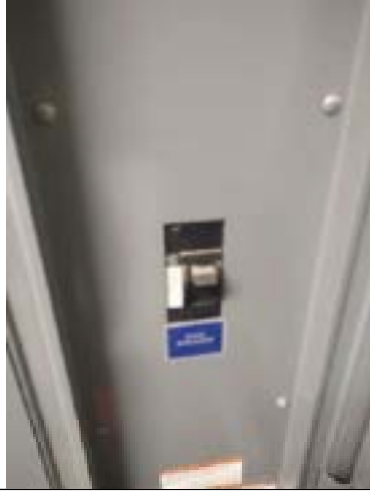
Panelboard shows signs of age.

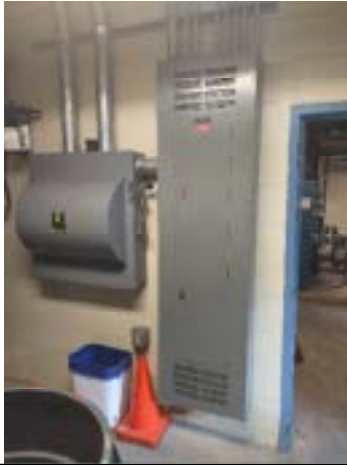
Old main circuit breaker.

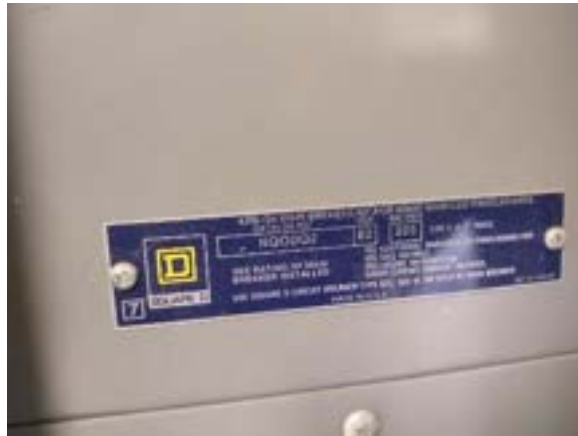
Main breaker showing signs of age.

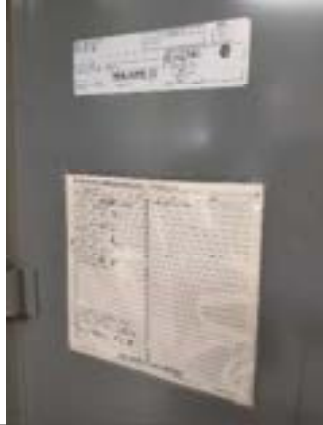
Older main breaker.

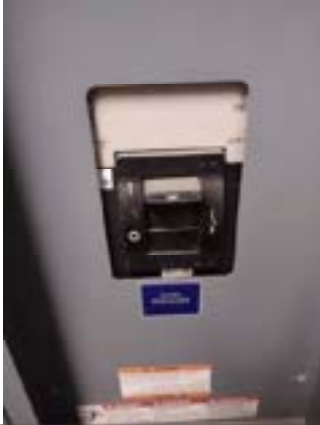
400 amp breaker for boiler room.

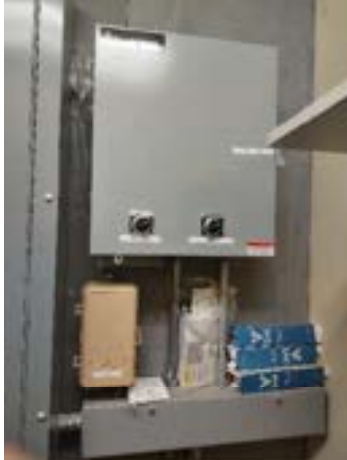
Automatic switches for pole and building lighting circuits.

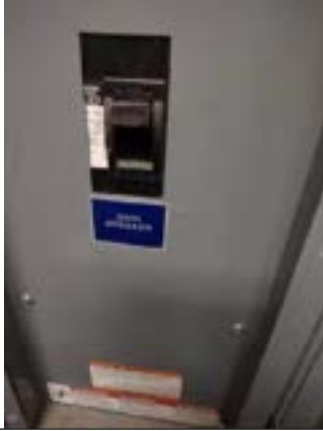
200 amp breaker for kitchen.

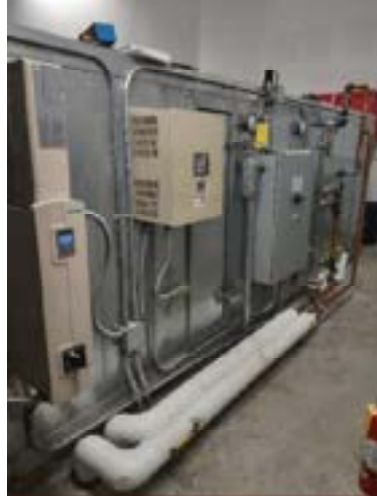
Upper AHU Room - Power, VFD, and piping arrangement

- Replace VFDs.
- Lighting control in many areas do not utilize occupancy sensors. There did not appear to be many areas utilizing dimming or daylight sensing controls.

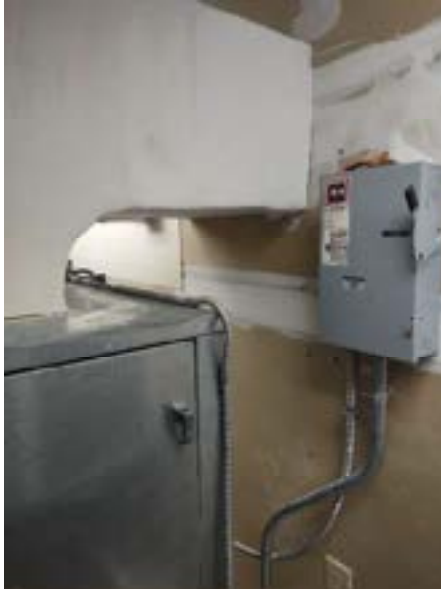
AHU disconnect switch.

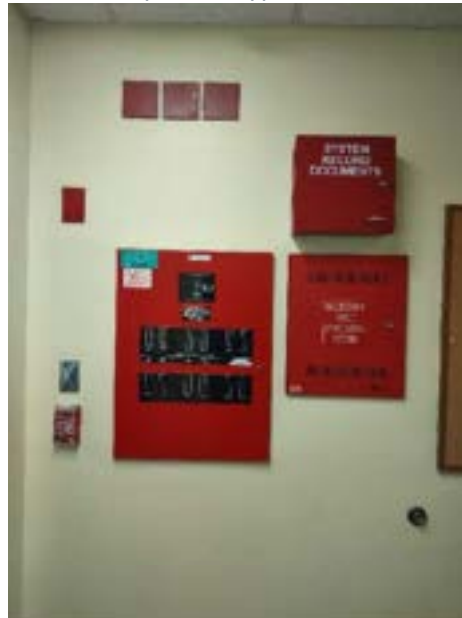
FACP – sub panel – typical
