## **FACILITIES CONDITION ASSESSMENT**

### **Rivendell Interstate School District**

Rivendell Academy East & West Wings | Samuel Morey Elementary | Westshire Elementary

September 25, 2025

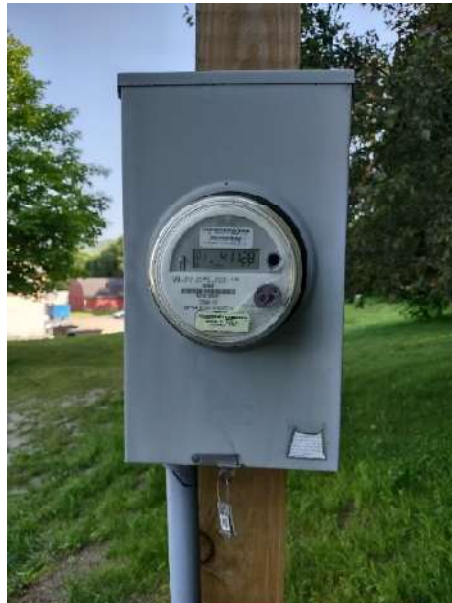
Meter for electrical service.

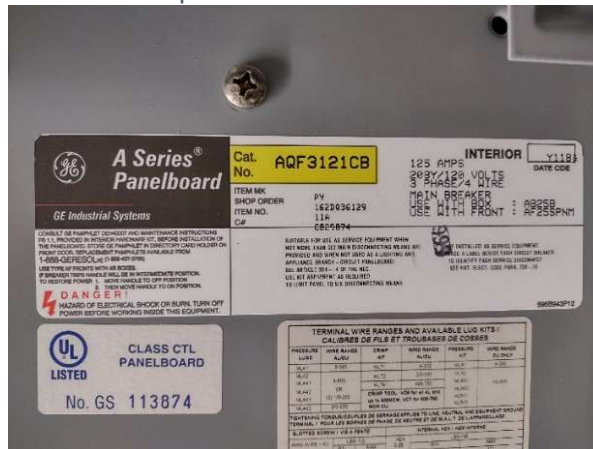
Generator subpanel.

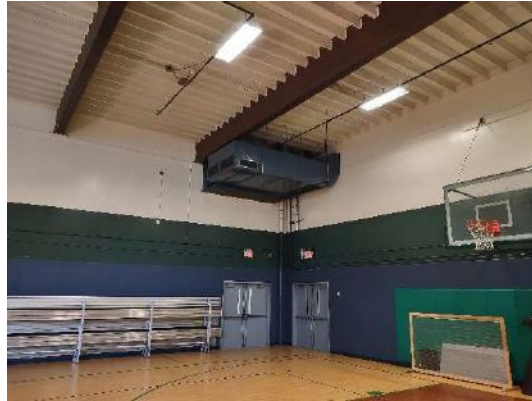
AHU in gym – older unit at the end of its service life.

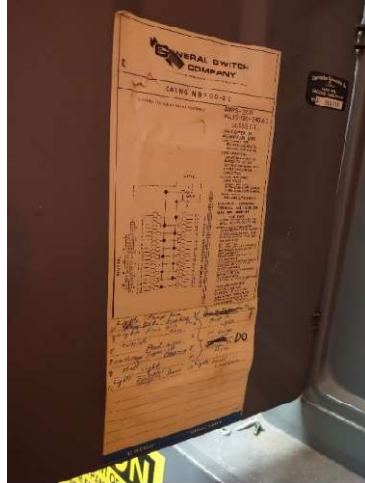
Sub panel original to the facility.

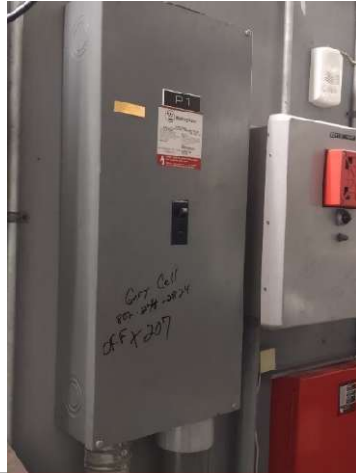
Electrical service disconnect switch to AHUs for gym.

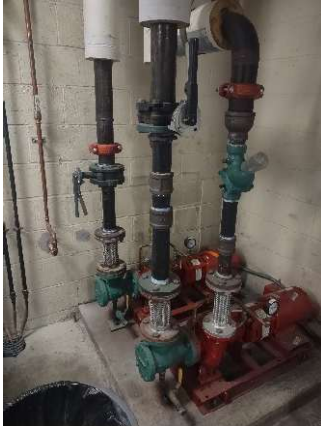
New auto control valves – Very good condition

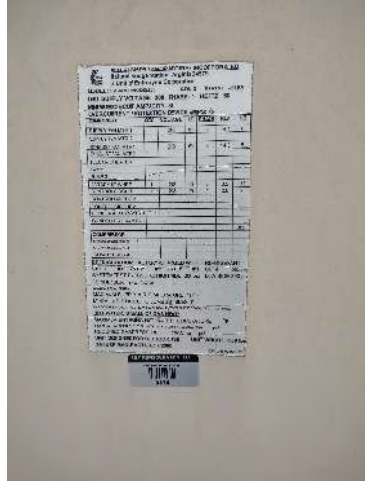
RTU on roof

Repair and replace heating system piping insulation. Inspect piping.  
Test, repair roof top units.  
Replace kitchen hoods.

Paint mechanical rooms and repair all through wall penetrations.  
Replace RTUs and split duct cooling systems.

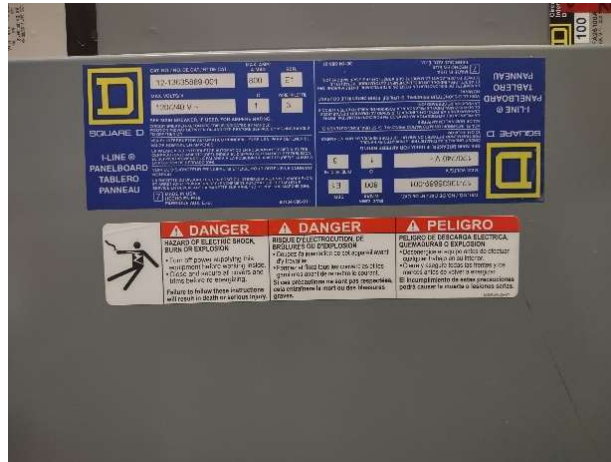
Older panelboard with fire emergency circuit.

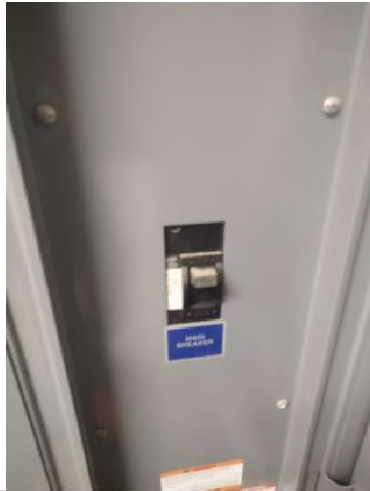
Panelboard shows signs of age.

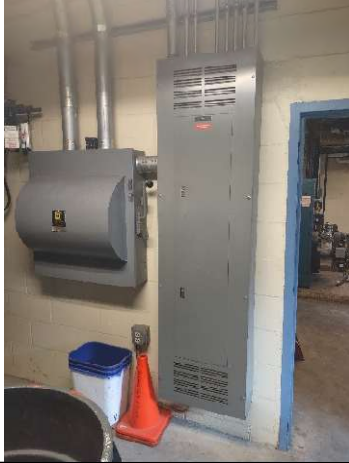
Old main circuit breaker.

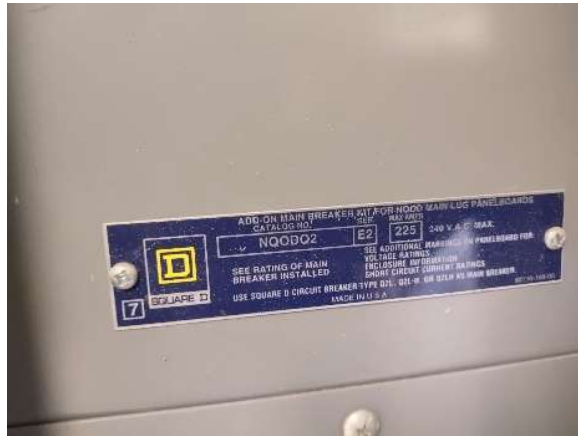
Main breaker showing signs of age.

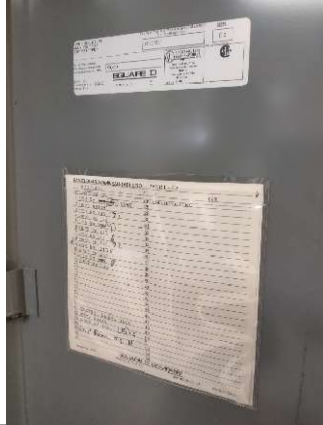
Older main breaker.

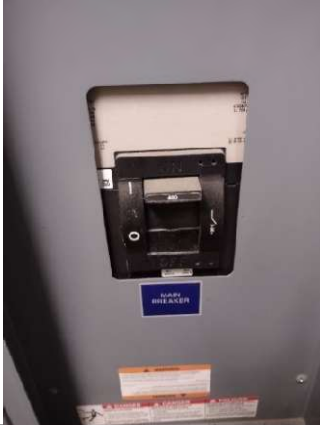
400 amp breaker for boiler room.

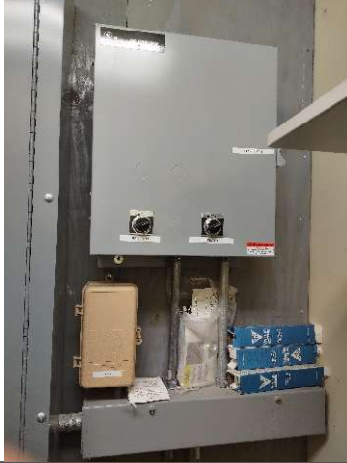
Automatic switches for pole and building lighting circuits.

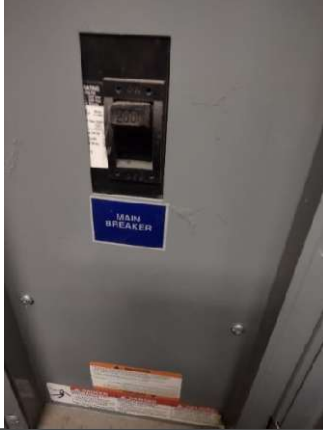
200 amp breaker for kitchen.

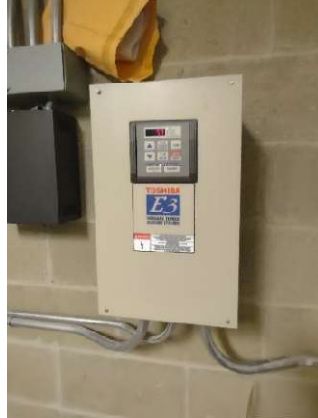
Stage AHU controls.

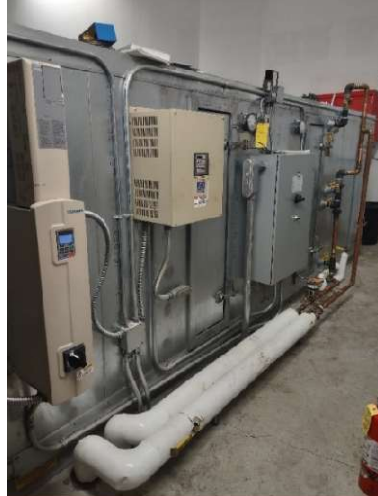
Upper AHU Room - Power, VFD, and piping arrangement

- Replace VFDs.
- Lighting control in many areas do not utilize occupancy sensors. There did not appear to be many areas utilizing dimming or daylight sensing controls.

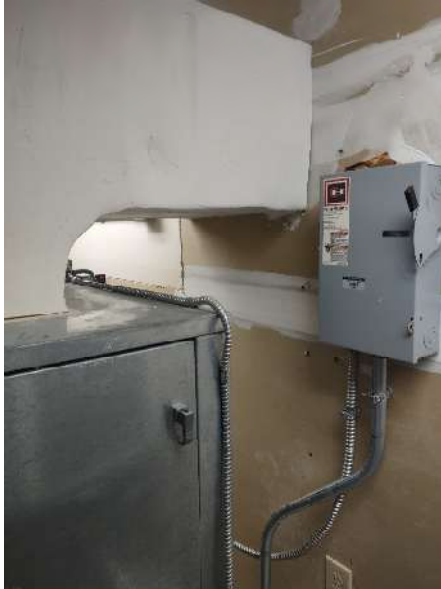
AHU disconnect switch.
