## **FACILITIES CONDITION ASSESSMENT**

### **Rivendell Interstate School District**

Rivendell Academy East & West Wings | Samuel Morey Elementary | Westshire Elementary

September 25, 2025

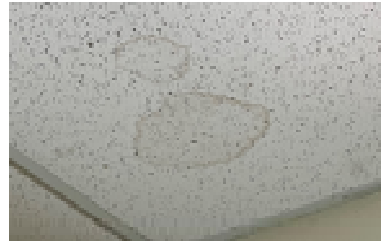
| | | Ceiling | Fair condition. ACT has stains.<br>Recommendation – Replace stained tile. Verify there are no active water leaks. Replace unseated tiles. |

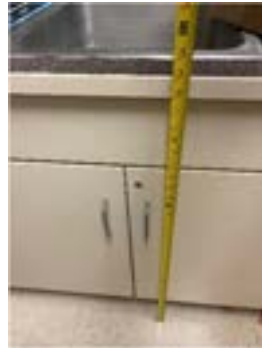
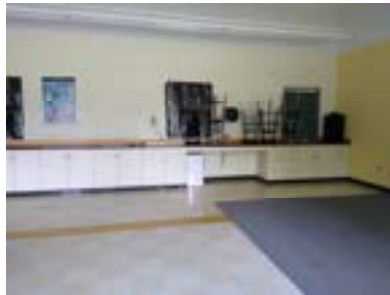
| | | Millwork | Not in compliance with ADA regulations; base cabinets at 3'-4", lacks knee space.<br>Recommendation – Replace base cabinets with ADA compliant units.<br><br> |

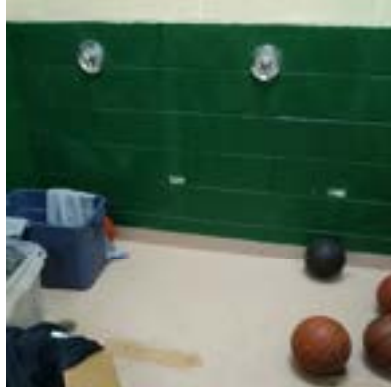
| | | Floor | Poor condition. Epoxy worn in shower areas.<br>Poor condition at the remainder of Locker room floors.<br>Recommendation – replace all locker room tile and remaining flooring.<br> |

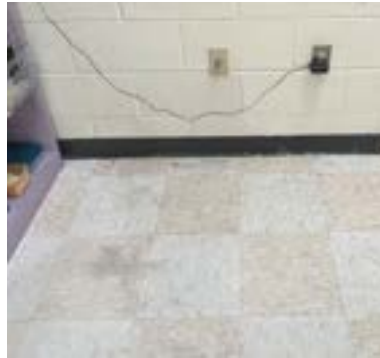
| | | Floor | Fair condition. Many large scuff marks.<br>Recommendation – Clean. |

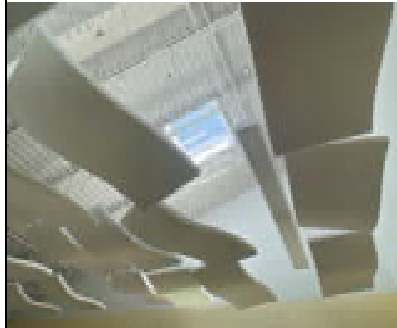
| | | Ceiling | <p>Fair condition. GWB soffits have some scuffs, marks and general wear. Recommend repainting GWB soffits.</p> <p>ACT dropped ceiling clouds are in fair condition. However, they need to be realigned and spaces out evenly with the intended pattern.</p> |

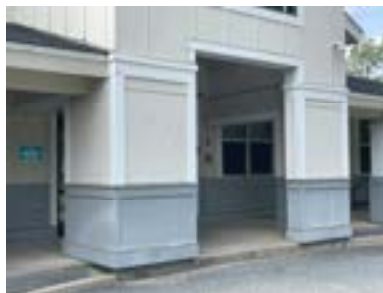
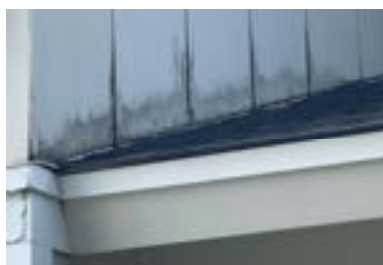
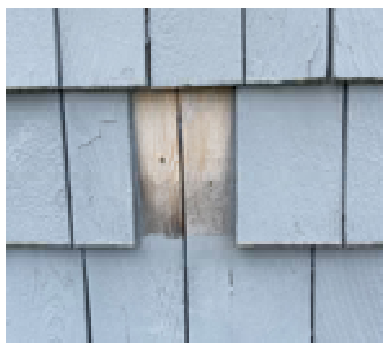
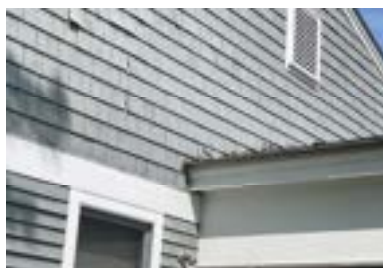
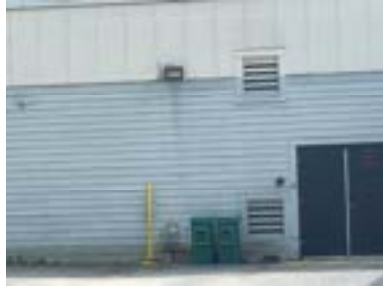
| | | Siding | <p>Fair condition. Wood clapboards and trim boards have peeling paint and paint appears faded; most prevalent around entry drop off area.</p> <p>Recommendation – Repair, Prep, and repaint clapboards and trim. Replace clapboards beyond repair. Replace missing shingle siding and repair deteriorated portions of shingle siding and vertical board and batten siding where it meets and shows excessive warping.</p> |

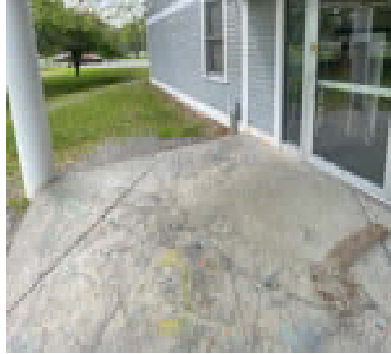
| 3. | Elements [e.g. Columns] | Concrete Pads at Exterior Doors | <p>Concrete foundation in poor condition. Recommendation – Repair cracks, clean misc. paint and seal all concrete pads.</p> |

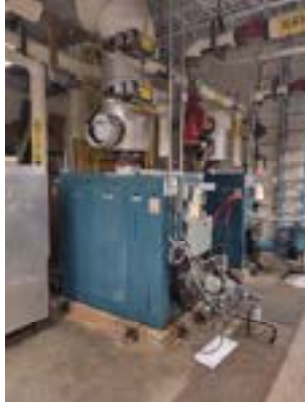
Boiler #1 at the end of its service life.

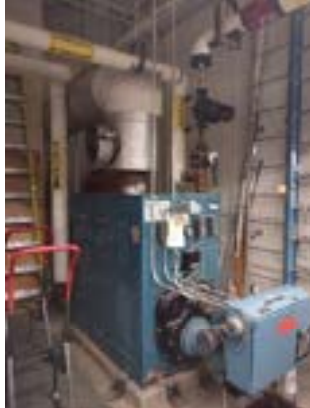
Boiler #2 at the end of its service life.

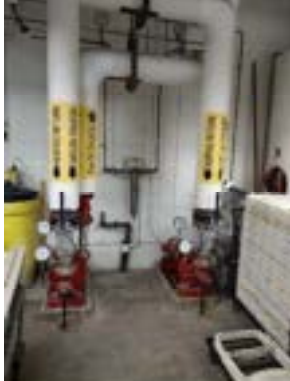
| | | <p>Heating zone circulation pumps – good to fair condition.</p> |

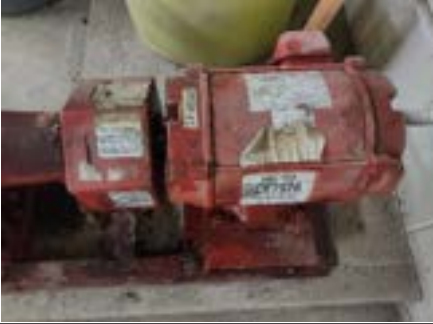
| | | <p>Fair condition – circulation pump and motor</p> |

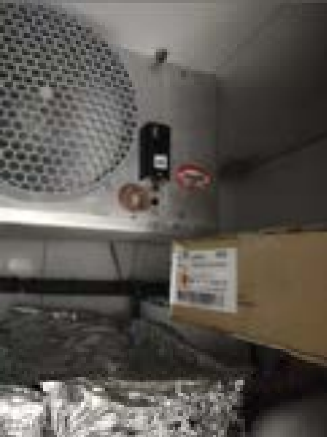
| | | <p>Kitchen refrigerated walk in #1.</p> |

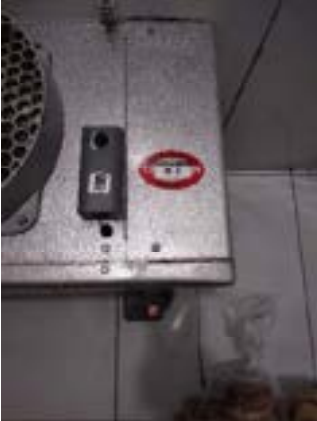
| | | <p>Kitchen refrigerated walk in #2.</p> |

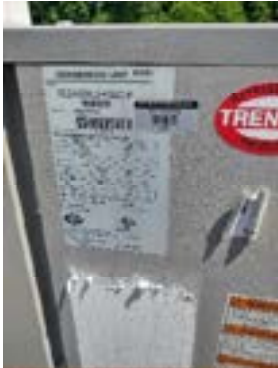
| | | <p>Outdoor condenser unit #1.</p> |

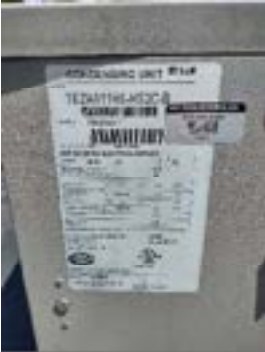
| | | <p>Outdoor condenser unit #2.</p> |

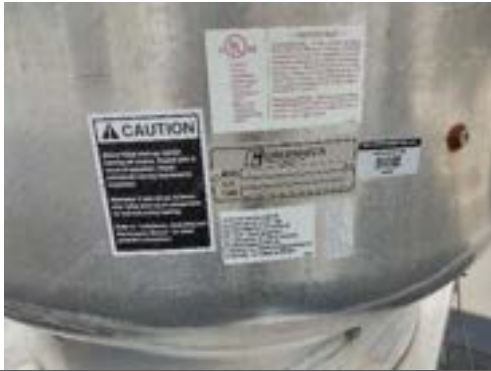
| | | <p>Kitchen grill exhaust fans.</p> |

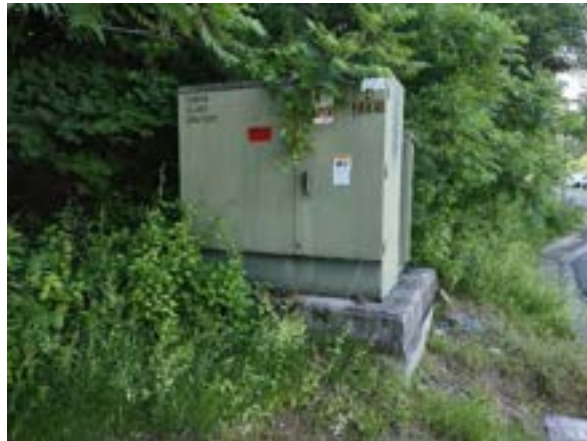
150 kVA -12.5 kV – 208/120V service transformer.

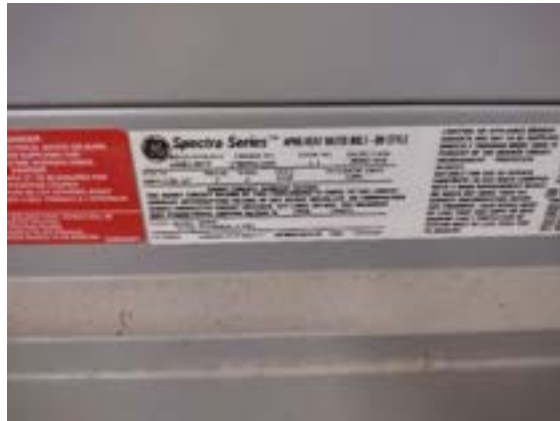
Service Main Panelboard.

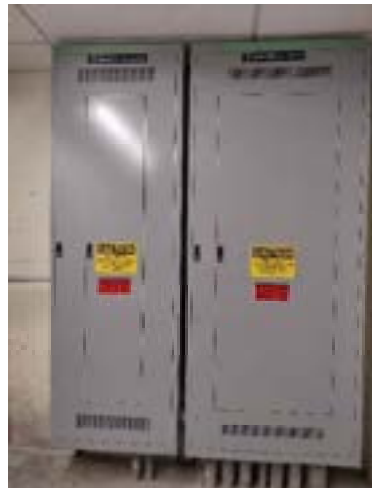
Main Panelboards

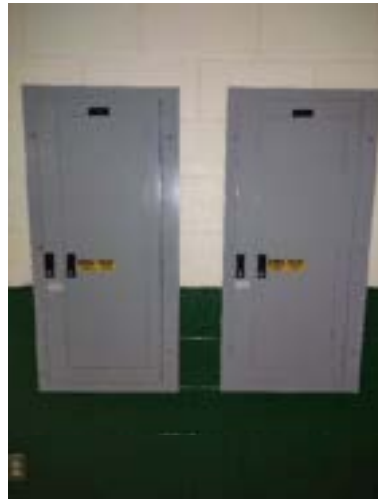
Hallway lighting subpanels - typical.

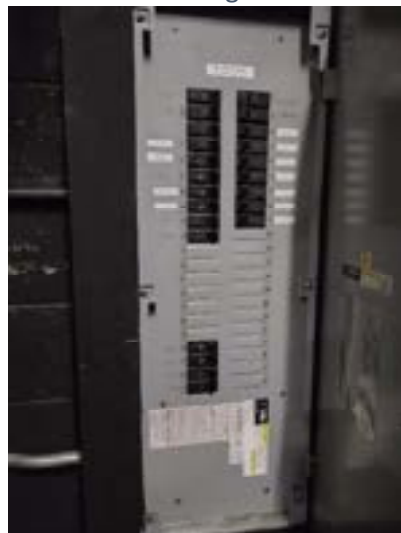
Panelboard for stage.

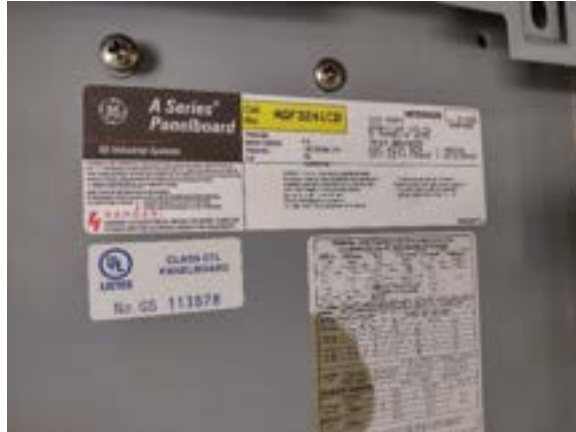
Sub panel for lighting circuits – typical

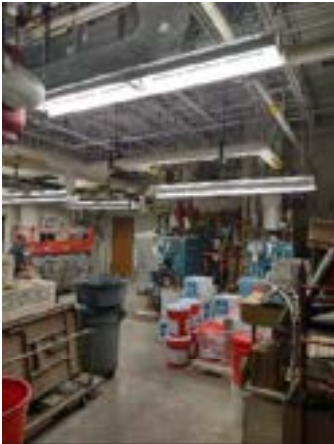
| 3. | Lighting | Typical traditional lighting. The fixtures appear to still be incandescent and fluorescent type. |

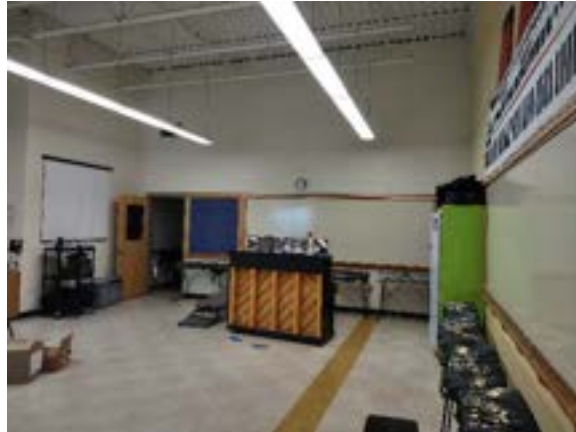
T-8s should be replaced with LED.

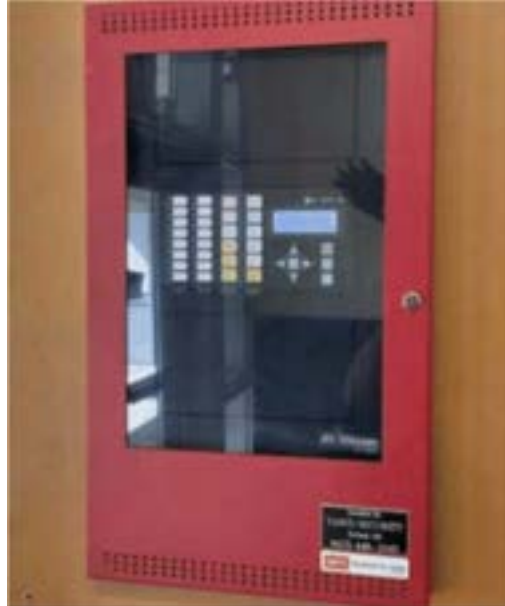
The main fire alarm panel. There were no violation notes on the front cover.

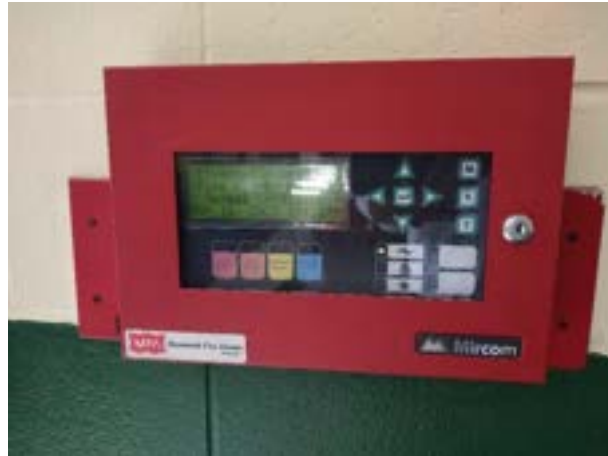
FACP – remote annunciator- appears to be more than one

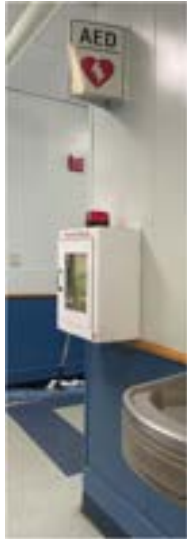
| | | Protruding Objects greater than allowed 4" | <p>AED is in surface mounted cabinet.</p> <p>Recommendation – Install AED in semi-recessed AED cabinet.</p> <p>Multi-Purpose 2131 has surface mounted fire extinguisher.</p> <p>Recommendation – Reinstall fire extinguisher in semi-recessed cabinet.</p> <p>South corridor bench and drinking fountain.</p> <p>Recommendation – Install cane rail or end panel at bench, install ADA compliant drinking fountain.</p> |

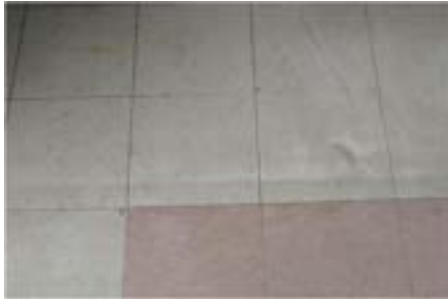
| | | Floor – North End | <p>Poor condition. Cracks and differential settlement in VCT along assumed slab joint lines, scrapes, gouges, discoloring.</p> <p>Recommendation – Install new flooring after flashing concrete slab.</p> |

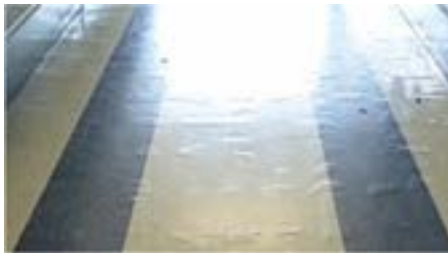
| | | Floor – South End | <p>Poor condition. Bubbling under VCT, edge of flooring at exterior door threshold chipped.</p> <p>Recommendation – Replace flooring.</p> |

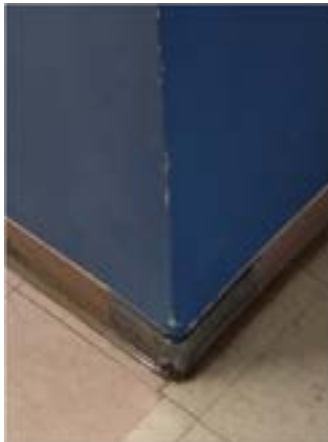
| | | Walls/ Columns – North End | <p>Poor condition. External corners damaged, wall base damaged, paint scraped / missing.</p> <p>Recommendation – Patch and repaint walls, replace wall base.</p> |

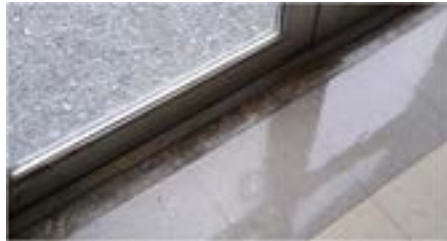
| | | Floor | Good condition. Rough edge at exterior door threshold.<br>Recommendation – Intsall wider threshold.<br> |

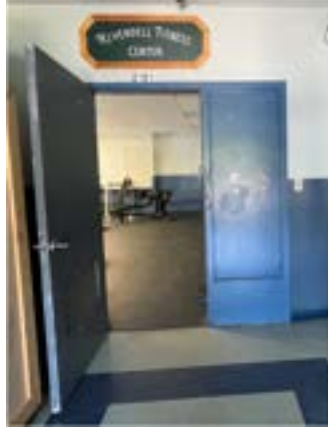
| | | Doors | Poor condition.<br>Recommendation – Replace doors and frames. |

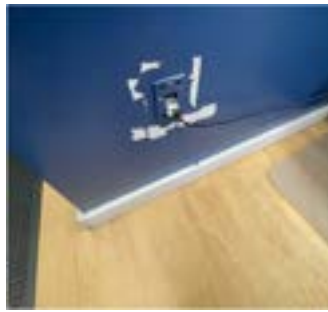
| | | Walls/ Columns | Fair condition, some damage at east wall.<br>Recommendation – Repair and repaint damaged areas.<br> |

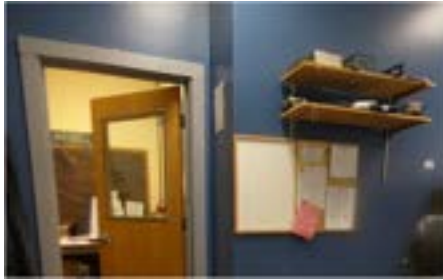
| | | Millwork | <p>Wall mounted adjustable shelves protrude beyond 4".<br/>Recommendation – Remove shelves or move piece of furniture below shelving as cane detection.</p> |

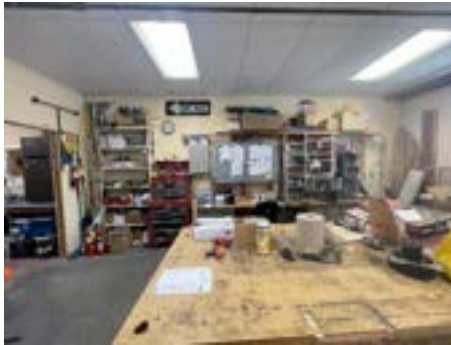
| 12. | Facilities Shop 2104 | | <p>Many surfaces covered by tools, equipment, work surfaces, and materials. Notes reflect only areas that are observable.</p> |
| | | Floor | <p>Fair condition. Concrete has crack near sink. Painted finish has worn off.<br/>Recommendation – Repair crack and recoat surface.</p> |

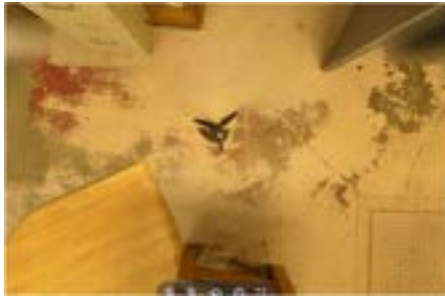
| | | Floor | Poor condition. Concrete floor has cracks and finish has worn off.<br>Recommendation – Repair cracks and repaint.<br> |

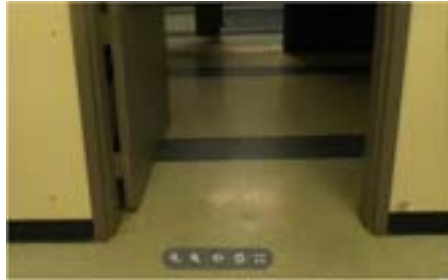
| | | Walls/ Columns | Fair condition with some damage.<br>Recommendation – Repair and paint damaged areas. |

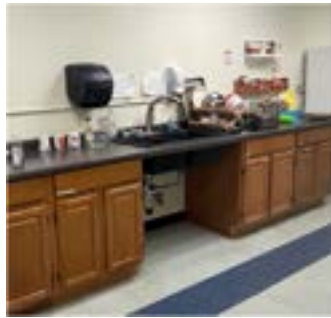
| | | Millwork | Fair condition. Counter height not in compliance with ADA standards, sink drain lacks ADA required insulation. Recommendation – Install ADA compliant sink/counter with drain insulation.<br> |

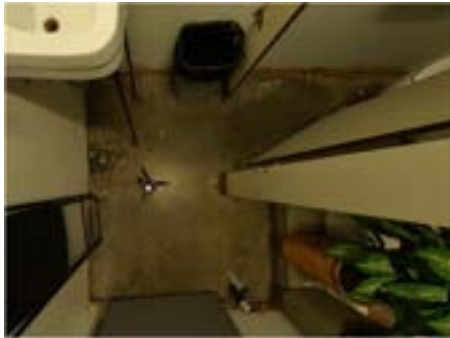
| | | Floor | Poor condition. Bare concrete.<br>Recommendation – Install flooring.<br> |

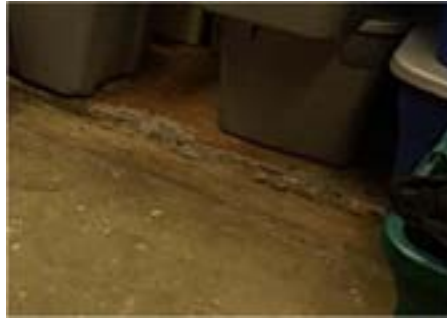
| | | Floor | Poor. Most of floor is concrete slab with perimeter rough cut topping material.<br>Recommendation – Prep floor and install new flooring.<br> |

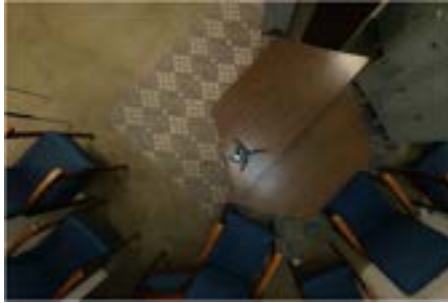
| | | Floor | <p>Fair condition. Unpainted concrete, slopes to drain in two locations with loose flooring used to cover one location.</p> <p>Recommendation – If floors are intended for everyday use, remove drains, flash concrete, install new flooring.</p> |

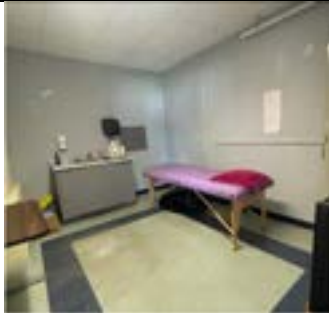
| 26. | Room 2116 | | |

| | | Floor | <p>Poor condition. Portion of floor discolored and scraped.</p> <p>Recommendation – Replace VCT flooring.</p> |
| | | Walls/ Columns | <p>Poor condition.</p> <p>Recommendation – Patch and repaint.</p> |

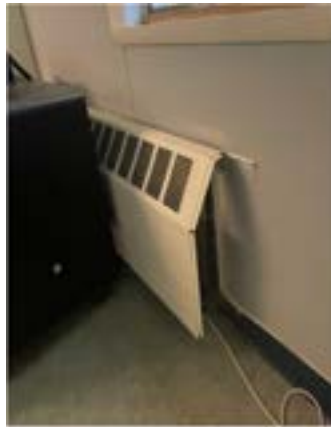
| | | Walls/ Columns | Good condition. Finned tube convactor missing end panel.<br>Recommendation – Replace end panel. |

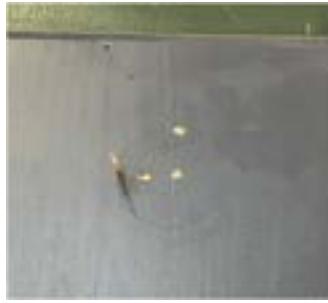
| | | Walls/ Columns | Good condition. Some minor damage. |

| | | | Recommendation – Minor repair and touch up painting.<br> |

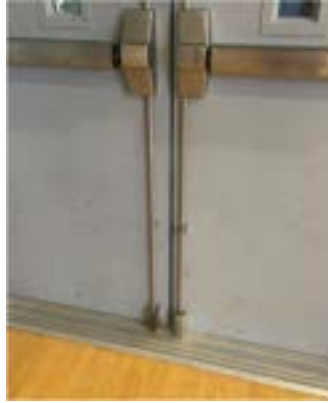
| | | Doors | Fair condition. Some dings and scratches, missing parts on surface rods to east double doors.<br>Recommendation – Repair and repaint doors and frames, repair surface rods.<br> |

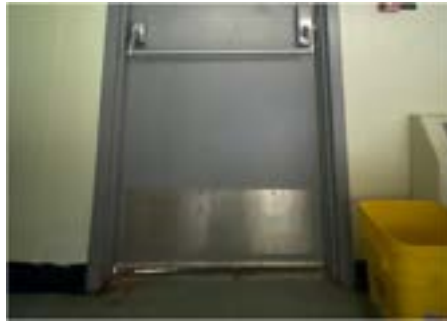
| | | Doors | Good condition – Interior door.<br>Fair condition – Exterior door. Large gap at bottom left.<br>Recommendation – Install new weatherstripping and address threshold if necessary.<br> |

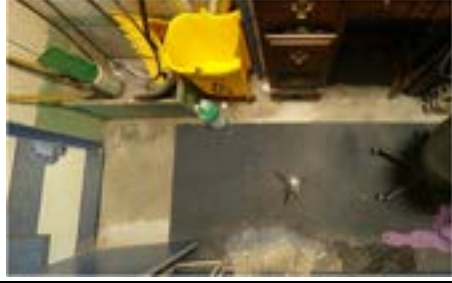
| | | Floor | Fair condition. Most of floor is covered by walk-off mat and cannot be fully assessed. Visible portions are concrete that is sound, painted finish worn off.<br>Recommendation – Repaint floor. |

| | | Ceiling | Poor condition. ACT damaged. Utility space so not critical. |
| | | Doors | Fair condition. Door edge scraped.<br>Recommendation – Repaint door edge. |

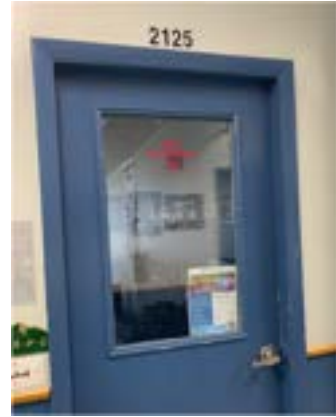
| | | Doors | Fair condition. Paint scrapes on door and frame.<br>Recommendation – Repaint door and frame. |

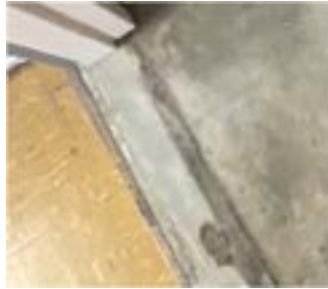
| | | Doors | Good condition. Some chips and scrapes on exterior of 2134, damaged threshold to storage room.<br>Recommendation – Repaint exterior face of door 2134, replace threshold to storage room. |

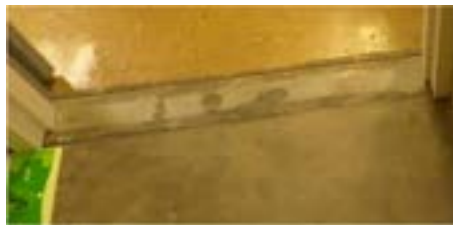
| 39. | Storage for<br>District Office<br>2128, 2134 | | |

| | | Floor | Fair condition. Sealed concrete floor. Damaged threshold.<br>Recommendation – Replace threshold to storage room. |

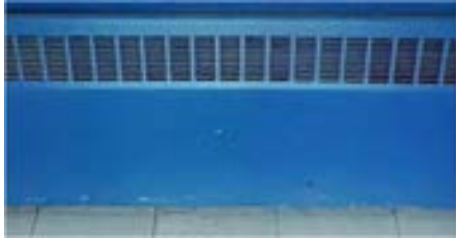
| | | Walls/ Columns | Good condition. Window sills have chips, finned tube convector has scrapes.<br>Recommendation – Repaint sills and convector. |

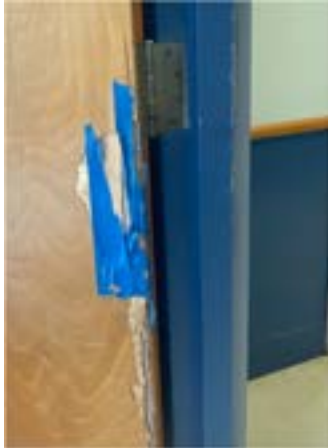
| | | Doors | Good condition – North door and exterior door.<br>Poor condition – South door.<br>Recommendation – Replace wood south door, paint frame. |
| | | Borrowed Lites | Fair condition – South door sidelite, see door notes above. |

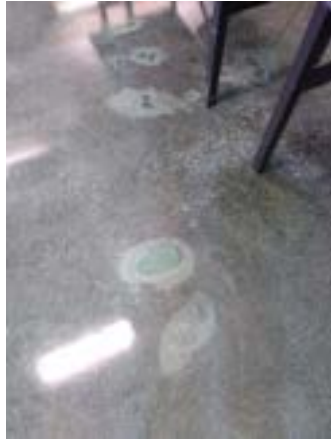
| | | Floor | <p>Fair condition. Some discoloration, surface finish scrapes, chips. No immediate action required.</p> |

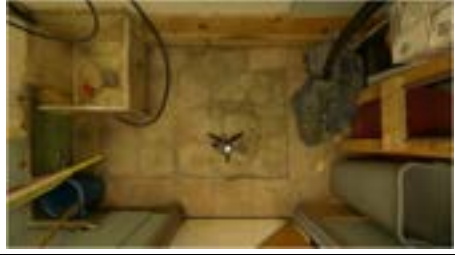
| 45. | Janitor's Closet<br>2135 | | |

| | | Floor | Very poor condition. Portion of VCT missing, remaining VCT is damaged.<br>Recommendation – Replace flooring.<br> |

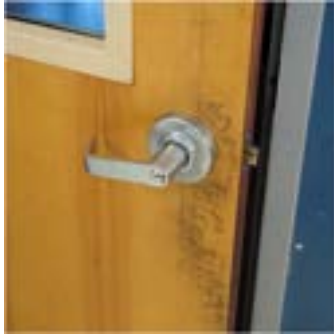
| | | Doors | <p>Poor condition – Entry doors. Worn finishes, chips, scrapes, loose hardware.<br/>Recommendation – Replace doors and hardware.</p> |

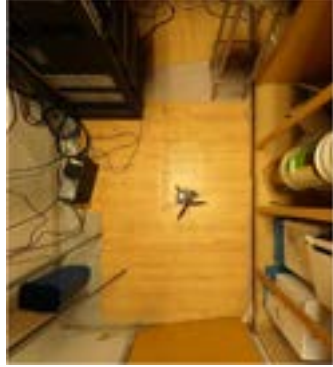
| | | Floor | Poor condition. Random sizes of sheet flooring loose laid on VCT.<br>Recommendation – Install static dissipative flooring. |

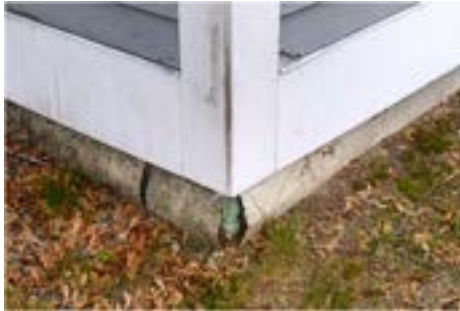
| | | Foundation | <p>Fair condition. Southern portion of building foundation insulation cover has broken / bowed sections. Recommendation – Repair / replace damaged areas.</p> |

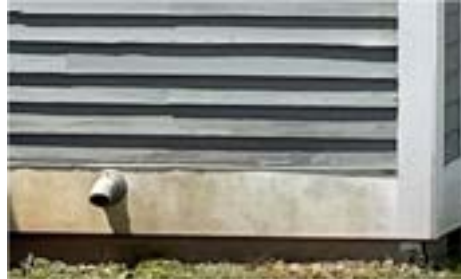
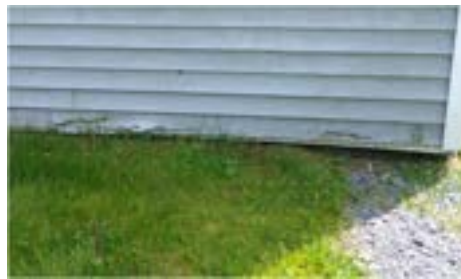
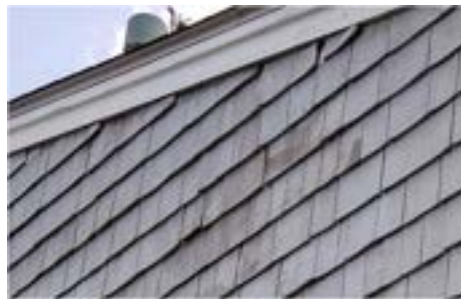
| | | Siding | <p>Poor condition – Southern portion. Wood clapboards have numerous areas of rot. Trim boards under exterior doors have areas of rot. Gable end shakes have areas of cupping and deterioration. Trim boards at bottom of wall show discoloration. All siding and trim should be painted.</p> |

Recommendation – Replace wood siding and replace trim under doors. Clean and repaint any wood elements to remain.

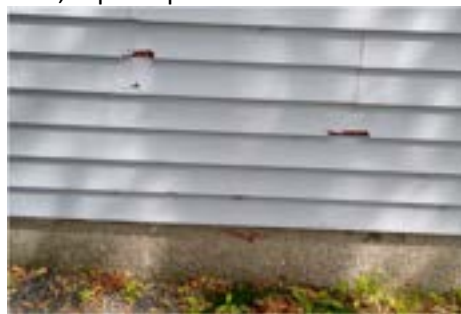
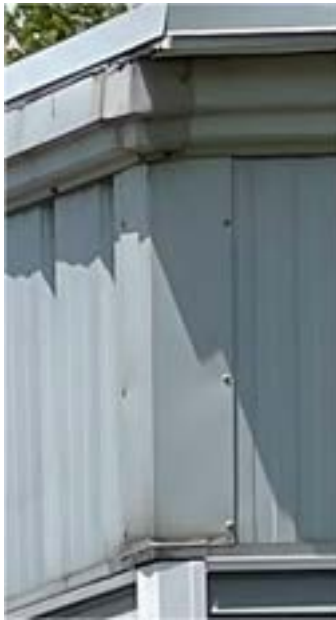
Good condition – North portion. Various locations have cracked / broken vinly clapboards and broken vinyl trim pieces. Damage and makeshift corner pieces at panels above vinyl clapboards.

Recommendation – Replace broken vinyl clapboards and trim, replace panels.

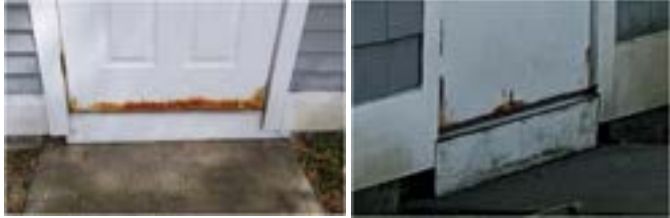
| | | | <p>Fair condition – Hollow metal doors. South portion of building has several HM doors with rust at bottom of door.</p> <p>Fair condition – Overhead door. Door has dents.</p> <p>Recommendation – Replace rusted doors, replace dented section of overhead door.</p> |

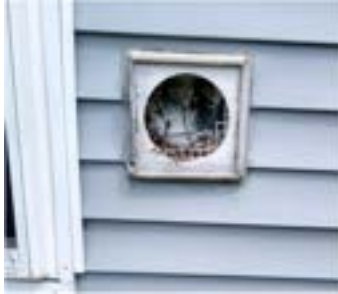
| | | Louvers | <p>Good condition. Two exhaust vents on west side of north portion of building in very poor condition.</p> <p>Recommendation – Replace vents or remove if not in use.</p> |

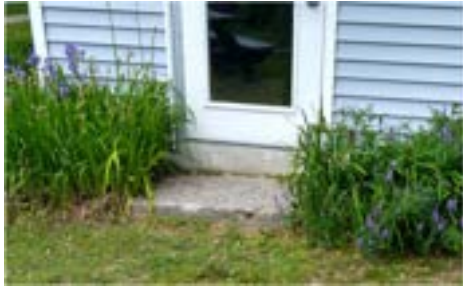
| | | Concrete Pads at Exterior Doors | <p>Poor condition. Cracks and rust at concrete pad at main entry. Crooked concrete pad at exit from Room 2136. Concrete pad eroded at north entry. No concrete pad at stair exit door.</p> <p>Recommendation – Install new concrete pads at exterior doors to meet ADA requirements.</p> |

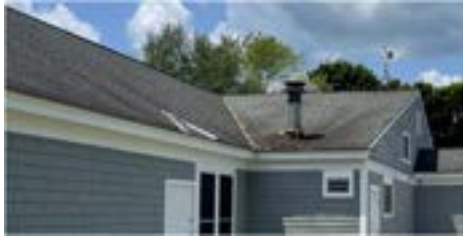
| | | Asphalt Shingles | Good condition – Northeast roof installed around 2023. Fair condition – South roofs. Some discoloration visible, no reports or signs of active leaks.<br> |

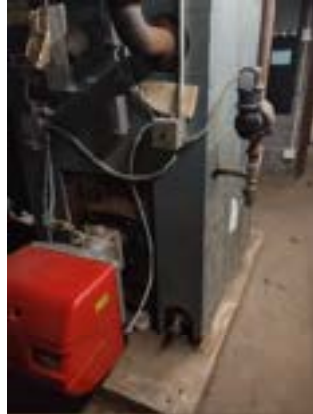
Basement boiler #1 with an oil service burner and boiler. This existing burner/boiler has 3 zones, was combustion tested in 2019, was installed in accordance with code, is well maintained but is at the of its service life. LN Consulting recommends that this equipment be upgraded.

Basement boiler #1 at the end of its service life.

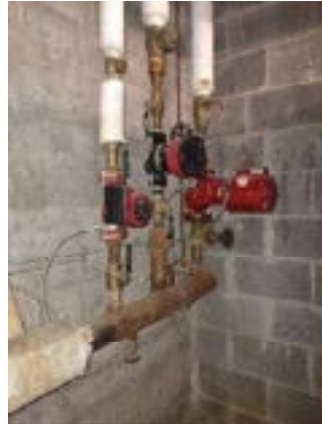
Newer circulation pumps.

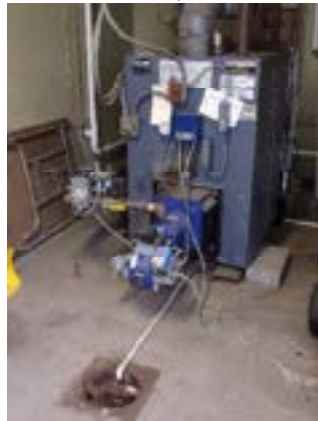
Room 133 Propane fired boiler #2 – 15 years into 30 year service life.

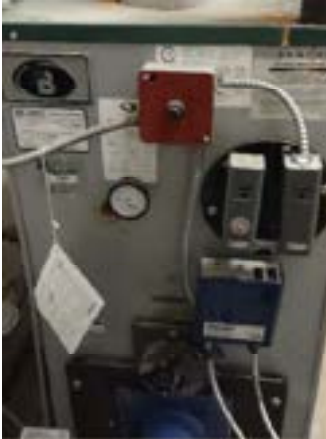
AHU Room boiler #3 – 15 years into a 30 year service life.

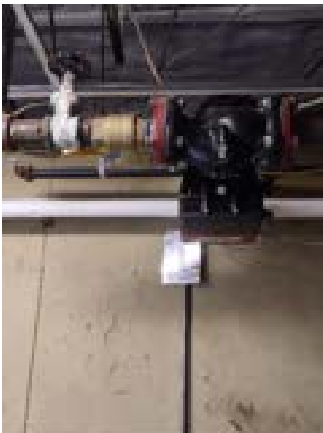
Newer circulation pump.

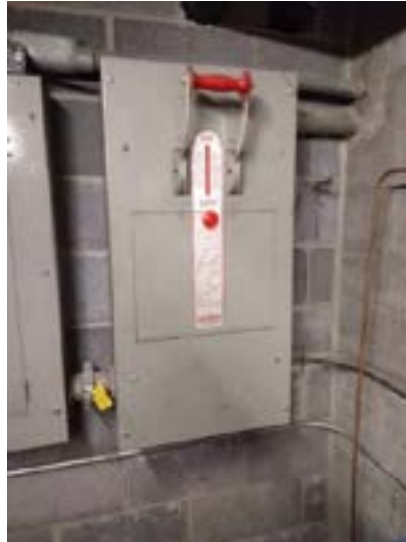
The main service equipment is in the basement. Functional but past its service life.

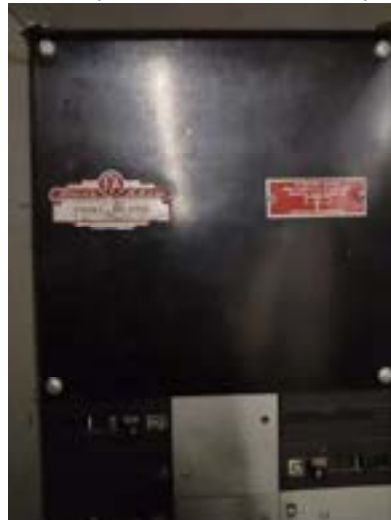
225 amp, 120/240 volt, three phase service panelboard.

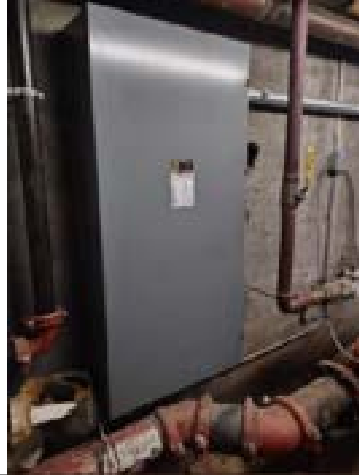
Newer 600A safety switch in very good condition.

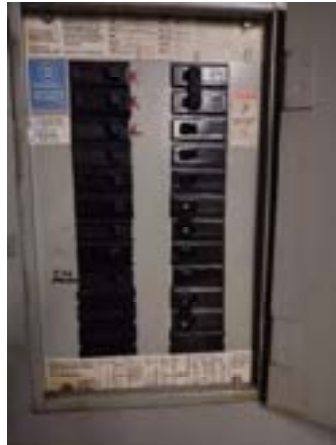
Sub panel original to the facility. Shows signs of corrosion and age.

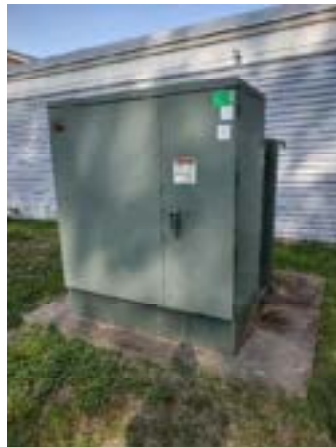
Pad mounted service transformer at the back of the school.

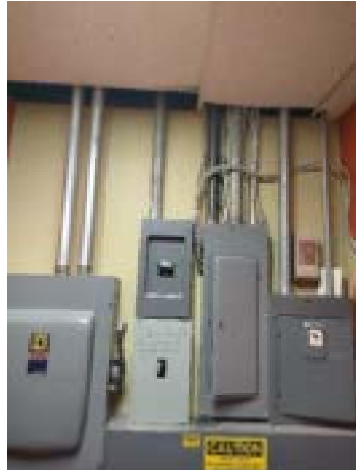
The 1<sup>st</sup> floor electrical service equipment is in Room 134 - Electrical. Functional but some components are past their service lives.

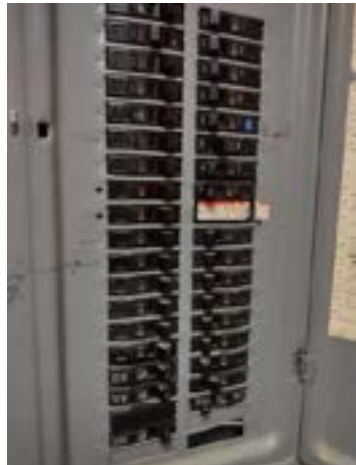
Functional but aging panel.

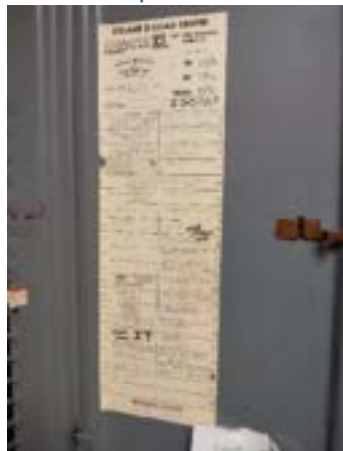
Functional panelboard shows signs of aging.

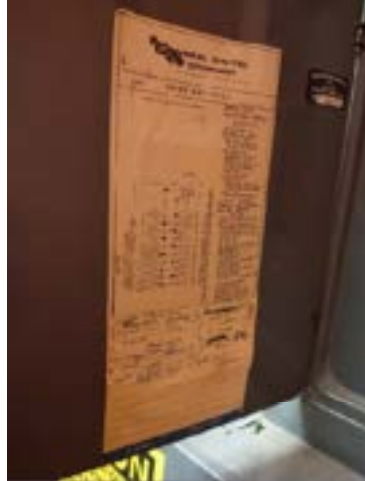
Sub panel original to the facility.

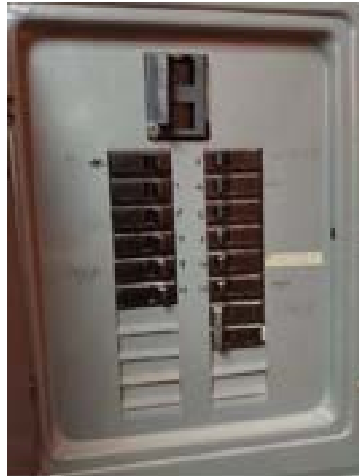
Sub panel original to the facility. Shows signs of age.

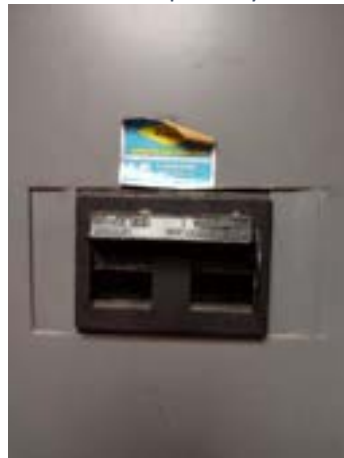
Older 200 amp safety switch.

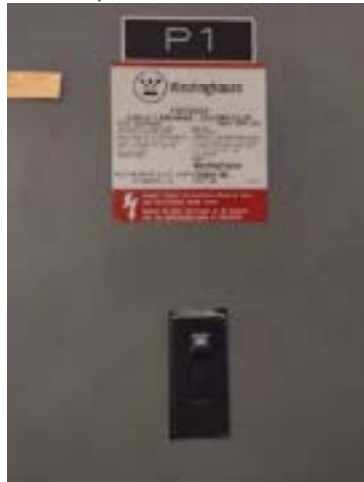
200 amp, 120/240 volt, main breaker – AHU room.

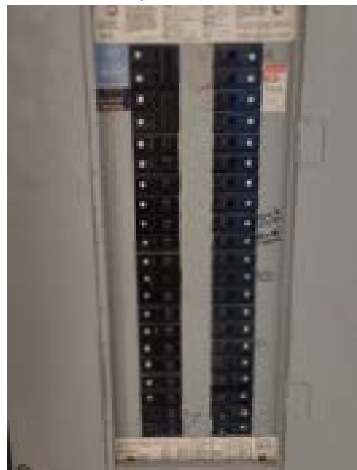
Functional panelboard shows signs of age.

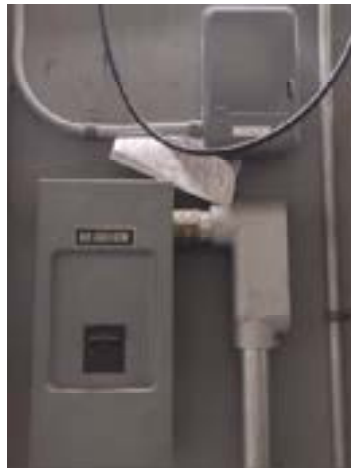
Older disconnect switch.

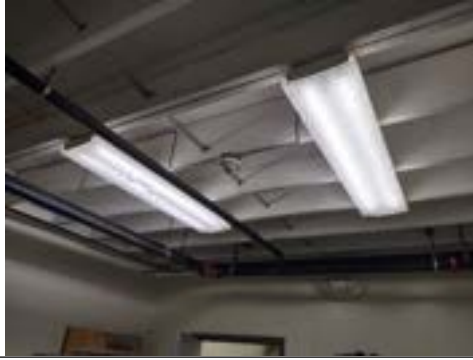
Typical traditional lighting. These tend to provide more glare since they do not “disperse” the light but rather simply shine down. The fixtures appear to still be incandescent and fluorescent type.

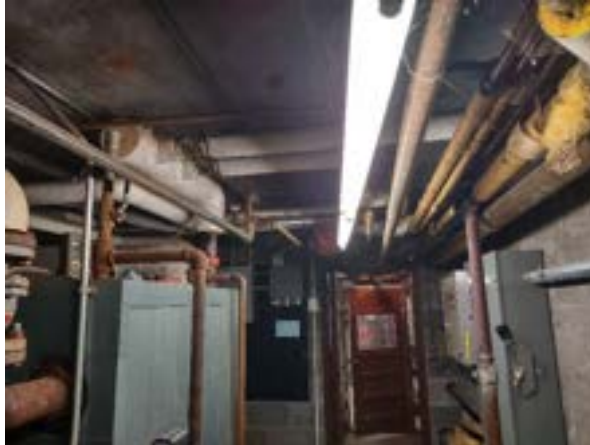
T-8 lighting in the boiler room.

T-8s should be replaced with LED.

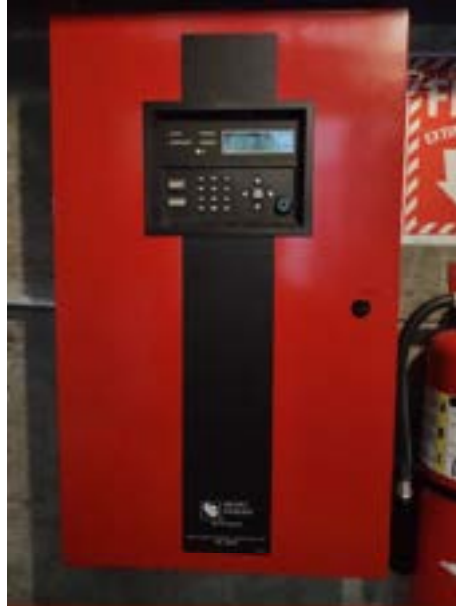
The fire alarm system control panel is an audible and addressable type system. It appears to be in good condition. The front cover indicates no violations.

The main fire alarm panel. There were no violation notes on the front cover.

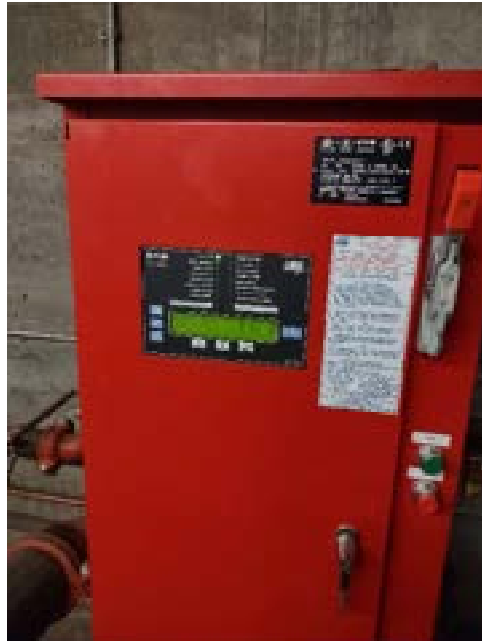
Fire pump controller – recently installed and well maintained.

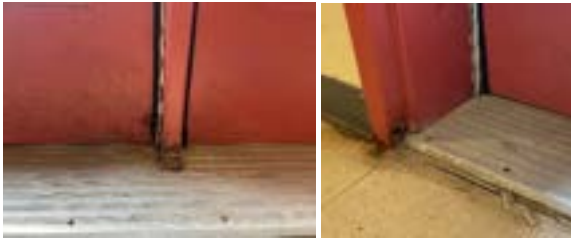
| | | Doors | Poor condition. Recommendation – replace exterior storefront doors.<br> |

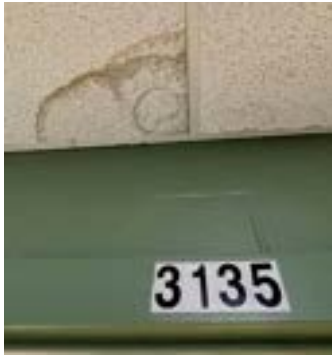
| | | Ceiling | <p>Poor condition. Water staining outside room 3135.</p> <p>Recommendation – Replace damaged tiles.</p> |

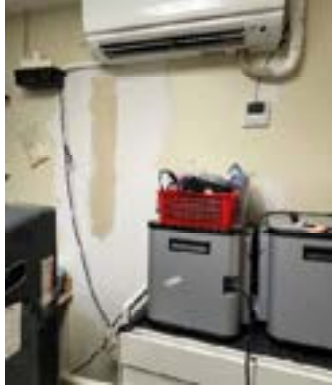
| | | Walls/ Columns | Poor condition.<br>Recommendation – Patch and paint several areas.<br> |

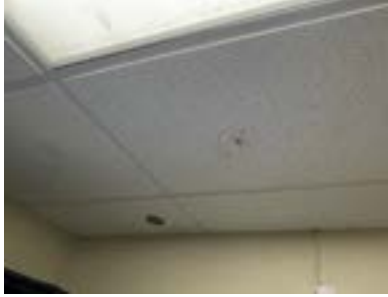
| | | Ceiling | Fair condition. ACT stained at multiple locations, light fixtures have debris.<br>Recommendation – Replace tile, clean light fixtures. |

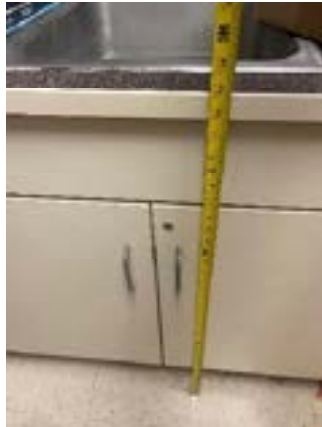
| | | Millwork | Fair condition. Materials in fair condition but the cabinet height is not in compliance. Base cabinets at 34.5" with non-accessible sink.<br>Recommendation – Replace cabinets and sink with ADA compliant units. |

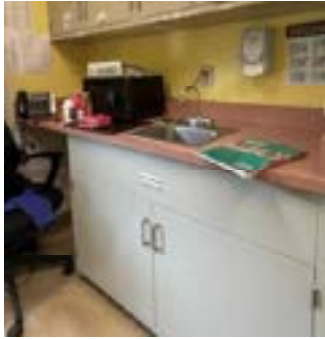
| | | Millwork | <p>Poor Condition. Nurse's Station counter height not in compliance with ADA standards. No ADA access to the sink.</p> <p>Recommendation – Install new ADA open cabinet below sink and 34" counter above base cabinets. Install new door to the right (leading to Office 3135) of the cabinets.</p> |

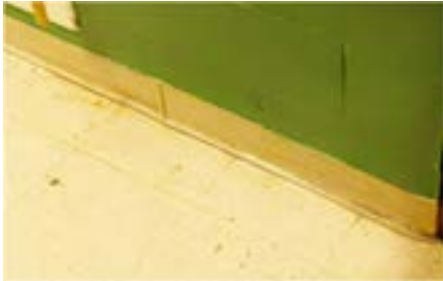
| | | Walls/ Columns | <p>Good condition. Wall base is discolored. Recommendation – Replace wall base.</p> |

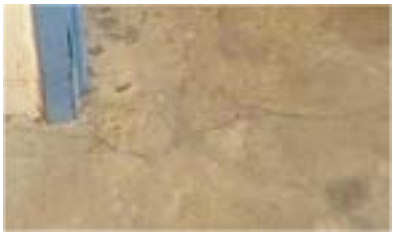
| | | Floor | <p>Fair condition. Floor is concrete and is assumed suitable for room and use. Crack at doorway between two mechanical rooms. Floor slopes up immediately upon entry to rooms from corridor or exterior.</p> <p>Recommendation – Repair crack and seal floor.</p> |

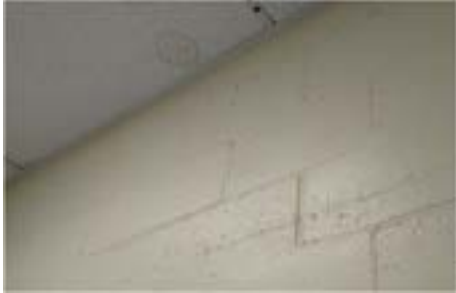
| | | | <p>Poor condition – Wall base in room 3126.<br/>Recommendation – Replace wall base in room 3126.</p> |

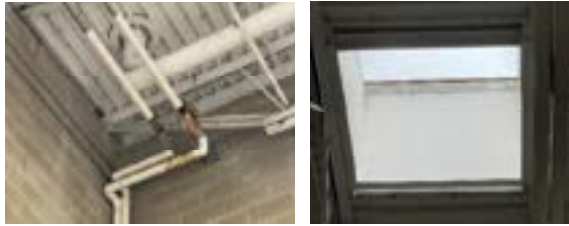
| | | Ceiling | <p>Fair condition. Skylights have visible signs of water penetration. Water leaking at pipes at ceiling.</p> <p>Recommendation – Investigate skylight leaks for repairs, repair leaks at pipes.</p> |

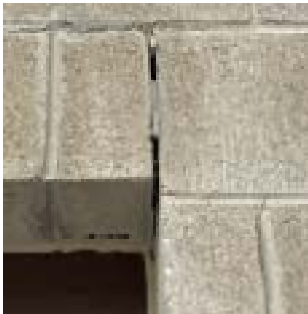
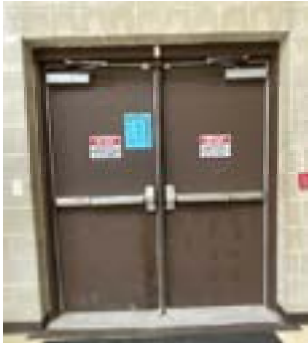
| | | Doors | <p>Fair condition. Dings and dents at all doors, water damage / rust at base of hollow metal doors. Caulking joint above door deteriorating. Recommendation – Repair / replace mortar and soft joints above exterior doors. Repair damage to doors and frame or replace.</p> |

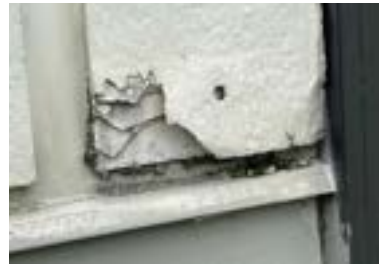
Isolated areas of siding discoloration for various reasons.

Recommendation – Repaint all discolored areas. Patch, repair refinish to match existing. Approximately 10% of façade.

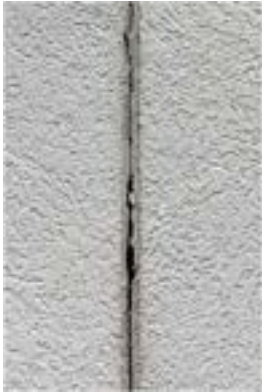
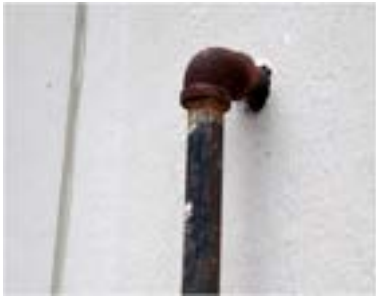
| | | <p>Some exterior wall penetrations are not sealed.<br/>Recommendation – Seal around all exterior wall penetrations.</p> |

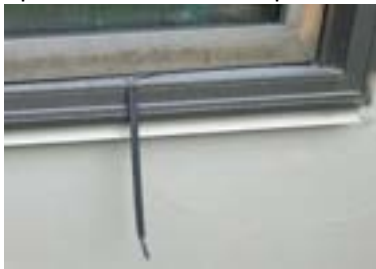
| | Windows | <p>Fair condition. Seals around operable units are falling off. Windows losing finish color.<br/>Recommendation – Provide new seals on operable windows. Repaint windows.</p> |

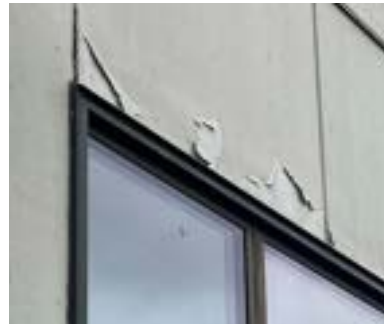
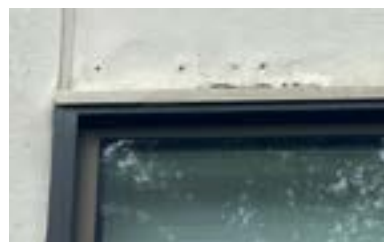
Additional areas of siding damage at windows specifically. Refer to above siding section for recommendations.

Approximately 90% of windows.

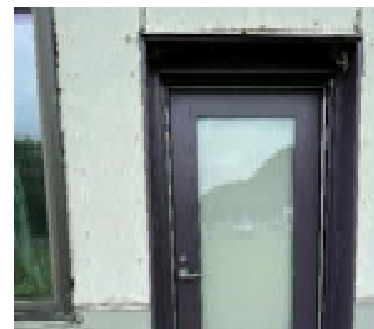
Additional areas of siding damage at doors specifically. Refer to above siding section for recommendations.

Approximately 80% of doors.

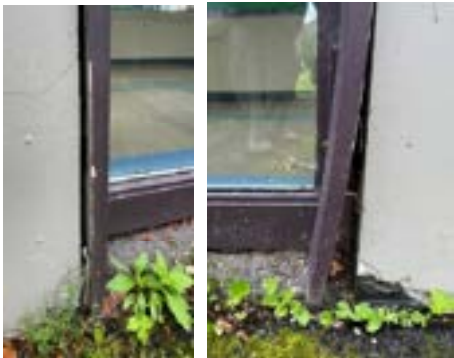
| 3. | Elements [e.g., Columns] | | <p>Deterioration at wood post base.</p> <p>Recommendation – Replace deteriorated wood elements.</p> |

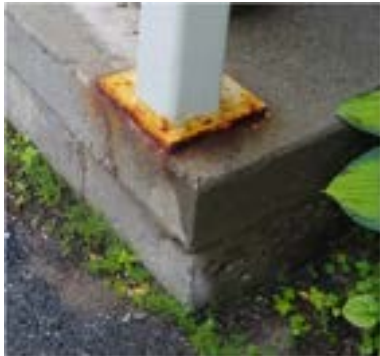
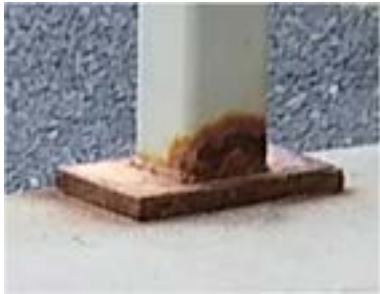
| | | <p>Rusted post base plate and bottom of posts (5 posts).<br/>Recommendation – Replace posts and base plates.</p> |

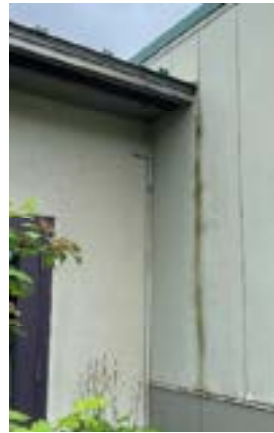
| 4. | Roof | <p>Fair condition. Low Slope Roof single-ply EPDM membrane at gym installed c.1999 so may be approaching end of service life. Pitched Roof standing seam metal installed c.2019.</p> <p>Water shedding from pitched roof on south side above Media Room is deteriorating siding below.<br/>Recommendation – Install rain diverter or gutter to protect siding.</p> |

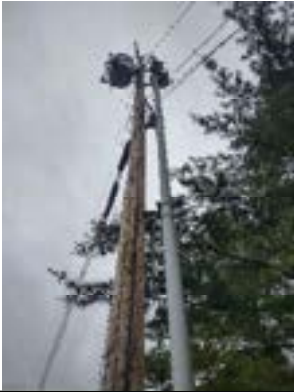
| 2. | Electrical | <p>Pole mounted transformer electrical service fed underground to electric vault.</p> |

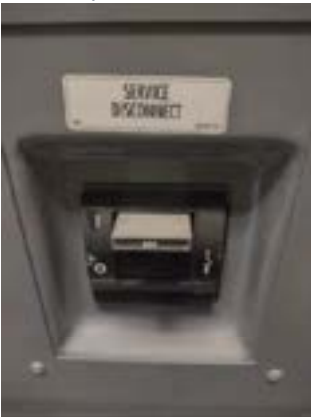
| | | <p>800 amp Main Breaker</p> |

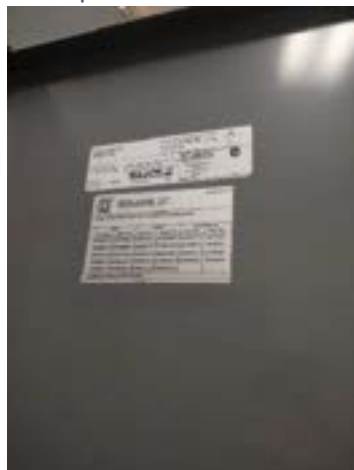
Older main circuit breaker.

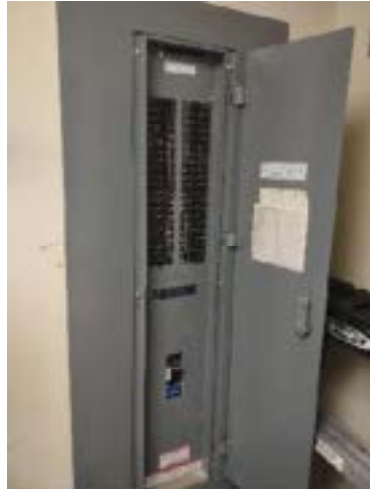
Switch product data.

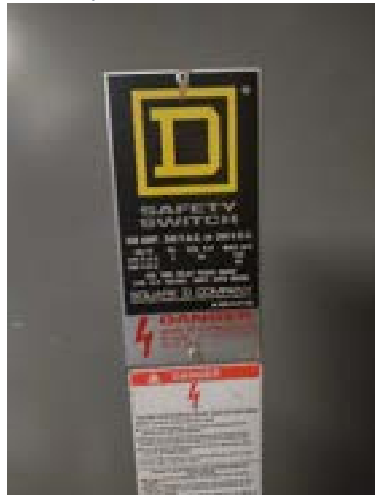
Double throw switch.

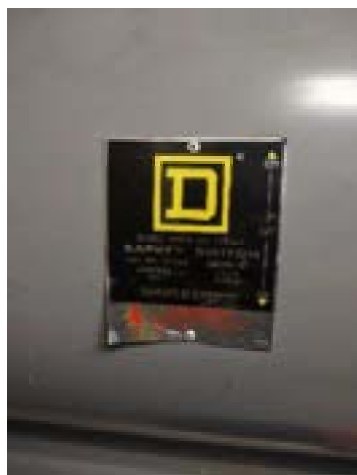
Full panel with fire emergency circuit.

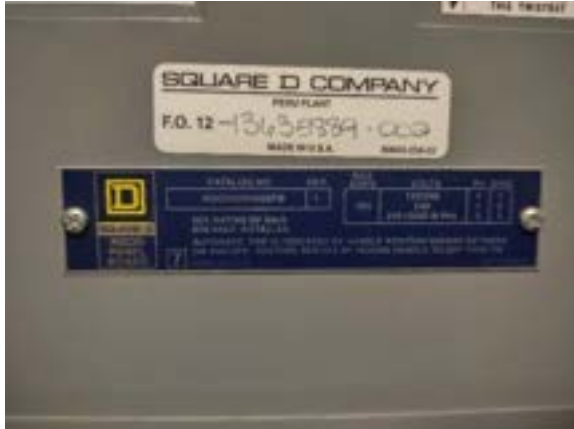
Older main breaker.

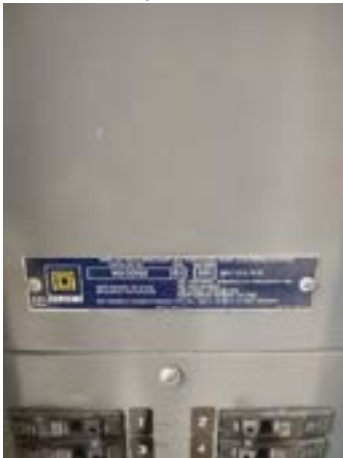
Older breakers in fully populated panel.

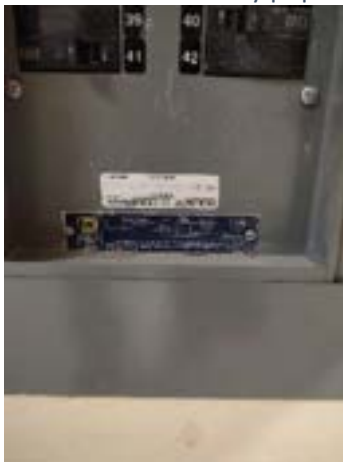
Panelboard near end of service life.

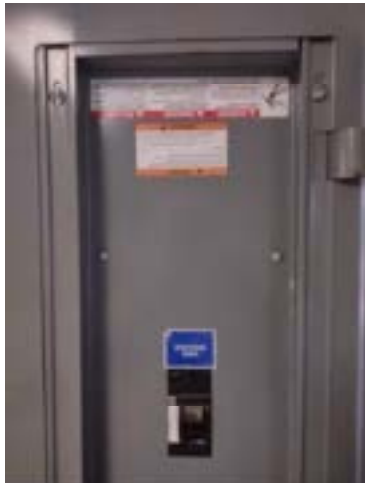
Fully populated panel with older breakers.
