## **FACILITIES CONDITION ASSESSMENT**

### **Rivendell Interstate School District**

Rivendell Academy East & West Wings | Samuel Morey Elementary | Westshire Elementary

September 25, 2025

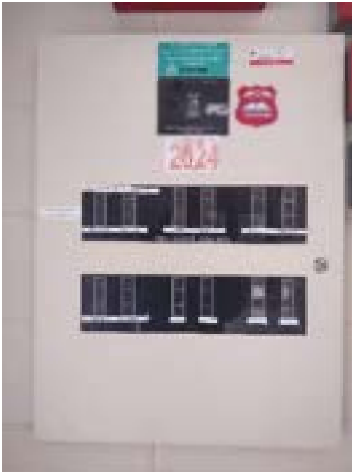
| 4. | Fire Alarm | The main fire alarm panel. There were no violation notes on the front cover. |

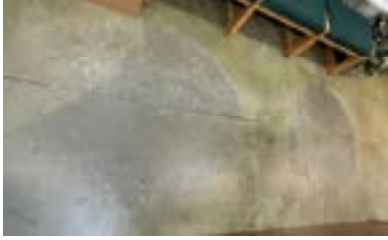
| 6. | Reception 4101 | | |

| | | Floor | Good condition. Floor shows wear, but concrete is holding up well.<br> |
| | | Ceiling | ACT in Good condition. Light fixtures are dated incandescent. |

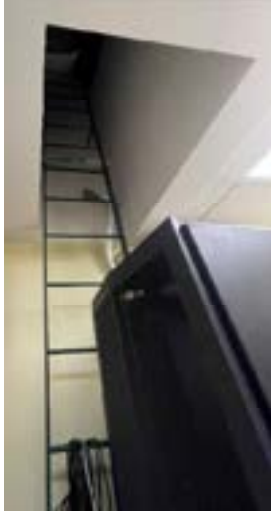
| | | Ceiling | Good condition. There is a roof hatch ladder going in good condition. Hatch above has visible light coming through does not appear to be sealing properly.<br>Recommendation – Review and repair or replace roof hatch. |

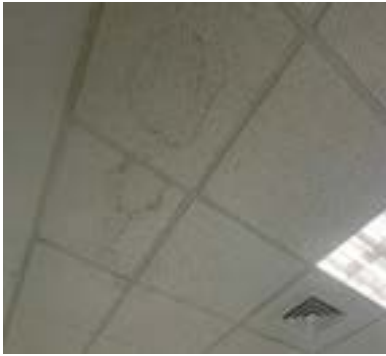
| | | Ceiling | Fair condition. Water Damage at a couple ceiling tile near diffuser<br>Recommendation – Replace stained ceiling tiles.<br><br> |

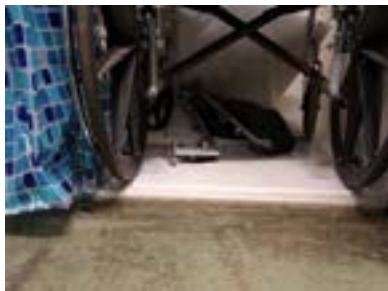
| | | Millwork | Fair condition however does not meet ADA requirements - 39" sink height.<br>Recommendation – Install sink at ADA height.<br>Fair condition - Shower portion.<br>Recommendation reseal around shower. |

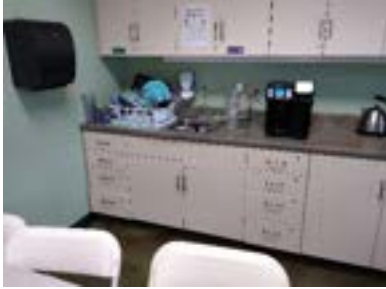
| | | Borrowed Lites | N/A |
|---|---|---|---|
| | | Millwork | <p>Millwork in Fair condition however does not meet ADA requirements - 38" sink counter laminate but no clear ADA access below.<br/> Recommendation – Install ADA access sink cabinet with proper counter height.<br/> Overhead storage adjacent to entry door.<br/> Recommendation – Remove or move shelving up to provide min. 6'-8" head clearance.</p> |

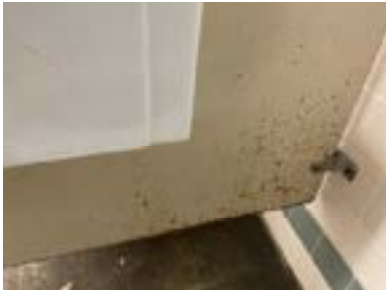
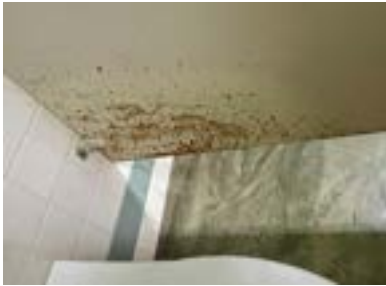
| | | Millwork | <p>Poor condition. Rusted out base of partitions.</p> <p>Recommendation – Replace partitions.</p> |
| 30. | Room 4129 Boys Restroom | | <p>Poor condition. Rusted out base of partitions.</p> <p>Recommendation – Replace partitions.</p> |

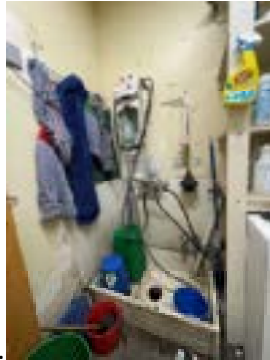
| 32. | Janitor Closet 4134 | | |

| | | Floor | Poor condition concrete floor.<br>Owner to review to determine if suitable for janitorial closet.<br><br>Recommendation – Renovate space with new flooring, sink, GWB. |
| | | Walls/ Columns | Scrapes and gouges around sink area, rough edges at sink backsplash.<br>Recommendation – Repair and repaint wall. |

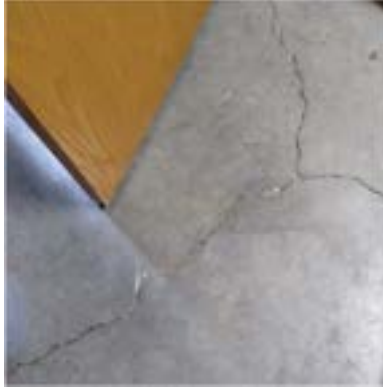
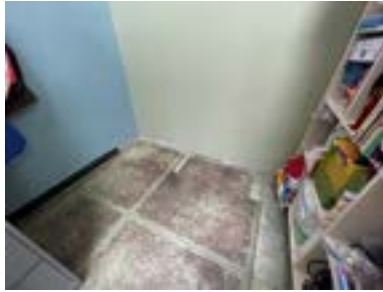
| | | Floor | <p>Floor obscured by stored material so only able to assess portion near entry door which has significant crack.</p> <p>Recommendation – Repair crack.</p> |
| | | Door | <p>Poor condition, door missing panic bar. Missing Exit Sign.</p> <p>Recommendation – Install exit sign above door and required panic hardware devices.</p> |

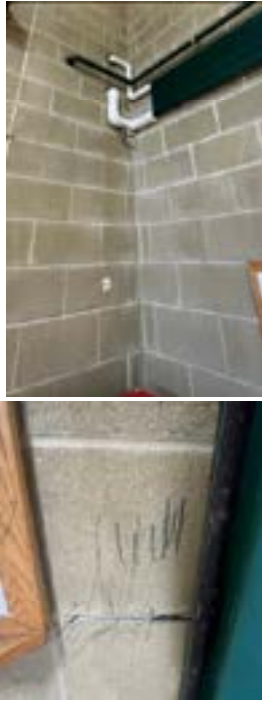
| 37. | Gym Room 4145 | | |

| | | Walls/ Columns | Fair condition. Scuffs, scratches, marks typical for use of space. |

| | | Ceiling | <p>Recommendation – Spot clean marked areas.</p> <p>Fair condition, no immediate action required.</p> |

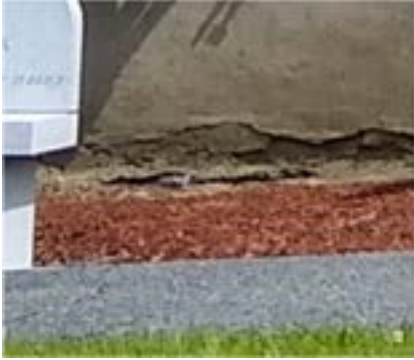
| | | | <p>Concrete foundation in poor condition. Foundation parging at south façade deteriorating where it meets the ground and to the right of the entry door.</p> <p>Recommendation – Repair parging.</p> |

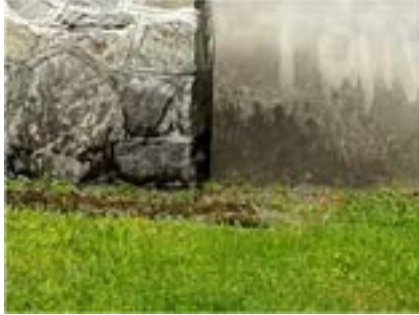
| | | <p>Stone foundation and window infill panels at east façade are discolored where they meet the ground. Recommendation – Clean materials and assess for damage.</p> |

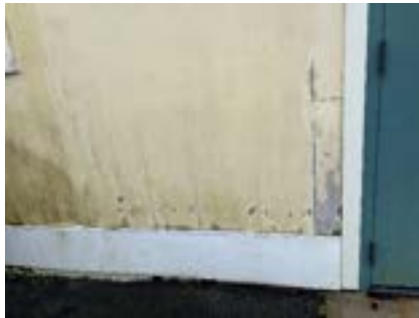
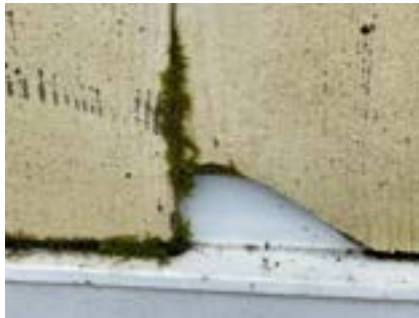
| | Siding / Trim | <p>Poor condition. See below photos for a wide variety of siding issues rendering the need for replacement. Recommendation – Replace siding and all associated trim. Confirm no water damage behind siding.</p> |

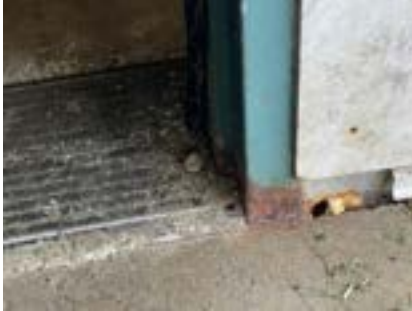
| | | Doors | <p>Poor condition. Damaged base of door and frame, rusted, worn, and faded.</p> <p>Recommendation – Repair doors and replace door / frame where necessary.</p> |

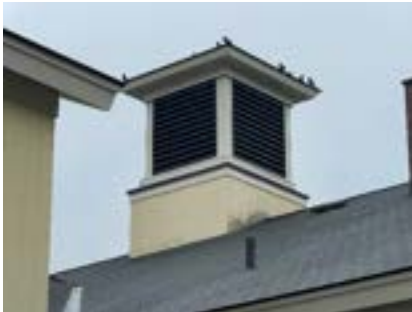
| 3. | Elements [e.g., Columns] | | <p>Siding Damage at base of Roof cupula. Cannot confirm if there is roof damage.</p> <p>Recommendation – Consult a roofing contractor to determine the probable cause of the leaks and to develop a plan to remediate them.</p> |

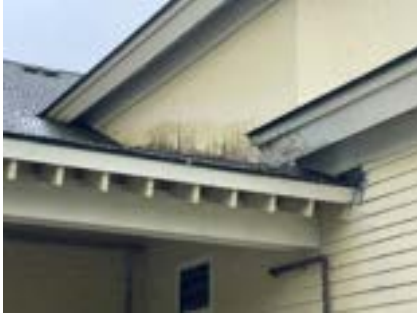
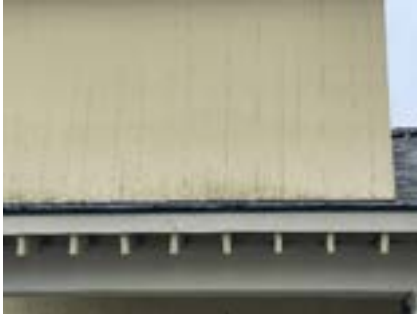
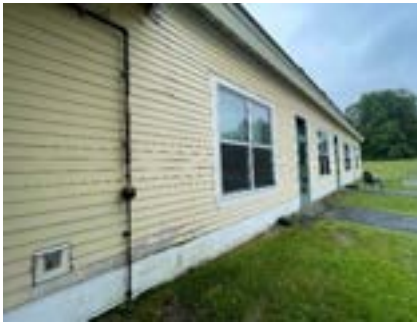
| 4. | | <p>Poor condition, particularly at roof to wall intersection. Large area where the gabled roof meets the higher wall there are signs of significant water damage. The roof and wall damage tracks to the ground.</p> <p>Recommendation – Consult a roofing contractor to determine the scope of work for the roof and best method to remediate the wall intersection problem.</p> |

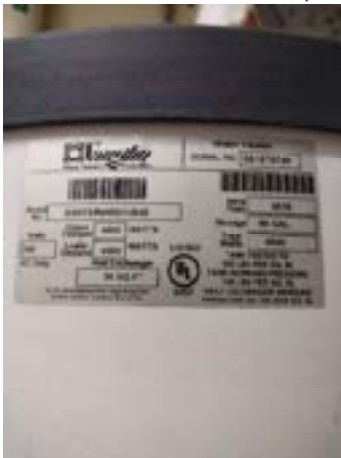
Older circulation pump.

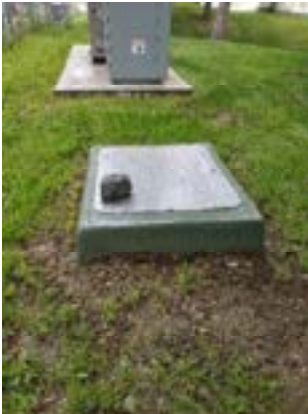
Electrical service vault manhole, generator, and ATS pad.

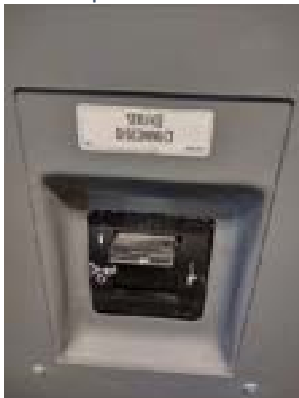
800 amp Main Breaker

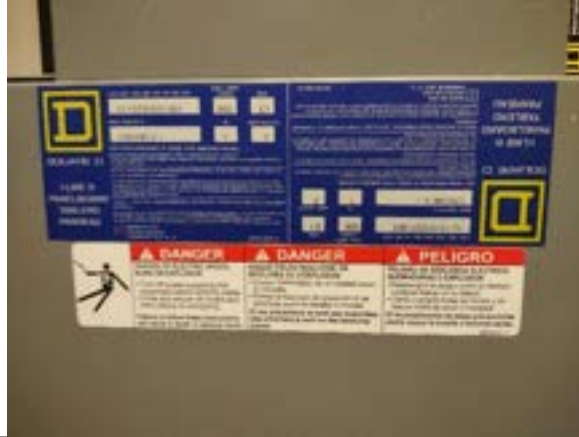
Service Main Panelboard. 800 amp, single phase.

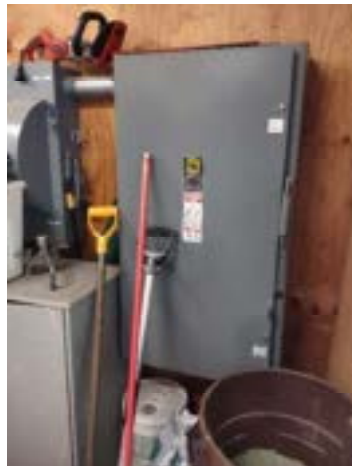
400 amp disconnect-double trouble safety switch for a generator. Switch is off.

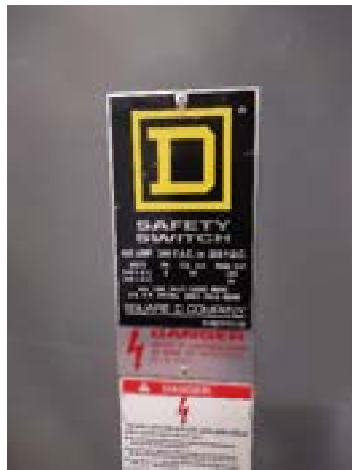
Electrical service to boiler room.

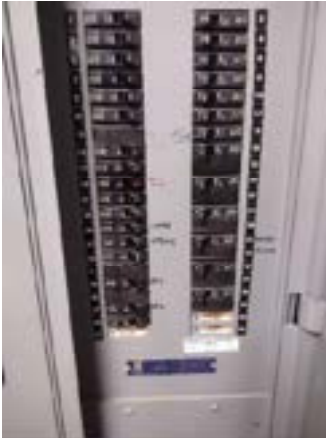
Panelboard for boiler room.

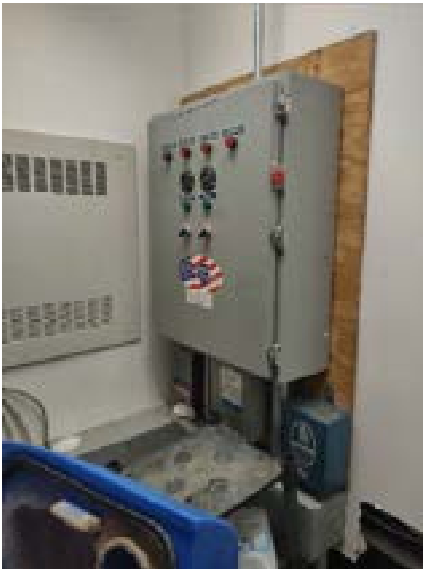
Control panel for well pumps.

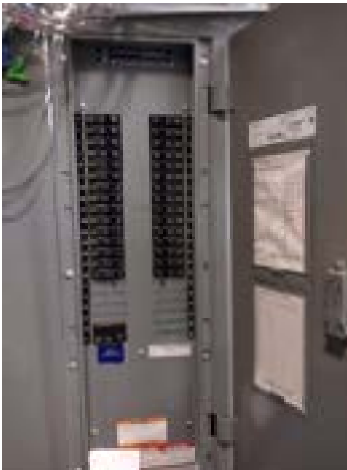
Panel for lighting and outlets – typical.

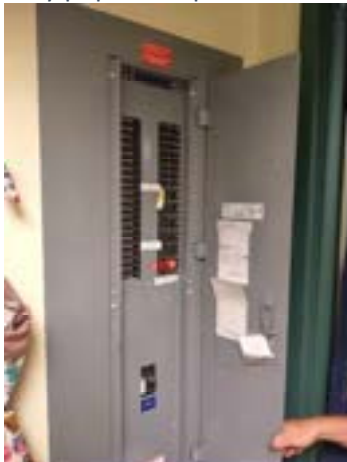
Fully populated panel with emergency fire circuit.

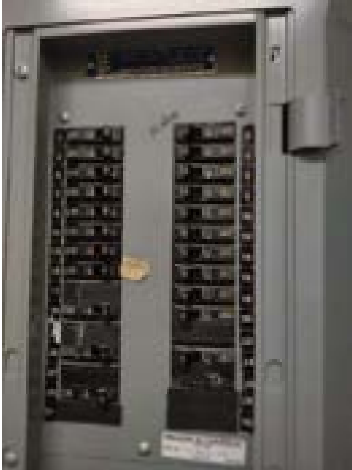
Panelboard for kitchen.

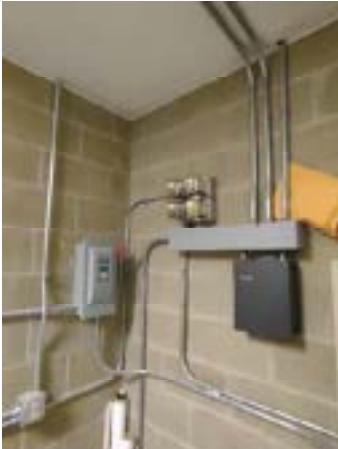
Stage AHU disconnect and wiring in conduit arrangement.

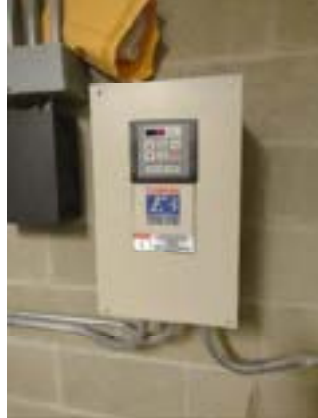
Stage AHU controls.

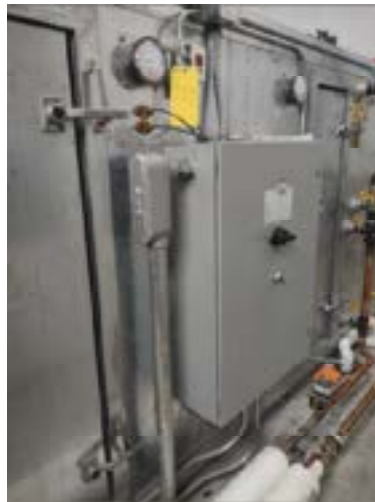
AHU Room above boiler room – auto shut off switch.

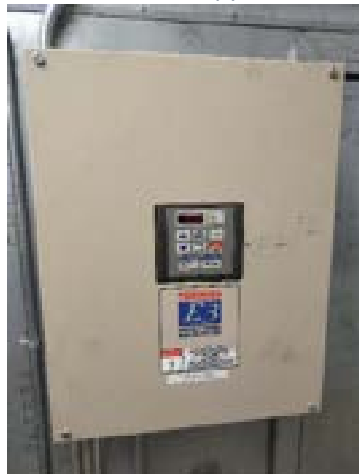
AHU controls in upper boiler room AHU space.

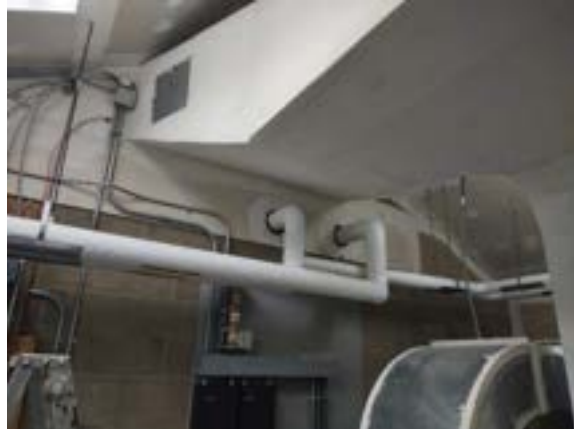
Damper control wiring.

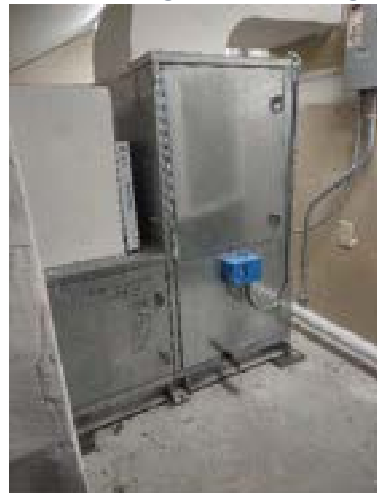
Control wiring for AHU arrangement.

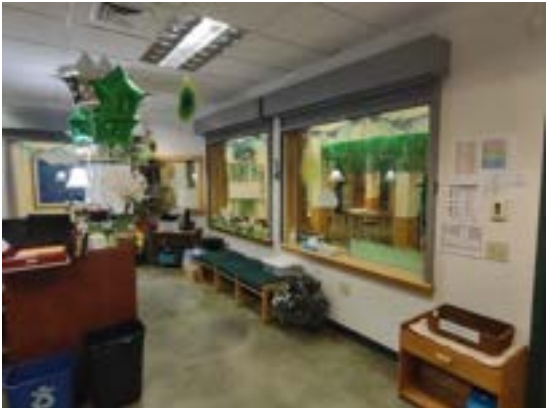
Some of the indoor lights are incandescent bulbs, T8 fluorescent, ceiling mounted 2" x 2", or 2" x 4" troffer type. This type of lighting is usually recommended for replacement with LED. All exterior lighting should be upgraded to LED type. The exterior mounted lighting is on timers and was not on during the day, suggesting either the time clock and a photocell controlling the lights are working correctly.

| | | <p>Typical traditional lighting. The fixtures appear to still be incandescent and fluorescent type.</p> |

The main recommendation that is not a safety issue is the replacement of the existing lighting with LED type. In conjunction with this, the controls would be upgraded to provide occupancy sensor control and dimming. The simplest way to accomplish this may be to provide new light fixtures with integral wireless controls. This would significantly reduce the amount of recircuiting required. There may be some incentives to upgrade.

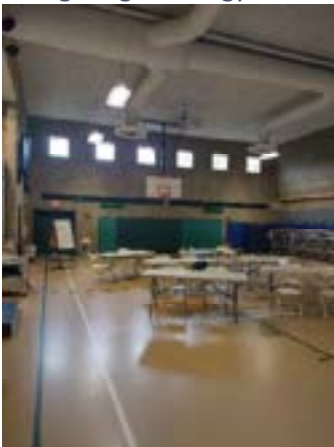
| | | <p>T-8 lighting in the gym.</p> |

T-8s should be replaced with LED.

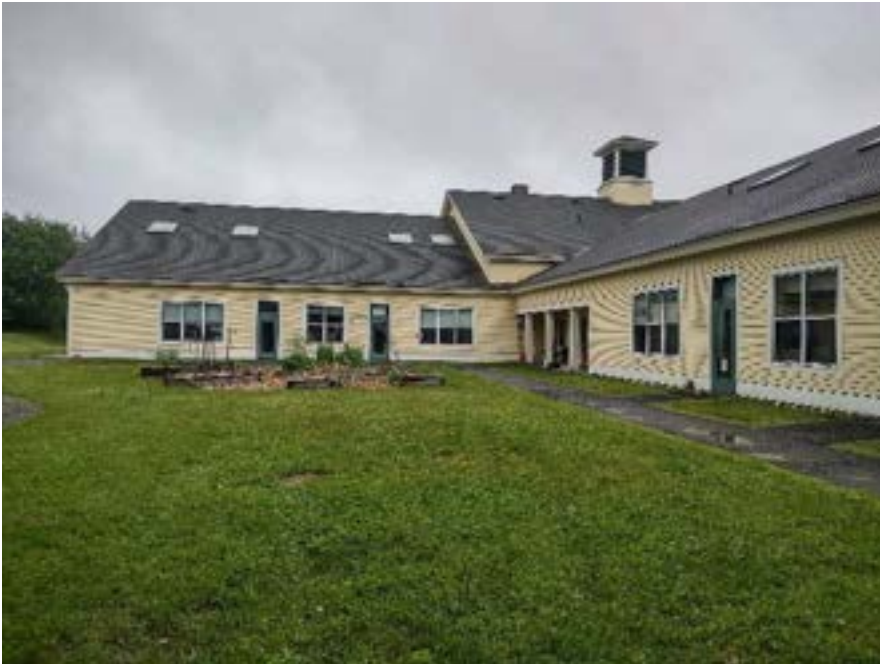
Exterior flood lights to be upgraded.

- Some electrical distribution equipment is obsolete and should be replaced as part of any facility upgrade.
- All lighting should be upgraded to LED lighting. This should include emergency lighting for exterior exit paths. Exterior floodlights have LED bulbs but the fixture should be replaced.

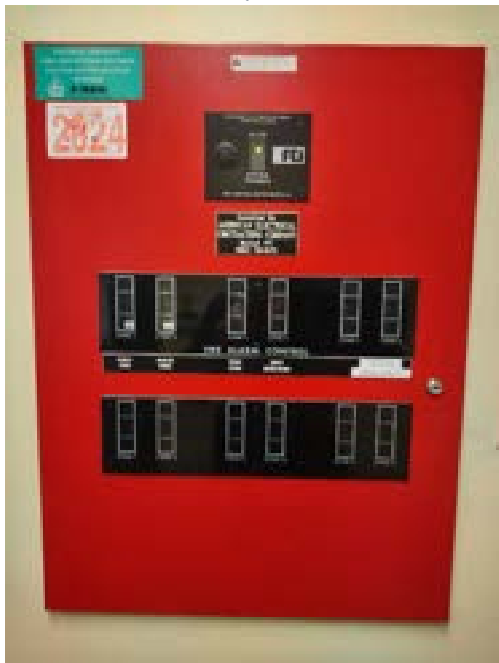
The fire alarm system control panel is an audible and addressable type system. It appears to be in good condition. The front cover indicates no violations. Inspected in 2024. The fire alarm system, however, does not appear to have voice notification.

| | <p>The main fire alarm panel. There were no violation notes on the front cover.</p> |
