## **FACILITIES CONDITION ASSESSMENT**

### **Rivendell Interstate School District**

Rivendell Academy East & West Wings | Samuel Morey Elementary | Westshire Elementary

September 25, 2025

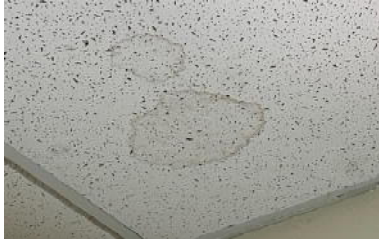
| | | Ceiling | Fair condition. ACT has stains.<br>Recommendation – Replace stained tile. Verify there are no active water leaks. Replace unseated tiles. |

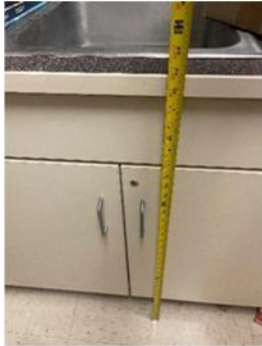
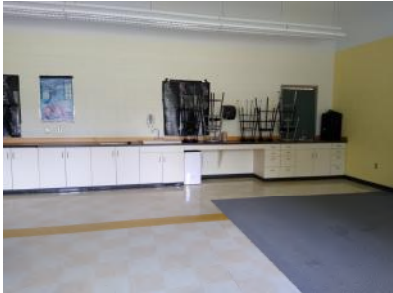
| | | Millwork | Not in compliance with ADA regulations; base cabinets at 3'-4", lacks knee space.<br>Recommendation – Replace base cabinets with ADA compliant units.<br><br> |

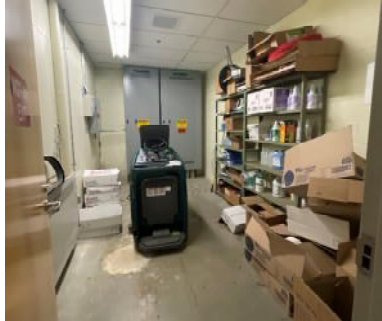
| 23. | Electrical 1123 | | |

| | | Floor | Poor condition. Exposed cracking and chipping of concrete floor.<br>Recommendation – patch, repair, and seal concrete floor. |
| | | Walls/ Columns | Fair condition.<br> |

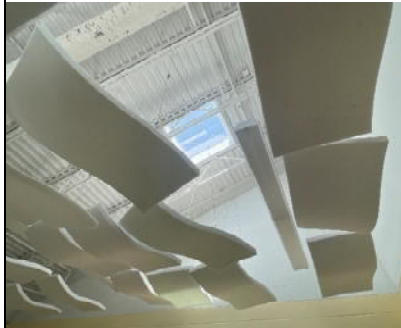
| | | Ceiling | <p>Fair condition. GWB soffits have some scuffs, marks and general wear. Recommend repainting GWB soffits.</p> <p>ACT dropped ceiling clouds are in fair condition. However, they need to be realigned and spaces out evenly with the intended pattern.</p> |

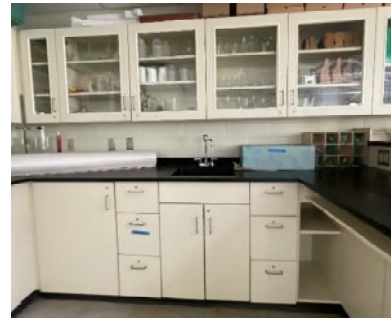
| | | Millwork | <p>Fair condition – Millwork and counters all rooms generally. 38" height work counters with 34" ADA portion at each space.</p> <p>Poor condition – Approximately 10% of laminate faces of counters peeling off.</p> <p>Recommendation – Repair delaminated portions.</p> |

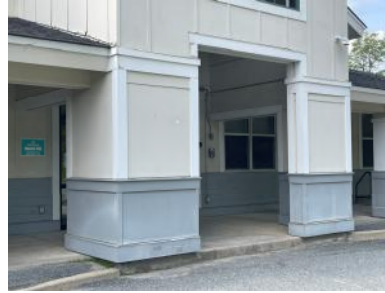
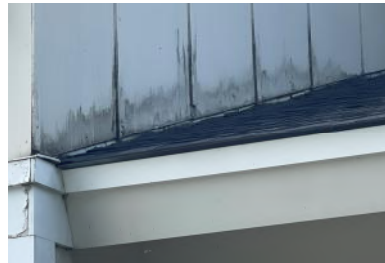
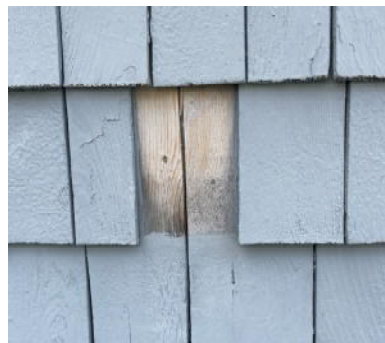
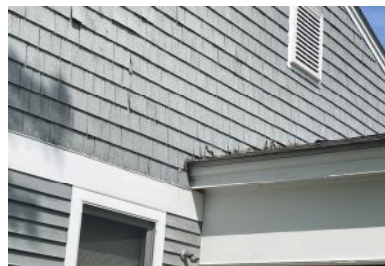
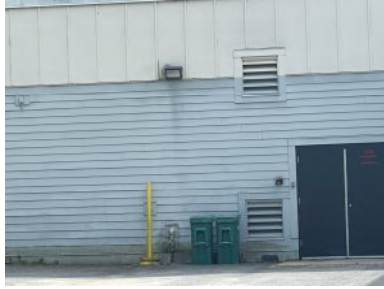
| | | Siding | <p>Fair condition. Wood clapboards and trim boards have peeling paint and paint appears faded; most prevalent around entry drop off area.</p> <p>Recommendation – Repair, Prep, and repaint clapboards and trim. Replace clapboards beyond repair. Replace missing shingle siding and repair deteriorated portions of shingle siding and vertical board and batten siding where it meets and shows excessive warping.</p> |

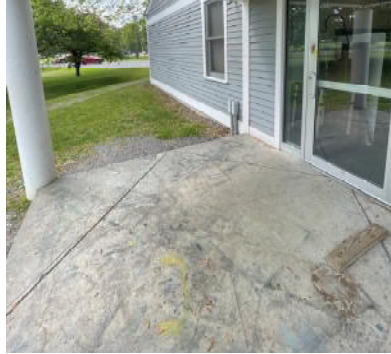
| 3. | Elements [e.g. Columns] | Concrete Pads at Exterior Doors | <p>Concrete foundation in poor condition. Recommendation – Repair cracks, clean misc. paint and seal all concrete pads.</p> |

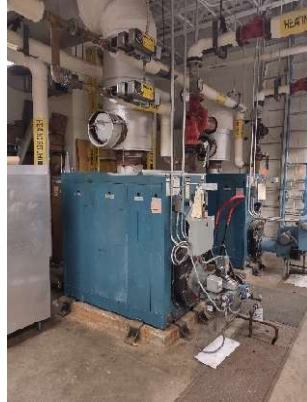
Boiler #1 at the end of its service life.

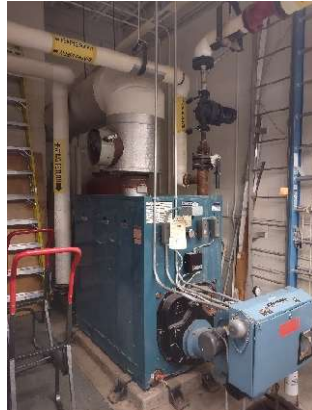
Boiler #2 at the end of its service life.

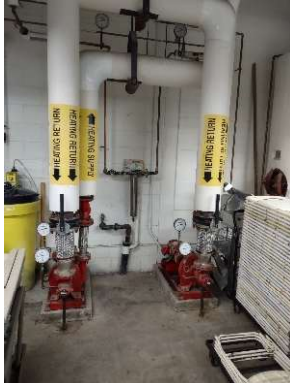
| | | <p>Heating zone circulation pumps – good to fair condition.</p> |

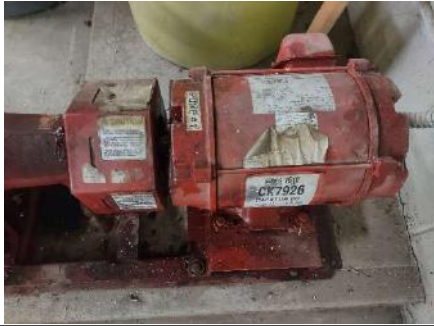
| | | <p>Fair condition – circulation pump and motor</p> |

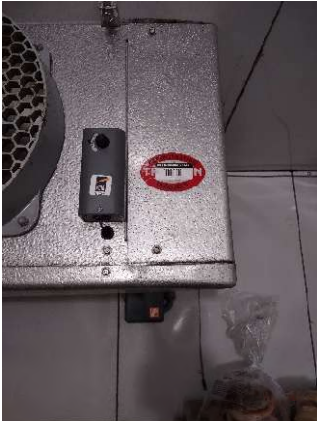
| | | <p>Kitchen refrigerated walk in #2.</p> |

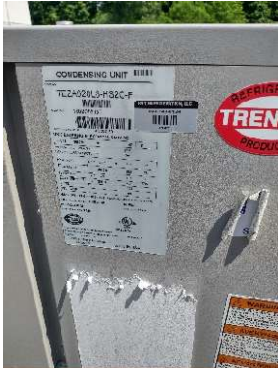
| | | <p>Outdoor condenser unit #1.</p> |

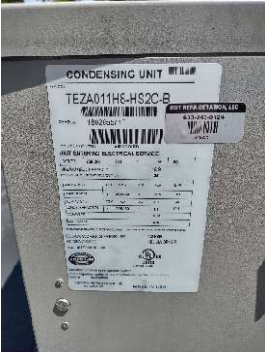
| | | <p>Outdoor condenser unit #2.</p> |

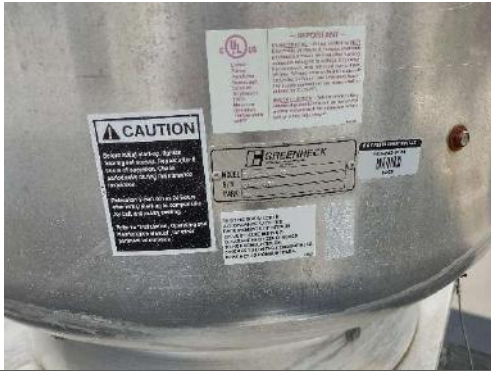
| | | <p>Kitchen grill exhaust fans.</p> |

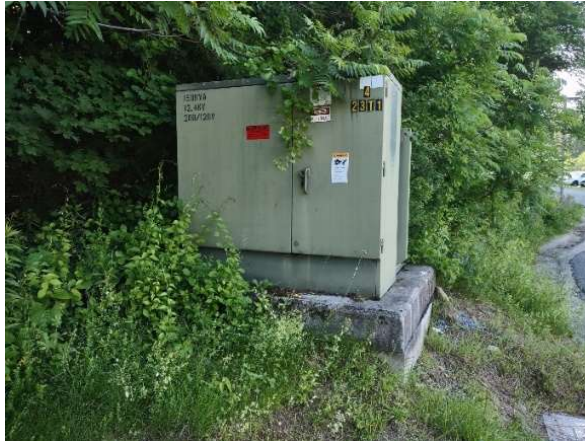
150 kVA -12.5 kV – 208/120V service transformer.

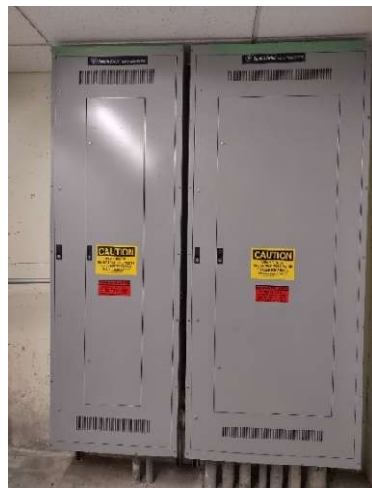
Main Panelboards

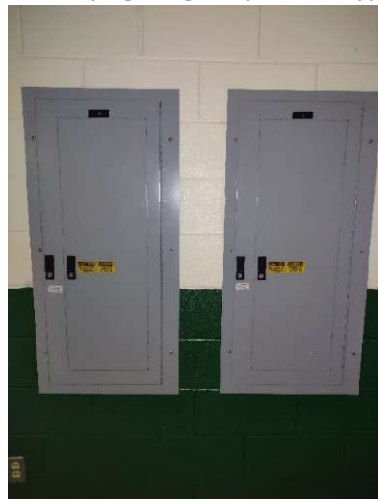
Hallway lighting subpanels - typical.

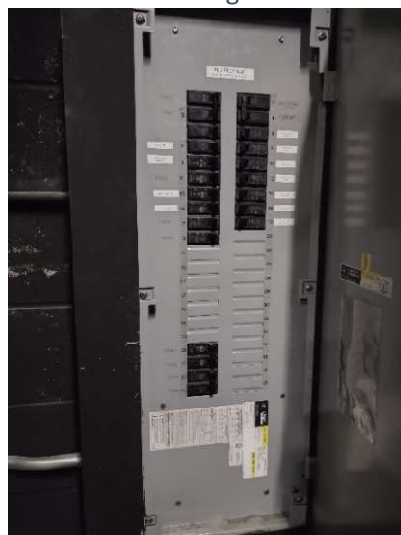
Panelboard for stage.

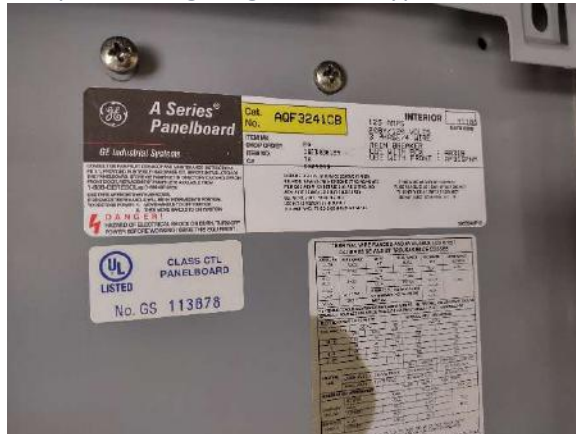
Sub panel for lighting circuits – typical

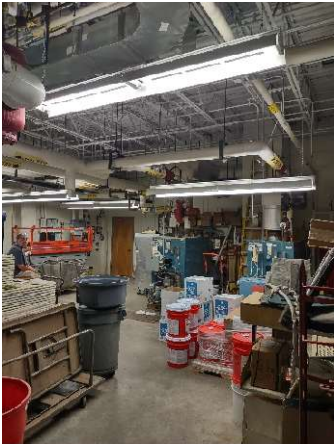
Some of the indoor lights are incandescent bulbs, T8 fluorescent, ceiling mounted 2" x 2", or 2" x 4" troffer type. This type of lighting is usually recommended for replacement with LED.

| 3. | Lighting | <p>Typical traditional lighting. The fixtures appear to still be incandescent and fluorescent type.</p> |

The main recommendation that is not a safety issue is the replacement of the existing lighting with LED type. In conjunction with this, the controls would be upgraded to provide occupancy sensor control and dimming. The simplest way to accomplish this may be to provide new light fixtures with integral wireless controls. This would significantly reduce the amount of recircuiting required. There may be some incentives to upgrade.

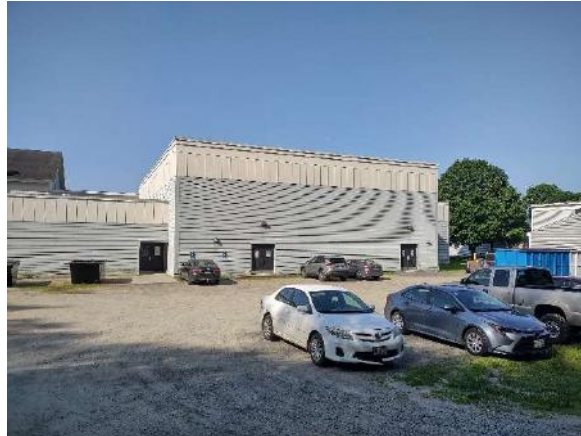
Exterior flood lights limited, showing signs of age.

- Some electrical distribution equipment is obsolete and should be replaced as part of any facility upgrade.
- All lighting should be upgraded to LED lighting. This should include emergency lighting for exterior exit paths. Exterior floodlights have LED bulbs but the fixture should be replaced.

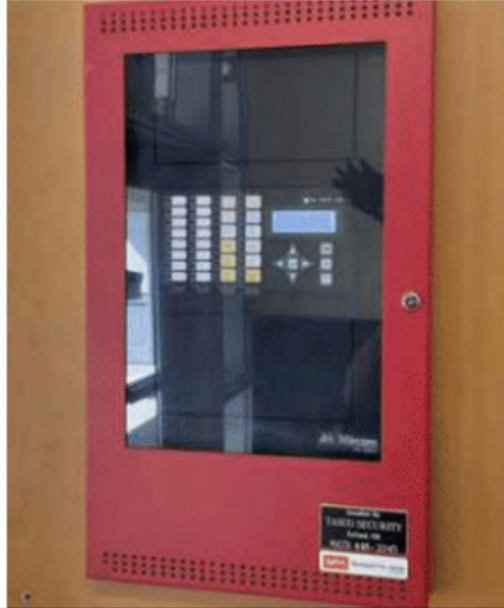
The main fire alarm panel. There were no violation notes on the front cover.

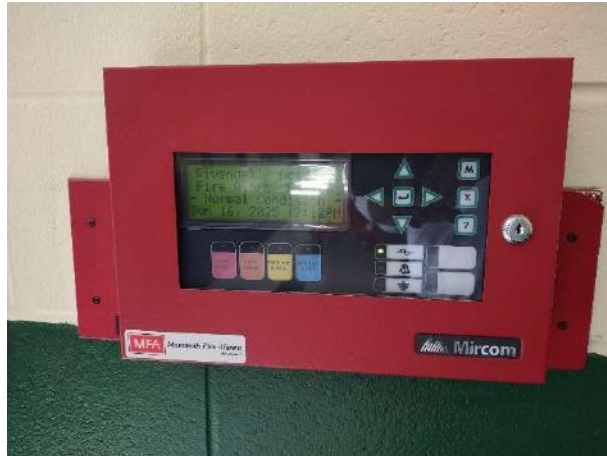
FACP – remote annunciator- appears to be more than one

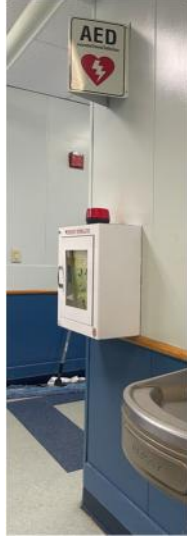
| | | Protruding Objects greater than allowed 4" | <p>AED is in surface mounted cabinet.<br/>Recommendation – Install AED in semi-recessed AED cabinet.</p> <p>Multi-Purpose 2131 has surface mounted fire extinguisher.<br/>Recommendation – Reinstall fire extinguisher in semi-recessed cabinet.</p> <p>South corridor bench and drinking fountain.<br/>Recommendation – Install cane rail or end panel at bench, install ADA compliant drinking fountain.</p> |

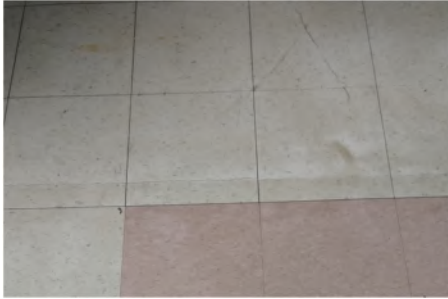
| | | Floor – North End | <p>Poor condition. Cracks and differential settlement in VCT along assumed slab joint lines, scrapes, gouges, discoloring.</p> <p>Recommendation – Install new flooring after flashing concrete slab.</p> |

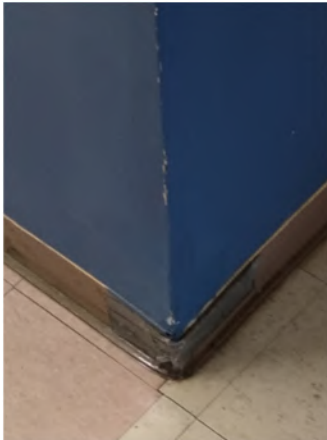
| | | Walls/ Columns – North End | <p>Poor condition. External corners damaged, wall base damaged, paint scraped / missing.</p> <p>Recommendation – Patch and repaint walls, replace wall base.</p> |

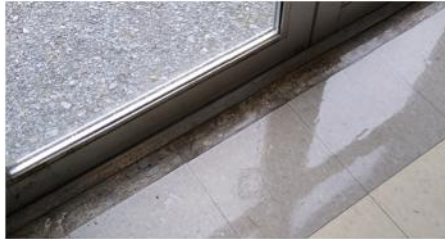
| | | Floor | Good condition. Rough edge at exterior door threshold.<br>Recommendation – Intsall wider threshold.<br> |

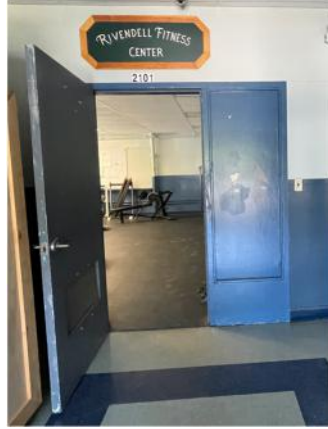
| | | Doors | Poor condition.<br>Recommendation – Replace doors and frames. |

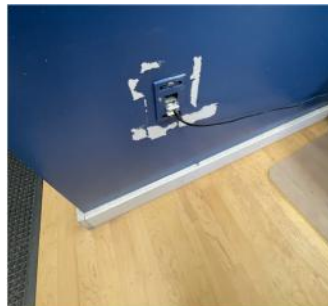
| | | Walls/ Columns | Fair condition, some damage at east wall.<br>Recommendation – Repair and repaint damaged areas.<br> |

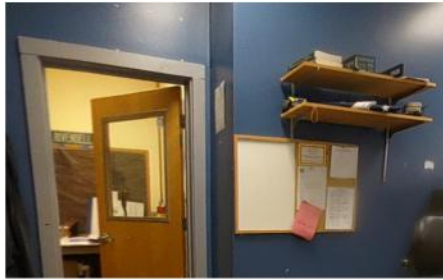
| | | Millwork | Wall mounted adjustable shelves protrude beyond 4".<br>Recommendation – Remove shelves or move piece of furniture below shelving as cane detection. |

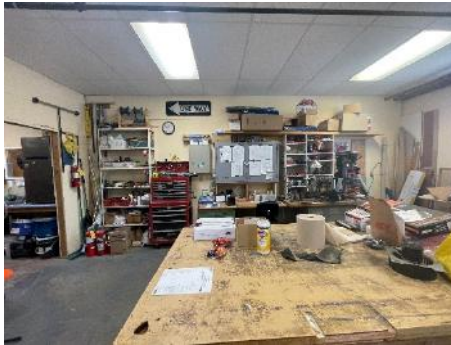
| | | Floor | Fair condition. Concrete has crack near sink. Painted finish has worn off.<br>Recommendation – Repair crack and recoat surface. |

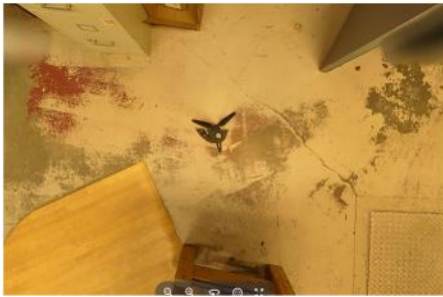
| | | Floor | Poor condition. Concrete floor has cracks and finish has worn off.<br>Recommendation – Repair cracks and repaint.<br> |

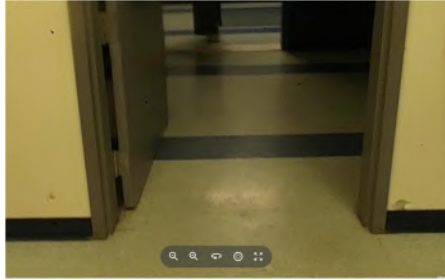
| | | Walls/ Columns | Fair condition with some damage.<br>Recommendation – Repair and paint damaged areas. |

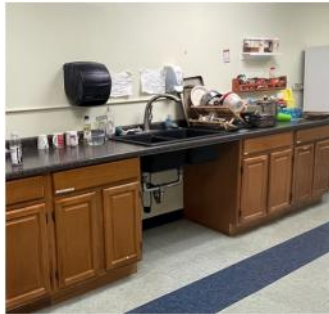
| | | Millwork | Fair condition. Counter height not in compliance with ADA standards, sink drain lacks ADA required insulation. Recommendation – Install ADA compliant sink/counter with drain insulation. |

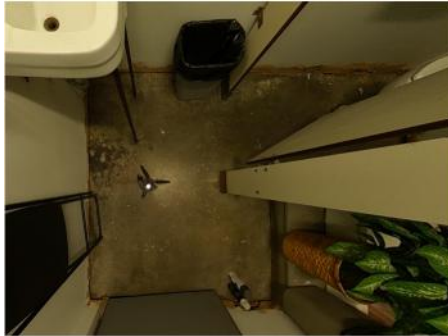
| | | Floor | Poor condition. Bare concrete.<br>Recommendation – Install flooring.<br> |

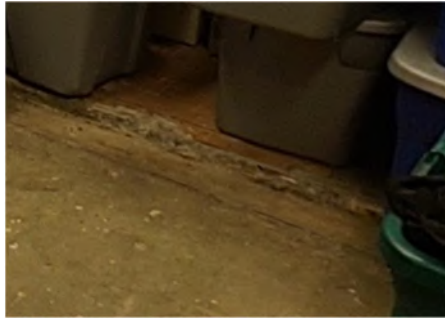
| | | Floor | Poor. Most of floor is concrete slab with perimeter rough cut topping material.<br>Recommendation – Prep floor and install new flooring.<br> |

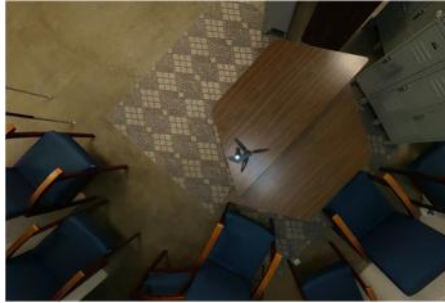
| | | Floor | <p>Fair condition. Unpainted concrete, slopes to drain in two locations with loose flooring used to cover one location.</p> <p>Recommendation – If floors are intended for everyday use, remove drains, flash concrete, install new flooring.</p> |

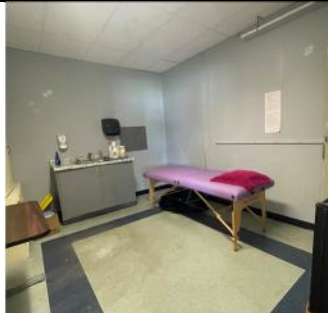
| | | Floor | <p>Poor condition. Portion of floor discolored and scraped.</p> <p>Recommendation – Replace VCT flooring.</p> |

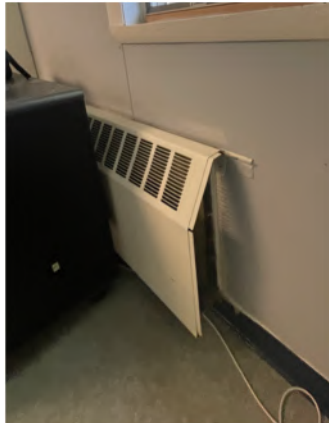
| | | Walls/ Columns | Good condition. Finned tube convactor missing end panel.<br>Recommendation – Replace end panel. |

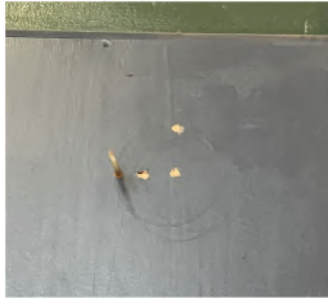
| | | Walls/ Columns | Good condition. Some minor damage. |

| | | | <p>Recommendation – Minor repair and touch up painting.</p> |

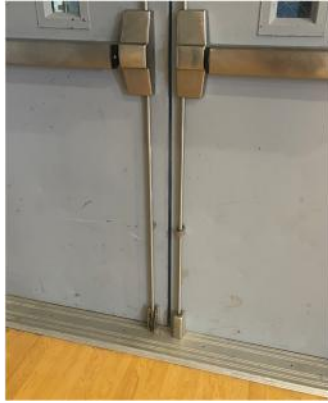
| | | Doors | <p>Fair condition. Some dings and scratches, missing parts on surface rods to east double doors.</p> <p>Recommendation – Repair and repaint doors and frames, repair surface rods.</p> |

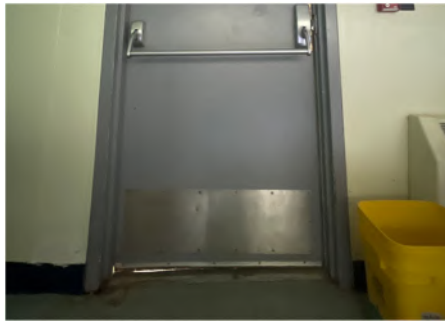
| | | Doors | Good condition – Interior door.<br>Fair condition – Exterior door. Large gap at bottom left.<br>Recommendation – Install new weatherstripping and address threshold if necessary.<br> |

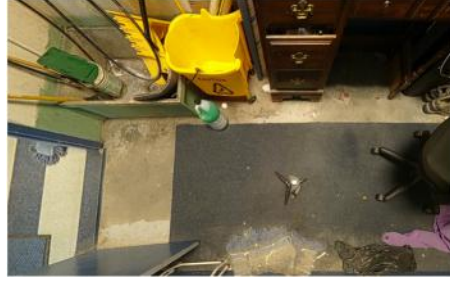
| | | Floor | Fair condition. Most of floor is covered by walk-off mat and cannot be fully assessed. Visible portions are concrete that is sound, painted finish worn off.<br>Recommendation – Repaint floor. |

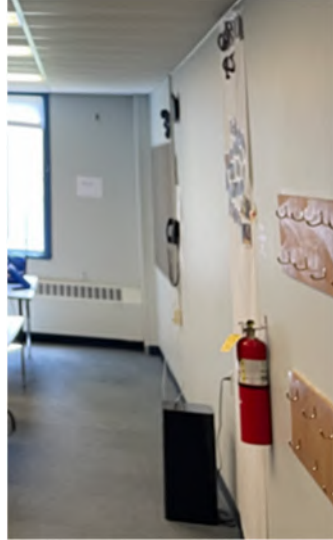
| | | Walls/ Columns | Good condition. Some dings and scrapes on blue wall.<br>Surface mounted fire extinguisher exceeds ADA maximum allowed projection.<br>Recommendation – Touch up damage and repaint blue wall. Place fire extinguisher out of path of travel or mount in semi-recessed cabinet. |

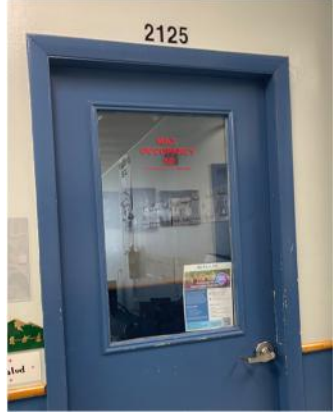
| | | Doors | Fair condition. Paint scrapes on door and frame.<br>Recommendation – Repaint door and frame. |

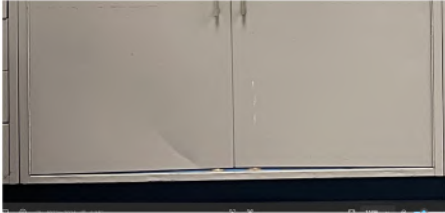
| | | Millwork | Fair condition. Door and drawer faces have dents, scrapes, door misalign.<br>Recommendation – Replace cabinetry.<br> |

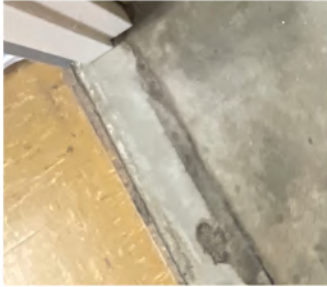
| | | Doors | Good condition. Some chips and scrapes on exterior of 2134, damaged threshold to storage room.<br>Recommendation – Repaint exterior face of door 2134, replace threshold to storage room. |

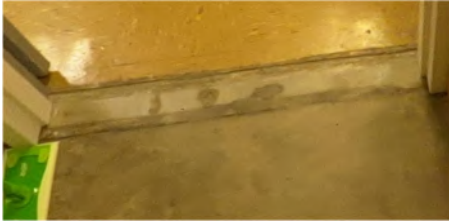
| | | Floor | Fair condition. Sealed concrete floor. Damaged threshold.<br>Recommendation – Replace threshold to storage room. |

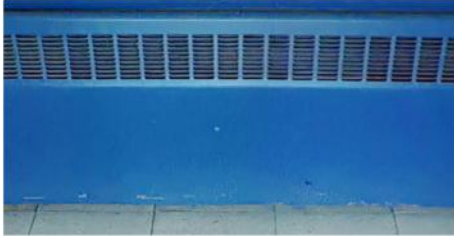
| | | Walls/ Columns | Good condition. Window sills have chips, finned tube convector has scrapes.<br>Recommendation – Repaint sills and convector.<br> |

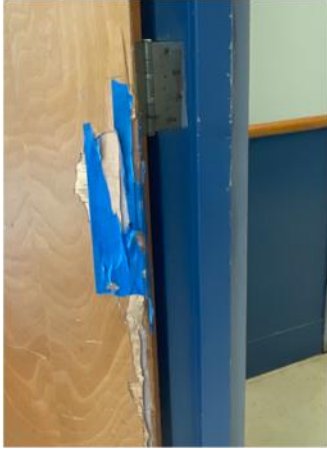
| | | Doors | Good condition – North door and exterior door.<br>Poor condition – South door.<br>Recommendation – Replace wood south door, paint frame.<br> |

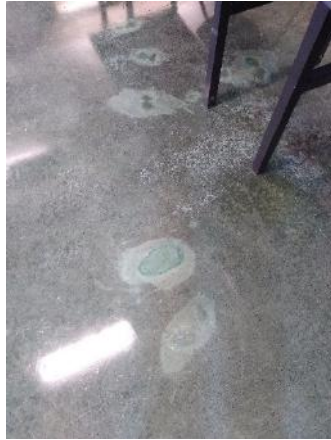
| | | Floor | Fair condition. Some discoloration, surface finish scrapes, chips. No immediate action required.<br> |

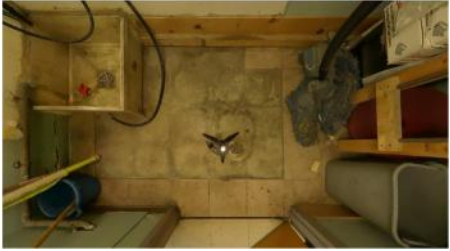
| | | Floor | Very poor condition. Portion of VCT missing, remaining VCT is damaged.<br>Recommendation – Replace flooring.<br> |

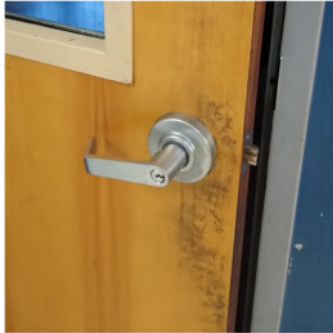
| | | Doors | <p>Poor condition – Entry doors. Worn finishes, chips, scrapes, loose hardware.<br/>Recommendation – Replace doors and hardware.</p> |

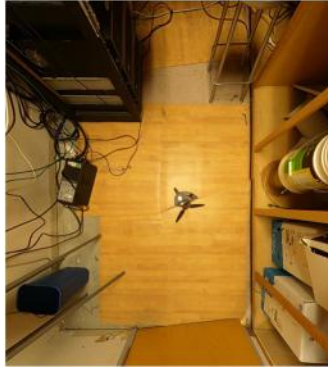
| | | Floor | Poor condition. Random sizes of sheet flooring loose laid on VCT.<br>Recommendation – Install static dissipative flooring. |

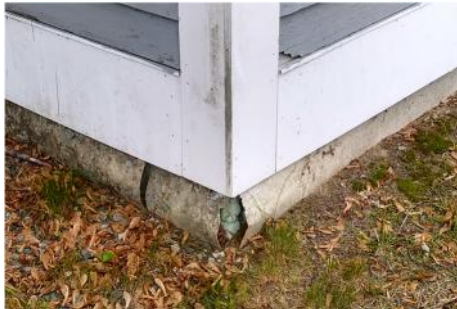
| | | Foundation | <p>Fair condition. Southern portion of building foundation insulation cover has broken / bowed sections. Recommendation – Repair / replace damaged areas.</p> |

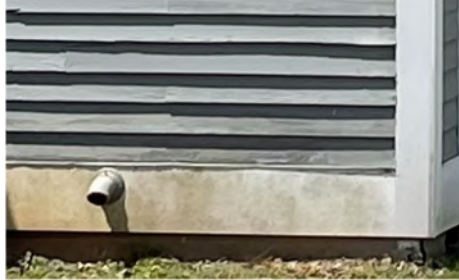
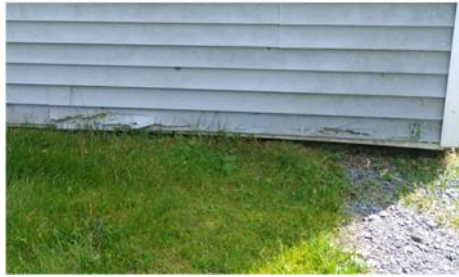
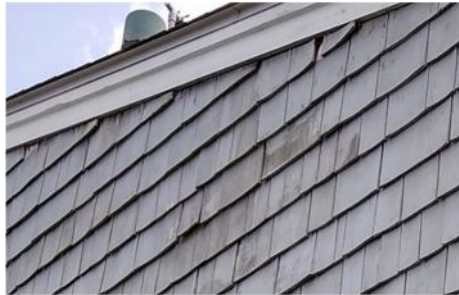
| | | Siding | <p>Poor condition – Southern portion. Wood clapboards have numerous areas of rot. Trim boards under exterior doors have areas of rot. Gable end shakes have areas of cupping and deterioration. Trim boards at bottom of wall show discoloration. All siding and trim should be painted.</p> |

Recommendation – Replace wood siding and replace trim under doors. Clean and repaint any wood elements to remain.

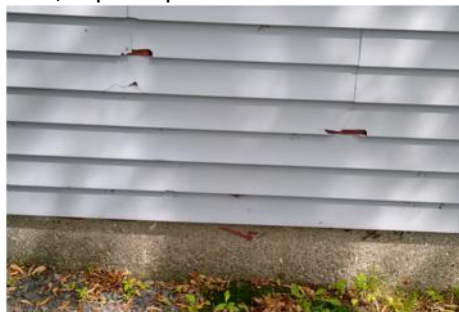
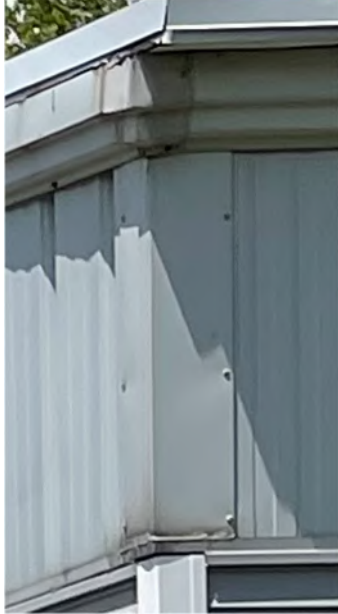
Good condition – North portion. Various locations have cracked / broken vinly clapboards and broken vinyl trim pieces. Damage and makeshift corner pieces at panels above vinyl clapboards.

Recommendation – Replace broken vinyl clapboards and trim, replace panels.

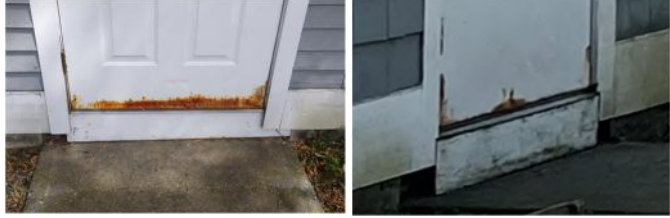
| | | | <p>Fair condition – Hollow metal doors. South portion of building has several HM doors with rust at bottom of door.</p> <p>Fair condition – Overhead door. Door has dents.</p> <p>Recommendation – Replace rusted doors, replace dented section of overhead door.</p> |

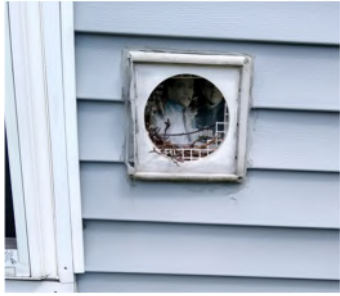
| | | Louvers | <p>Good condition. Two exhaust vents on west side of north portion of building in very poor condition.</p> <p>Recommendation – Replace vents or remove if not in use.</p> |

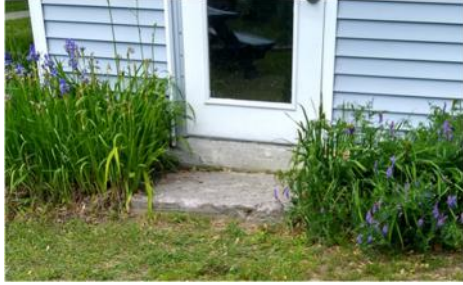
| | | Concrete Pads at Exterior Doors | <p>Poor condition. Cracks and rust at concrete pad at main entry. Crooked concrete pad at exit from Room 2136. Concrete pad eroded at north entry. No concrete pad at stair exit door.</p> <p>Recommendation – Install new concrete pads at exterior doors to meet ADA requirements.</p> |

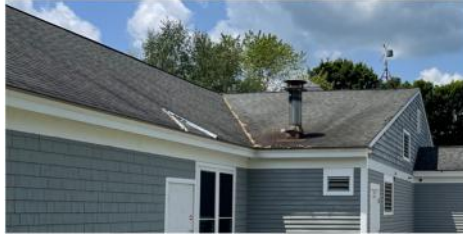
| | | Asphalt Shingles | Good condition – Northeast roof installed around 2023. Fair condition – South roofs. Some discoloration visible, no reports or signs of active leaks.<br> |

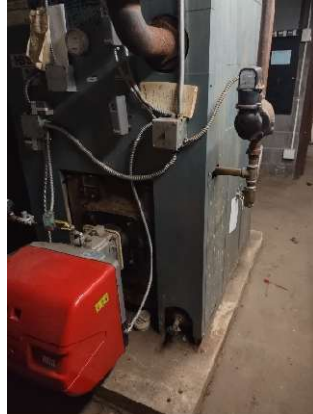
Basement boiler #1 with an oil service burner and boiler. This existing burner/boiler has 3 zones, was combustion tested in 2019, was installed in accordance with code, is well maintained but is at the of its service life. LN Consulting recommends that this equipment be upgraded.

Basement boiler #1 at the end of its service life.

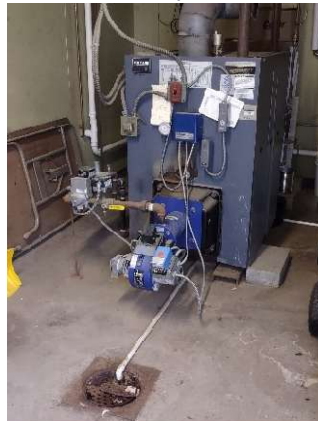
Room 133 Propane fired boiler #2 – 15 years into 30 year service life.

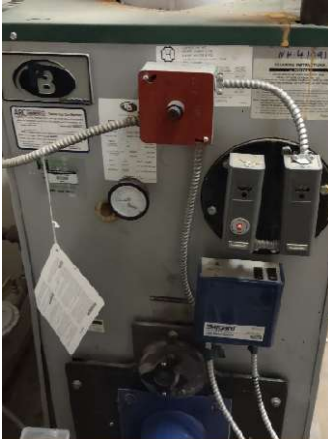
AHU Room boiler #3 – 15 years into a 30 year service life.

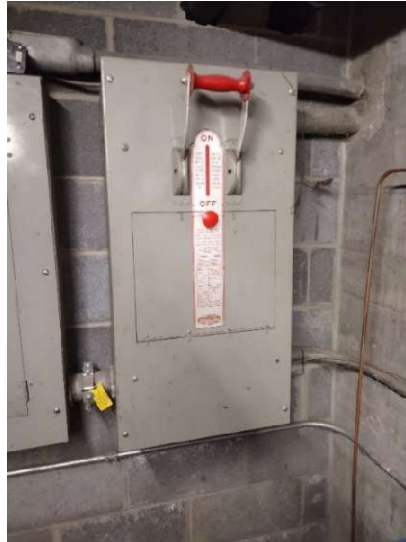
The main service equipment is in the basement. Functional but past its service life.

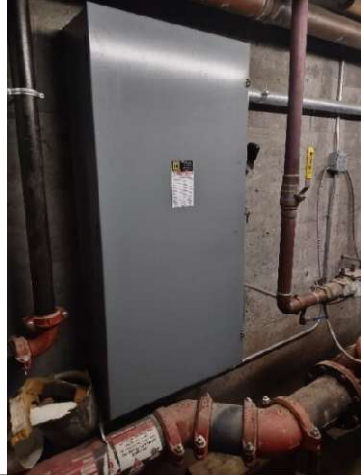
Newer 600A safety switch in very good condition.

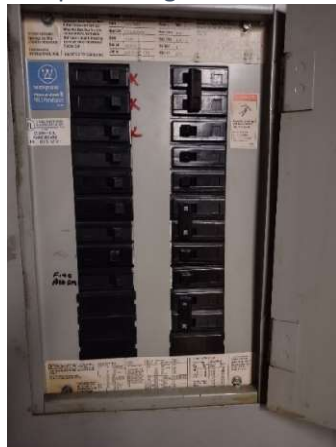
Sub panel original to the facility. Shows signs of corrosion and age.

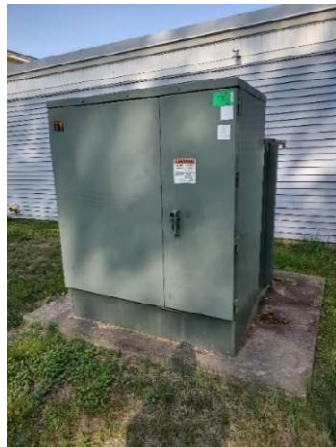
Pad mounted service transformer at the back of the school.

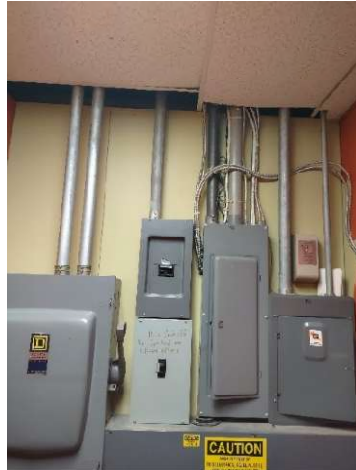
The 1<sup>st</sup> floor electrical service equipment is in Room 134 - Electrical. Functional but some components are past their service lives.

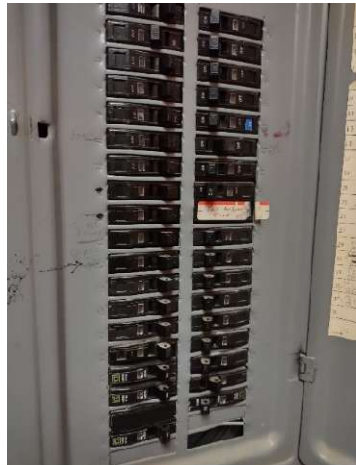
Functional but aging panel.

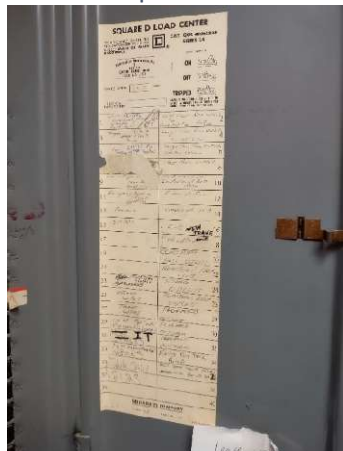
Functional panelboard shows signs of aging.

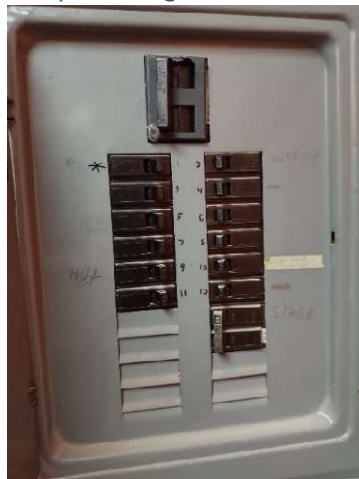
Sub panel original to the facility. Shows signs of age.

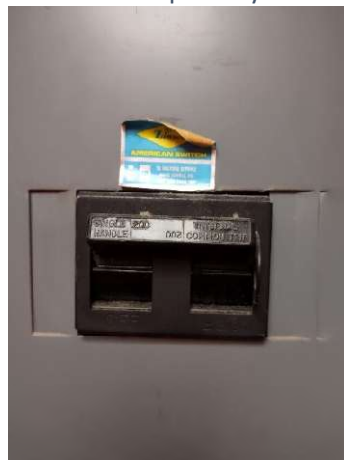
Older 200 amp safety switch.

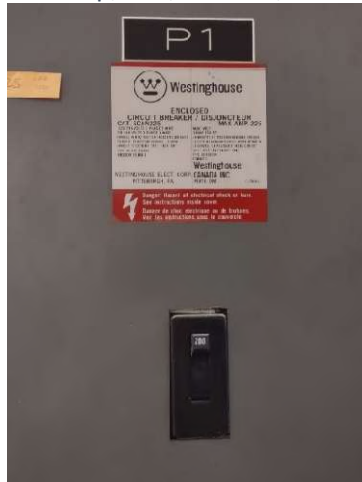
200 amp, 120/240 volt, main breaker – AHU room.

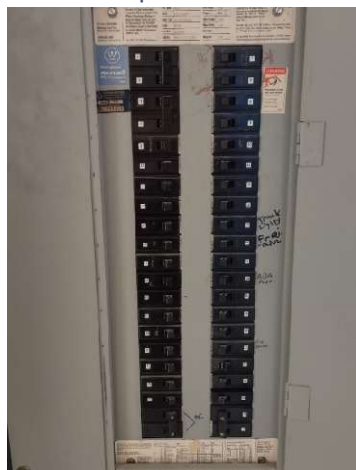
Functional panelboard shows signs of age.

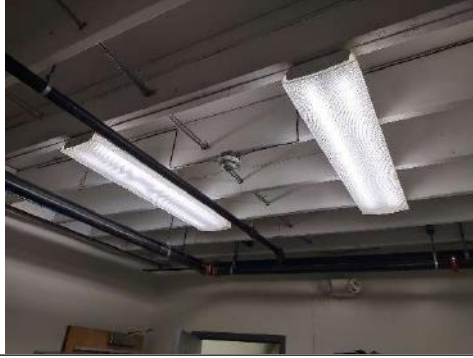
Typical traditional lighting. These tend to provide more glare since they do not “disperse” the light but rather simply shine down. The fixtures appear to still be incandescent and fluorescent type.

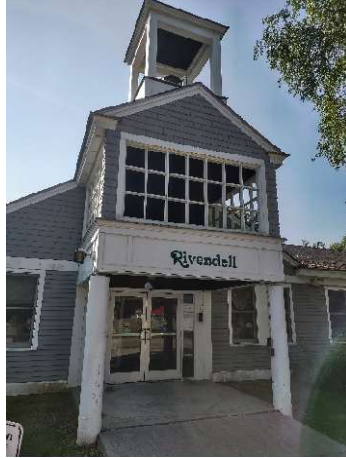
Exterior flood lights with CFL bulbs but showing signs of age.

- The electrical service and some distribution equipment is obsolete and should be replaced as part of any facility upgrade.
- All lighting should be upgraded to LED lighting. This should include emergency lighting for exterior exit paths. Exterior floodlights have LED bulbs but the fixture should be replaced.

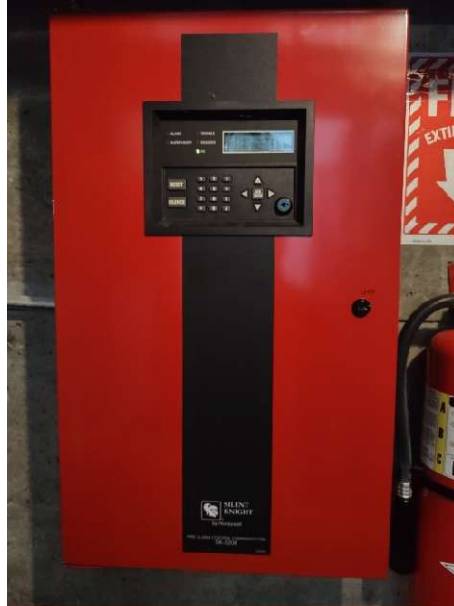
The main fire alarm panel. There were no violation notes on the front cover.

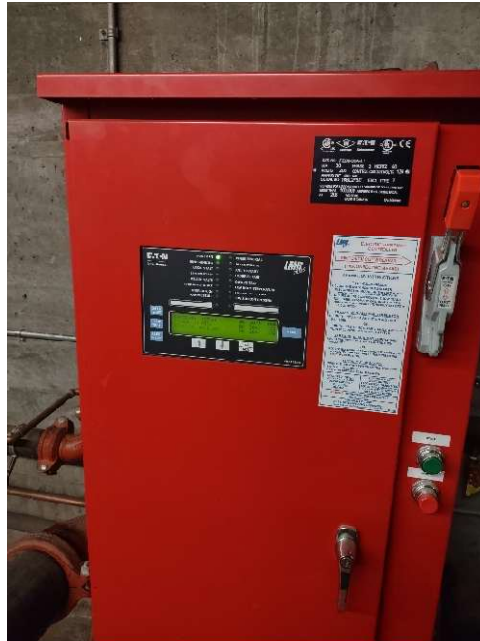
Fire pump controller – recently installed and well maintained.

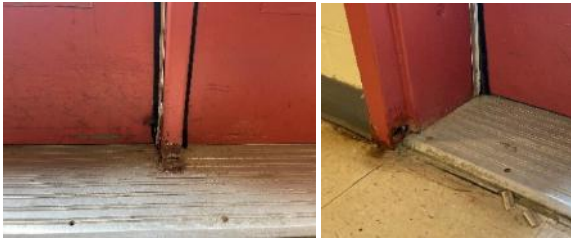
| | | Doors | Poor condition. Recommendation – replace exterior storefront doors.<br> |

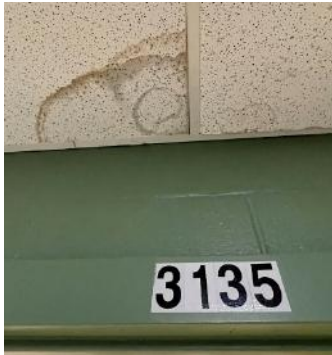
| | | Ceiling | <p>Poor condition. Water staining outside room 3135.</p> <p>Recommendation – Replace damaged tiles.</p> |

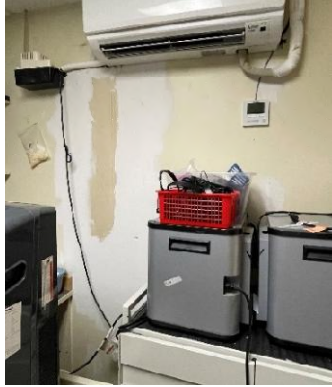
| | | Walls/ Columns | Poor condition.<br>Recommendation – Patch and paint several areas.<br> |

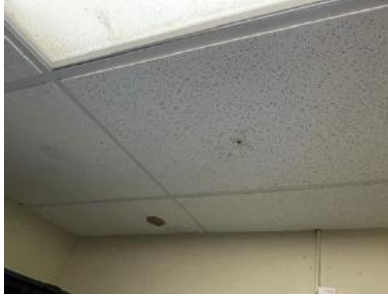
| | | Ceiling | Fair condition. ACT stained at multiple locations, light fixtures have debris.<br>Recommendation – Replace tile, clean light fixtures. |

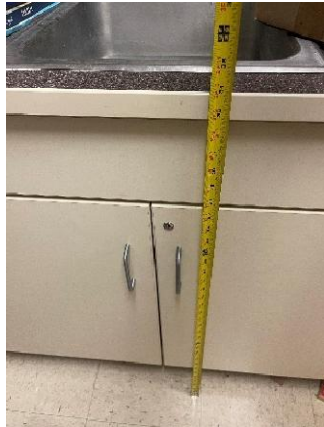
| | | Millwork | Fair condition. Materials in fair condition but the cabinet height is not in compliance. Base cabinets at 34.5" with non-accessible sink.<br>Recommendation – Replace cabinets and sink with ADA compliant units. |

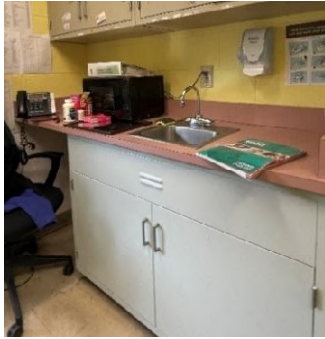
| | | Millwork | <p>Poor Condition. Nurse's Station counter height not in compliance with ADA standards. No ADA access to the sink.</p> <p>Recommendation – Install new ADA open cabinet below sink and 34" counter above base cabinets. Install new door to the right (leading to Office 3135) of the cabinets.</p> |

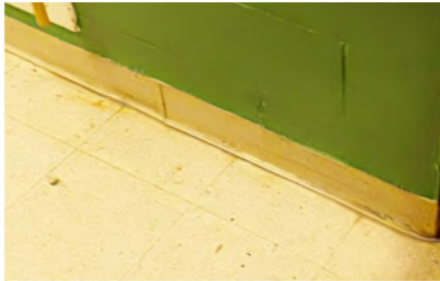
| | | Walls/ Columns | <p>Good condition. Wall base is discolored. Recommendation – Replace wall base.</p> |

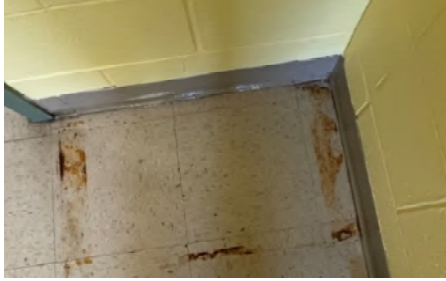
| | | Floor | <p>Fair / Poor condition. Majority of VCT is in fair condition, however, there are isolated areas where furniture locations have left damage and discoloration.</p> <p>Recommend – Replace stained and damaged tiles.</p> |

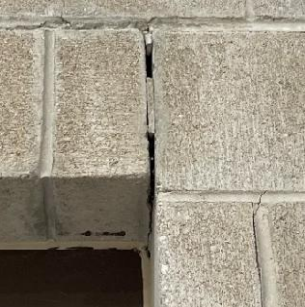
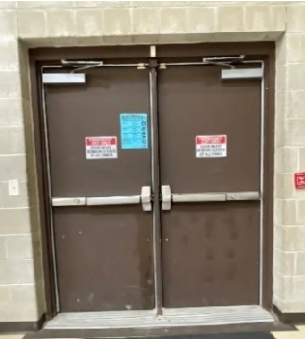
| | | Doors | <p>Fair condition. Dings and dents at all doors, water damage / rust at base of hollow metal doors. Caulking joint above door deteriorating. Recommendation – Repair / replace mortar and soft joints above exterior doors. Repair damage to doors and frame or replace.</p> <div> </div> |

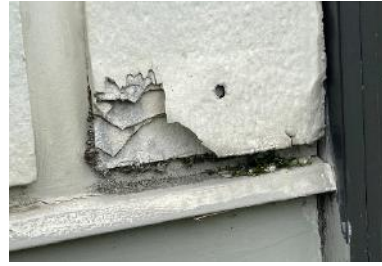
Isolated areas of siding discoloration for various reasons.

Recommendation – Repaint all discolored areas. Patch, repair refinish to match existing. Approximately 10% of façade.

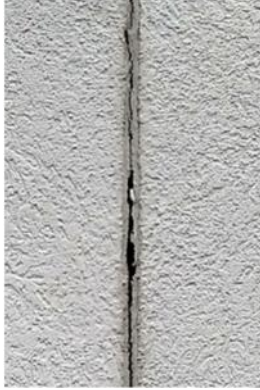
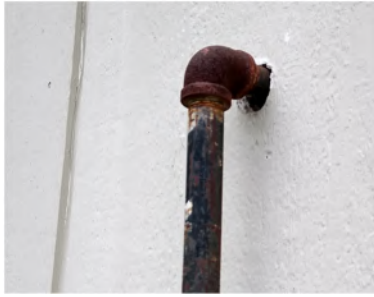
| | | <p>Some exterior wall penetrations are not sealed.<br/>Recommendation – Seal around all exterior wall penetrations.</p> |

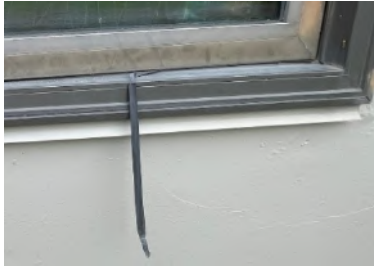
| | Windows | <p>Fair condition. Seals around operable units are falling off. Windows losing finish color.<br/>Recommendation – Provide new seals on operable windows. Repaint windows.</p> |

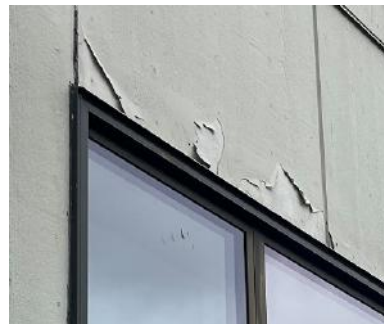
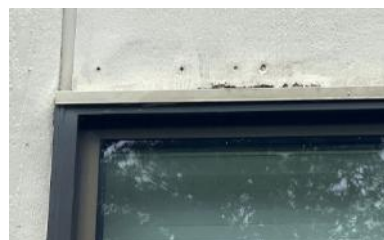
Additional areas of siding damage at windows specifically. Refer to above siding section for recommendations.

Approximately 90% of windows.

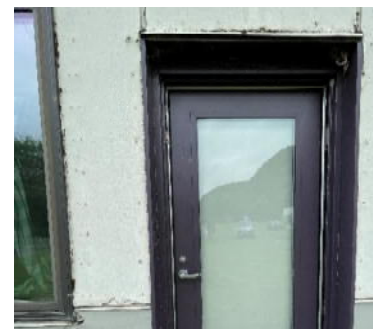
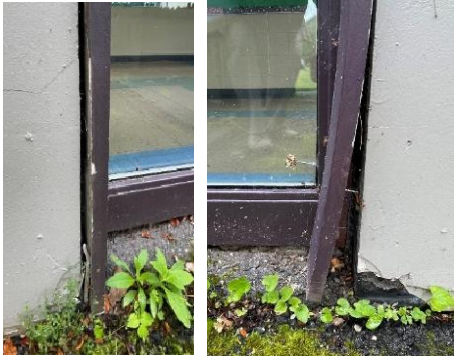
Additional areas of siding damage at doors specifically. Refer to above siding section for recommendations.

Approximately 80% of doors.

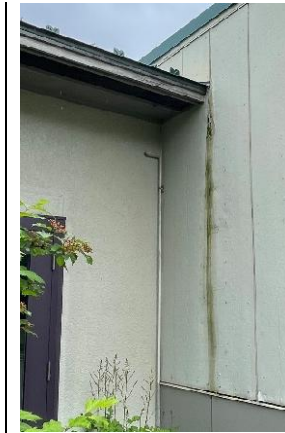
| 4. | Roof | <p>Fair condition. Low Slope Roof single-ply EPDM membrane at gym installed c.1999 so may be approaching end of service life. Pitched Roof standing seam metal installed c.2019.</p> <p>Water shedding from pitched roof on south side above Media Room is deteriorating siding below.<br/>Recommendation – Install rain diverter or gutter to protect siding.</p> |

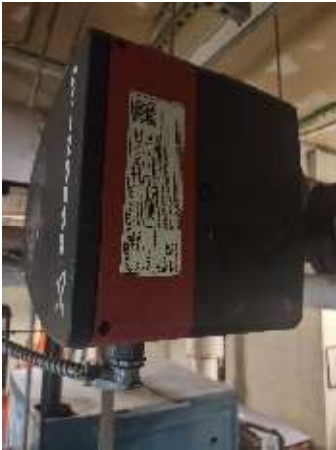
AHUs (2) with larges fans, and duct arrangement.

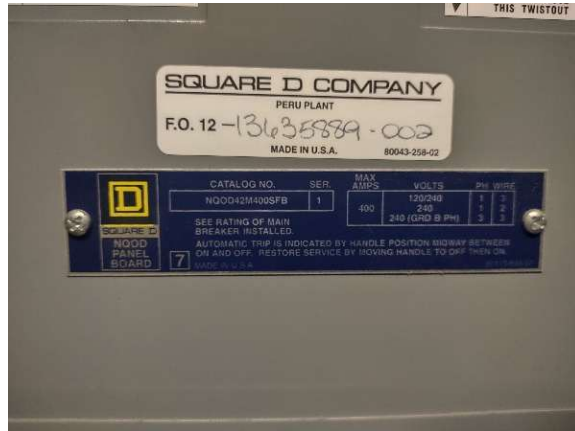
Older main breaker.

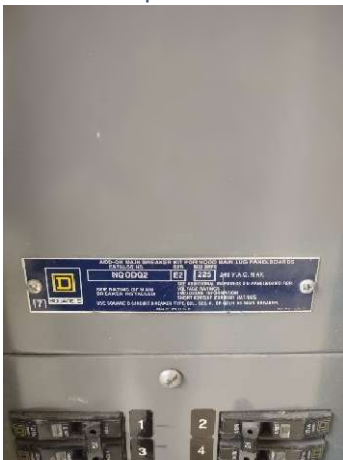
Older breakers in fully populated panel.

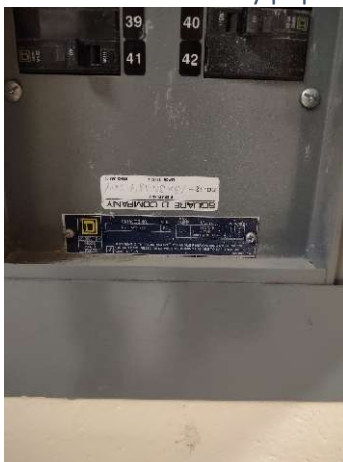
Panelboard near end of service life.

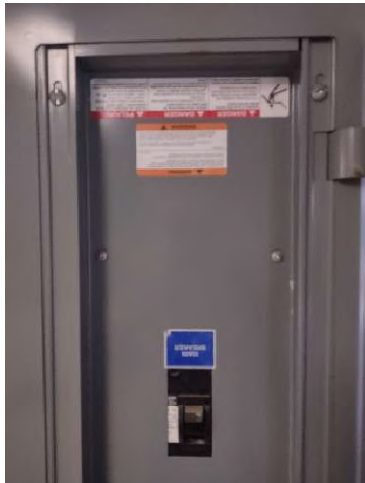
Fully populated panel with older breakers.

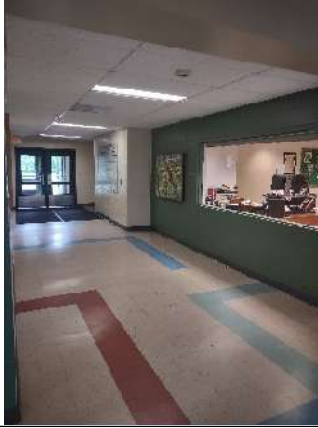
T-8 lighting – typical..

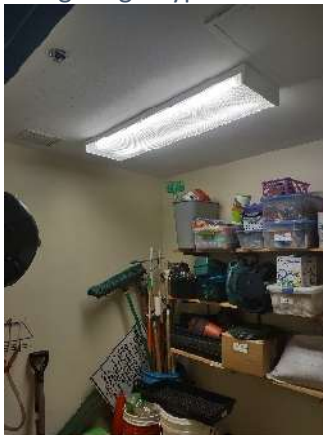
T-8s should be replaced with LED.

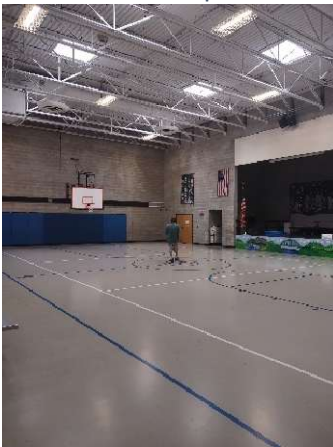
Exterior flood lights to be upgraded.

- Some electrical distribution equipment is obsolete and should be replaced as part of any facility upgrade.
- All lighting should be upgraded to LED lighting. This should include emergency lighting for exterior exit paths. Exterior floodlights have LED bulbs but the fixture should be replaced.

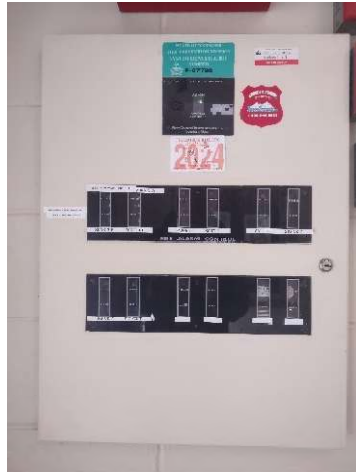
FACP – sub panel – typical

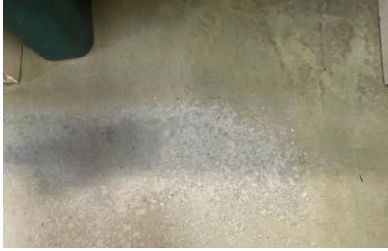
| | | Floor | Fair condition. Portions of the floor are obscured by walk-off carpet mats. Minor discoloration.<br> |

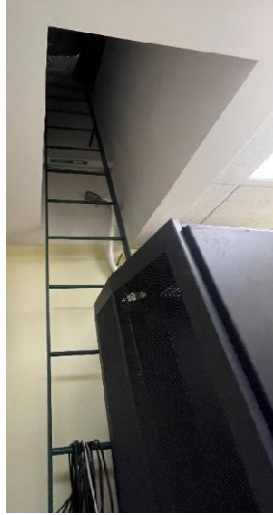
| | | Ceiling | Good condition. There is a roof hatch ladder going in good condition. Hatch above has visible light coming through does not appear to be sealing properly.<br>Recommendation – Review and repair or replace roof hatch. |

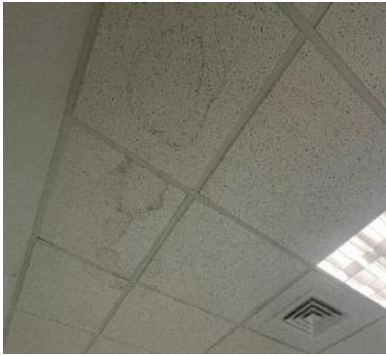
| | | Ceiling | Fair condition. Water Damage at a couple ceiling tile near diffuser<br>Recommendation – Replace stained ceiling tiles.<br><br> |

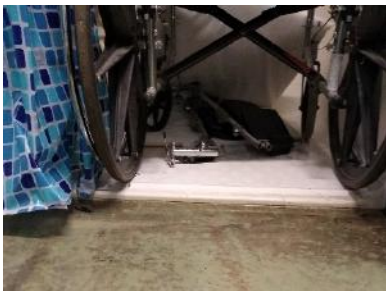
| | | Millwork | Fair condition however does not meet ADA requirements - 39" sink height.<br>Recommendation – Install sink at ADA height.<br>Fair condition - Shower portion.<br>Recommendation reseal around shower. |

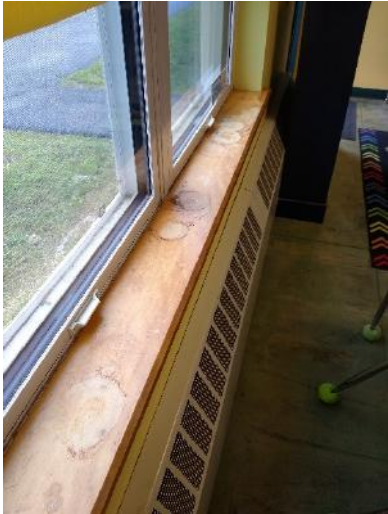
| | | Walls/ Columns | Good condition.<br>Windowsills poor condition.<br>Recommendation – Replace water damaged sills. |

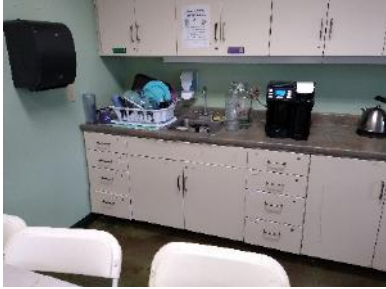
| | | Borrowed Lites | N/A |
|---|---|---|---|
| | | Millwork | <p>Millwork in Fair condition however does not meet ADA requirements - 38" sink counter laminate but no clear ADA access below.<br/> Recommendation – Install ADA access sink cabinet with proper counter height.<br/> Overhead storage adjacent to entry door.<br/> Recommendation – Remove or move shelving up to provide min. 6'-8" head clearance.</p> |

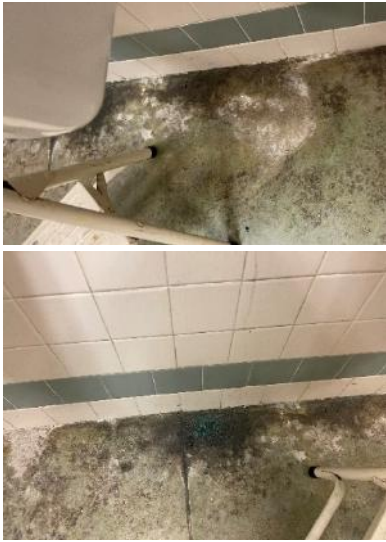
| | | Floor | Poor condition. Damaged floor shows signs of water damage.<br>Recommendation – Replace flooring or provide extensive cleaning / water damage repair to existing flooring. |

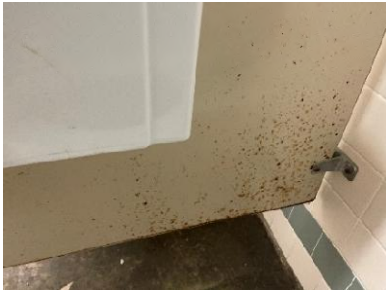
| | | Millwork | Poor condition. Rusted out base of partitions.<br><br>Recommendation – Replace partitions. |
