## **FACILITIES CONDITION ASSESSMENT**

### **Rivendell Interstate School District**

Rivendell Academy East & West Wings | Samuel Morey Elementary | Westshire Elementary

September 25, 2025

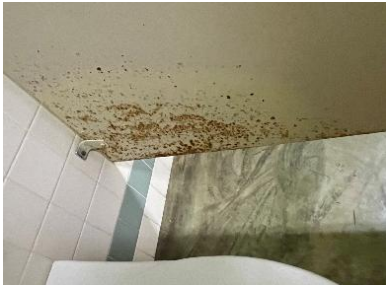
| 30. | Room 4129 Boys Restroom | | Poor condition. Rusted out base of partitions.<br><br>Recommendation – Replace partitions. |

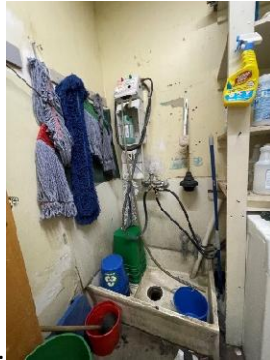
| | | Floor | Poor condition concrete floor.<br>Owner to review to determine if suitable for janitorial closet.<br><br>Recommendation – Renovate space with new flooring, sink, GWB. |

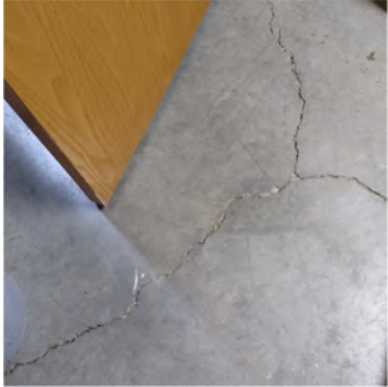
| | | Floor | <p>Floor obscured by stored material so only able to assess portion near entry door which has significant crack.</p> <p>Recommendation – Repair crack.</p> |

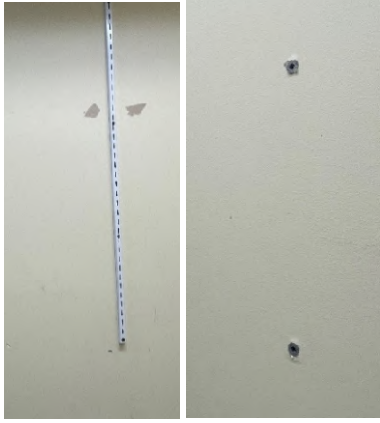
| | | Walls/ Columns | <p>Fair Condition. Holes and damage.</p> <p>Recommendation – Patch and paint.</p> |

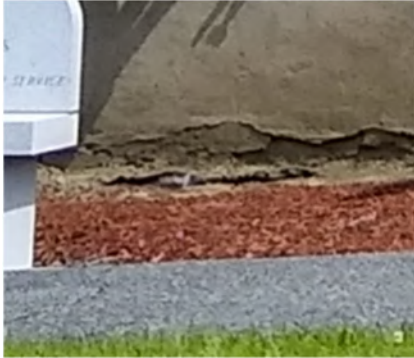
| | | | <p>Concrete foundation in poor condition. Foundation parging at south façade deteriorating where it meets the ground and to the right of the entry door.</p> <p>Recommendation – Repair parging.</p> |

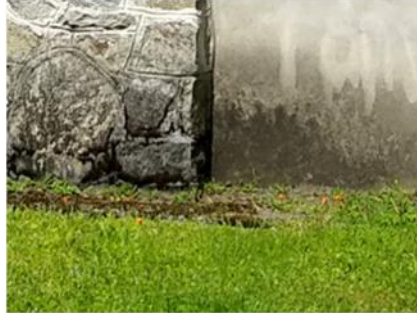
Stone foundation and window infill panels at east façade are discolored where they meet the ground. Recommendation – Clean materials and assess for damage.

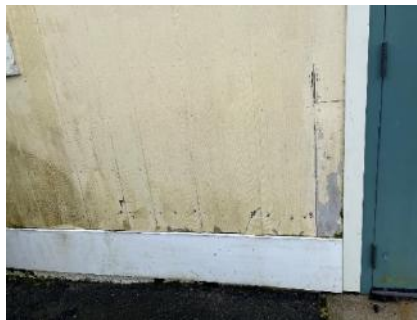
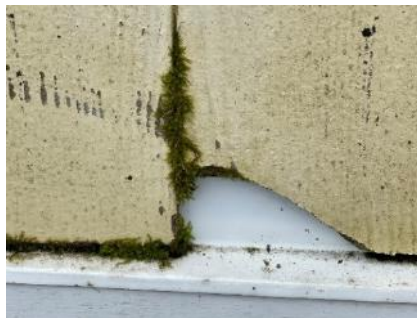
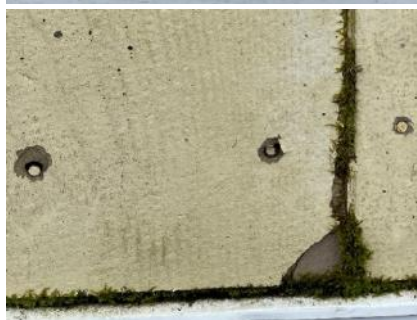
Siding / Trim

Poor condition. See below photos for a wide variety of siding issues rendering the need for replacement. Recommendation – Replace siding and all associated trim. Confirm no water damage behind siding.

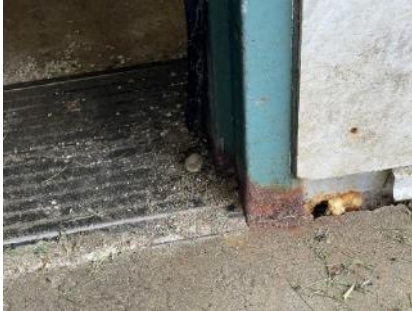
| | | Doors | <p>Poor condition. Damaged base of door and frame, rusted, worn, and faded.</p> <p>Recommendation – Repair doors and replace door / frame where necessary.</p> |

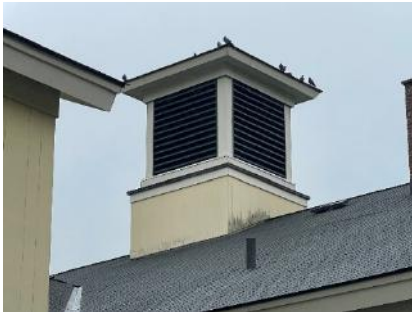
| 3. | Elements [e.g., Columns] | | <p>Siding Damage at base of Roof cupula. Cannot confirm if there is roof damage.</p> <p>Recommendation – Consult a roofing contractor to determine the probable cause of the leaks and to develop a plan to remediate them.</p> |

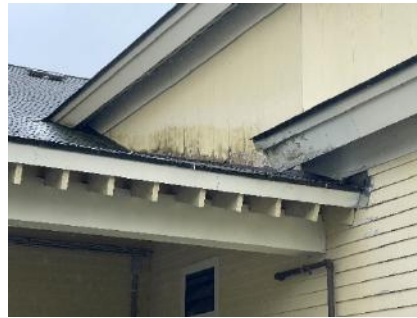
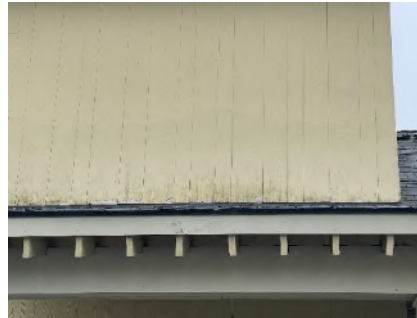
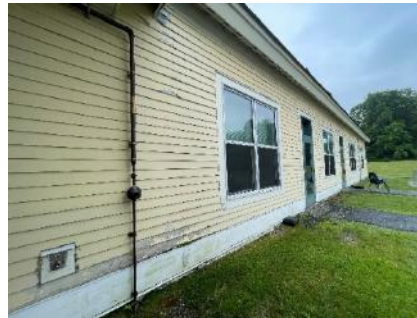
Poor condition, particularly at roof to wall intersection. Large area where the gabled roof meets the higher wall there are signs of significant water damage. The roof and wall damage tracks to the ground.

Recommendation – Consult a roofing contractor to determine the scope of work for the roof and best method to remediate the wall intersection problem.

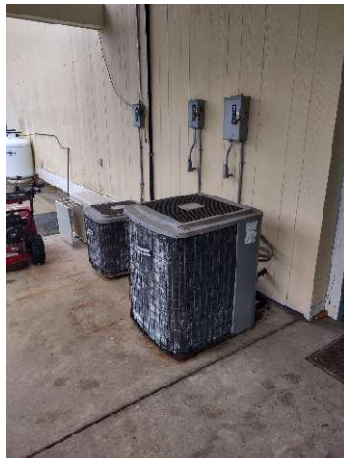
Split heating and cooling system is used in the office areas of the facility. These units are in good condition but should be cleaned. Inner blower fans, filters, tested, and more closely evaluated. They have completed more than half of their expected 15 to 20 years life cycle. The facilities upgrade project should include the replacement or upgrade of these split systems.

Split duct condenser unit.

Replace heating system circulation pumps and VFDs.  
Replace split duct cooling systems.  
Replace window mounted AC units.

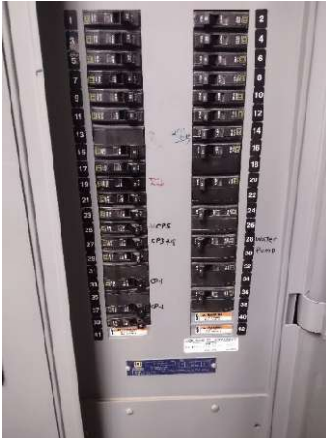
Panelboard for boiler room.

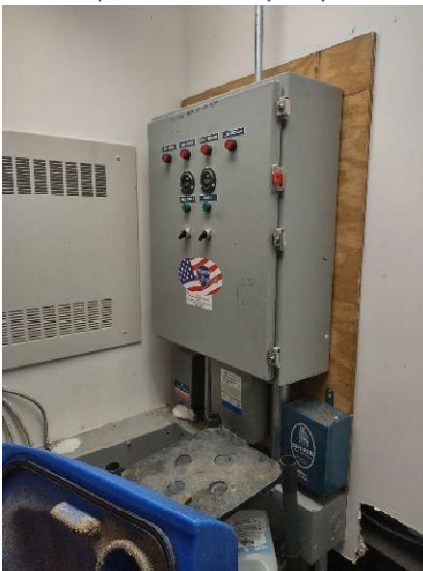
Control panel for well pumps.

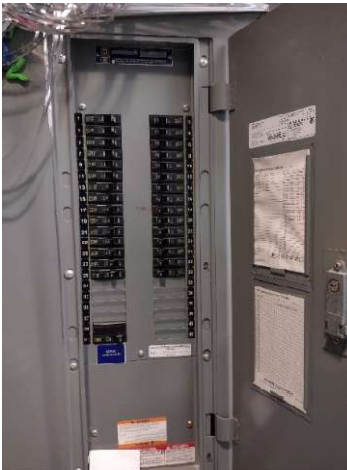
Panel for lighting and outlets – typical.

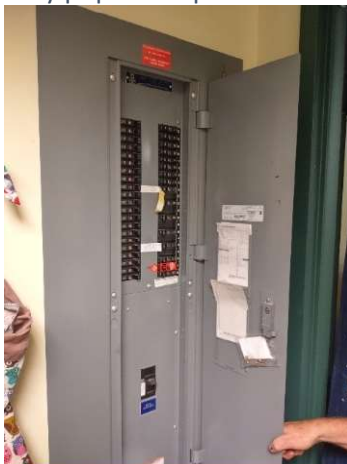
Fully populated panel with emergency fire circuit.

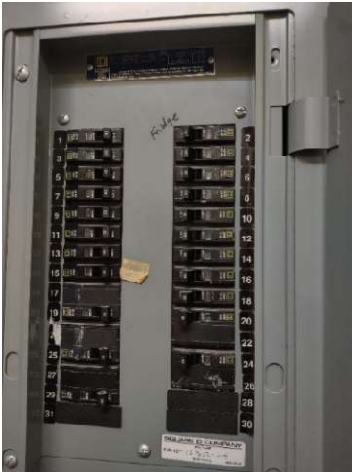
Panelboard for kitchen.

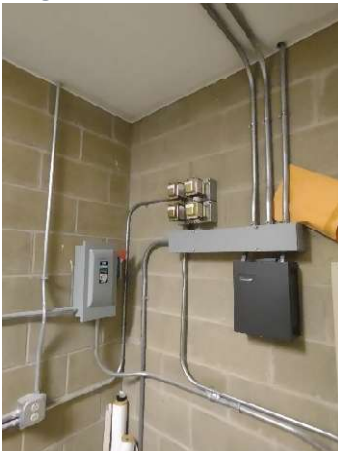
Stage AHU disconnect and wiring in conduit arrangement.

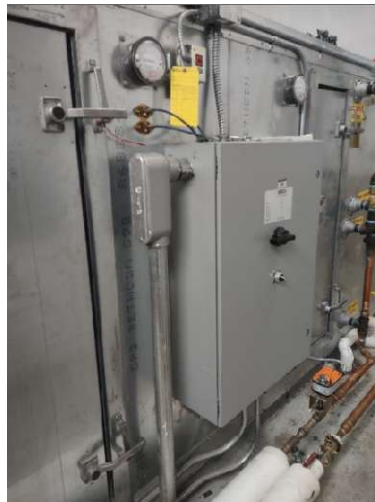
AHU Room above boiler room – auto shut off switch.

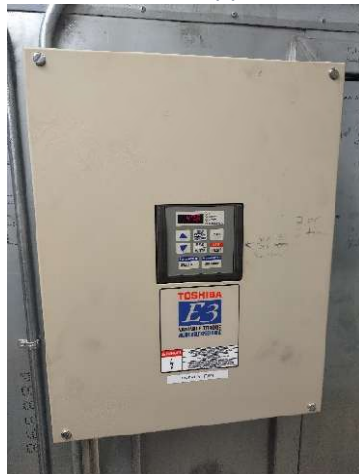
AHU controls in upper boiler room AHU space.

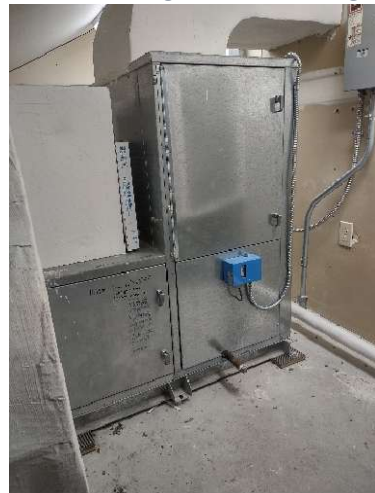
Control wiring for AHU arrangement.

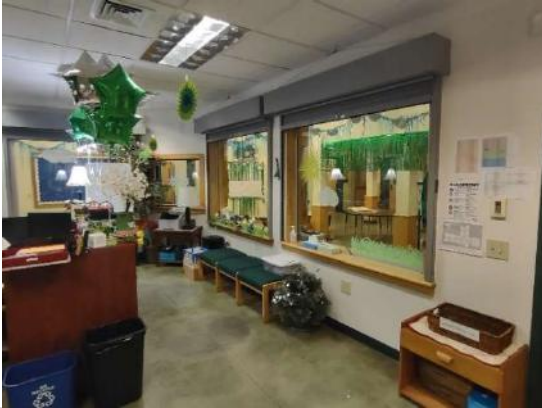
Some of the indoor lights are incandescent bulbs, T8 fluorescent, ceiling mounted 2" x 2", or 2" x 4" troffer type. This type of lighting is usually recommended for replacement with LED. All exterior lighting should be upgraded to LED type. The exterior mounted lighting is on timers and was not on during the day, suggesting either the time clock and a photocell controlling the lights are working correctly.

| 3. | Lighting | Typical traditional lighting. The fixtures appear to still be incandescent and fluorescent type. |

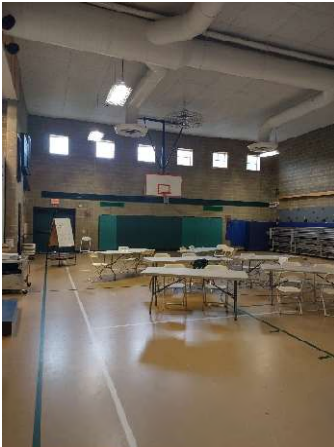
| | | T-8 lighting in the gym. |

T-8s should be replaced with LED.

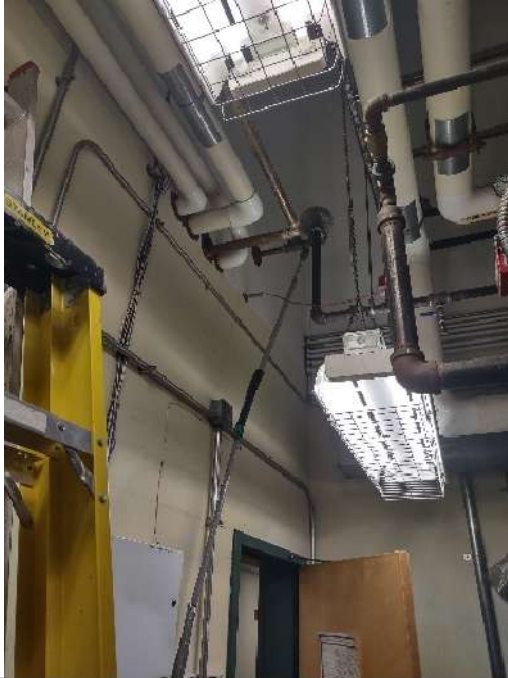
Exterior flood lights to be upgraded.

- Some electrical distribution equipment is obsolete and should be replaced as part of any facility upgrade.
- All lighting should be upgraded to LED lighting. This should include emergency lighting for exterior exit paths. Exterior floodlights have LED bulbs but the fixture should be replaced.

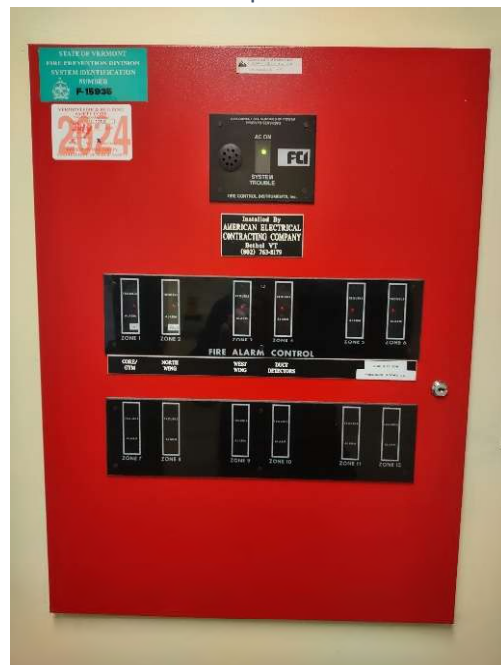
The fire alarm system control panel is an audible and addressable type system. It appears to be in good condition. The front cover indicates no violations. Inspected in 2024. The fire alarm system, however, does not appear to have voice notification.

The main fire alarm panel. There were no violation notes on the front cover.

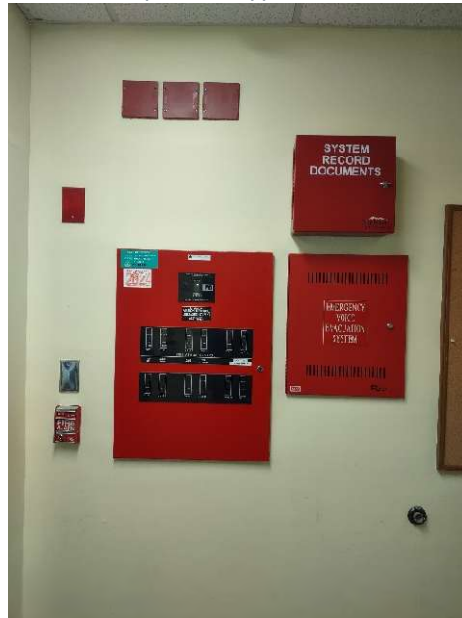
FACP – sub panel – typical
